ARKANSAS DEPARTMENT OF ENVIRONMENTAL QUALITY
Agricultural Permit Inspection Report

Inspection Date May 6, 2011	AFIN Number 71-0034	Permit Number 3819-WR-1	County Van Buren	Compliance Status In
Facility Name and Location Located 4 miles north of Jerusalem on CR 32 in Van Buren County Lat: N 35.4668 Long: W 92.8332		Name of Responsible Official Mr. Steve Sommers		Mailing Address Steve Sommers Sommers Hog Farm 484 Cascade Road Jerusalem, AR 72080
		Phone Number (479) 626-6814		
Legal Description Sec. <u>32</u> Tns. <u>10N</u> Rng. <u>14W</u>		Name of Person Contacted No one present		Title Owner
Grow or Produce for: Cargill Pork		Design Animal Type and Capacity 630 Sow, 800 Pig Farrowing (P-1)		
Evaluate the Following Areas: S-Satisfactory M-Marginal U--Unsatisfactory N-Not Evaluated				
Part 1 - Operation and Maintenance

Arkansas Department of Environmental Quality (ADEQ)
Official Photograph Sheet

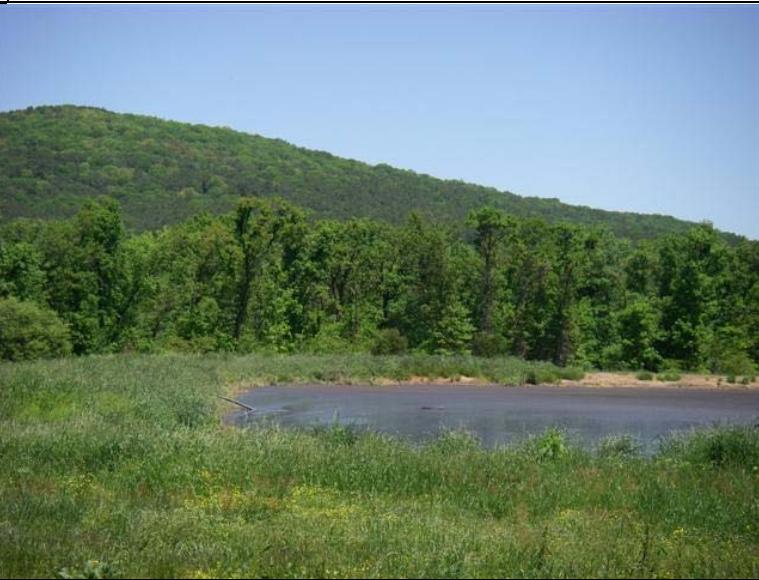
Location:	Sommer's Swine Farm, Van Buren County							
Photographer:		Tony Morris			Witness:			
Photo #	1	Of	2		Date:	05/06/11	Time:	11:24
Description:		The Holding Pond with submersible recycle flush water pump float and line visible.

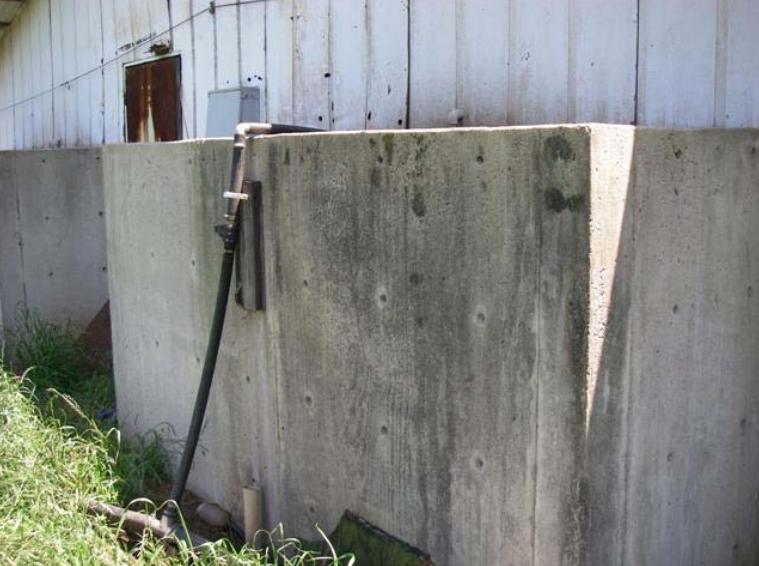
Photographer:		Tony Morris			Witness:			
Photo #	2	Of	2		Date:	05/06/11	Time:	11:26
Description:		Flush tanks on the side of the B&G barn. Concrete in good condition with no leaks or cracks.
