ADEQ Water NPDES No Exposure	AFIN: 56-00047	Permit #: AR00356	602
	VIRONMENTAL PROTECTION AGENCY Yashington, D.C. 20460		Form Approved OMB No. 2040-0003
NPDES Compli	ance Inspection R	Report	
	Section A: National Data Syst	stem Coding	
Transaction Code	DES 6 0 2 11 12 1	Yr/Mo/Day Ins 1 1 0 2 5 17 18	pec. Type Inspector Fac. Type V 19 S 20 1
	Remarks		
5 6 - 0 0 0 4 7		P O I	N S E T T
Inspection Work Days Facility Evalue 67 69 70 N		A	Reserved
	Section B: Facility D	ata	
Name and Location of Facility Inspected (For industrial us include POTW name and NPDES permit number) City of Trumann WWTP		Entry Time/Date 10:20 / October 25, 2011	Permit Effective Date October 1, 2009
¼ mile north of the Hwy 69 and Hwy 198 intersection. Trumann, AR Poinsett County		Exit Time/Date 14:55 / October 25, 2011	Permit Expiration Date September 30, 2014
Name(s) of On-Site Representative(s)/Title(s)/Phone and F Scotty Jones / Manager / 870-284-0418	ner Facility Data

This sanitary sewer overflow inspection revealed the following violation:

ADEQ Water NPDES No Exposure	AFIN: 56-00047	Permit #: AR0035602

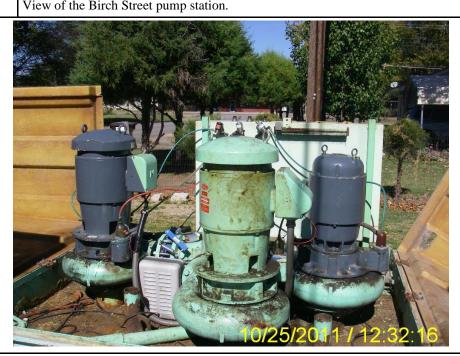
Water Division NPDES Photographic Evidence Sheet									
Location:	Ci	ty of Tr	umann, V	VWTP					
Photograph	Photographer: Michael Greenway Witness: Brent Walker								
Photo #	1	Of	6		Date:	10/25/2011		12:32	
Description	:	View o	f the Bird	ch Street pump station.

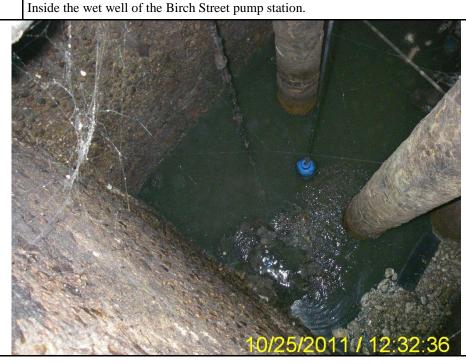
Photograph	ier:	Michael Greenway		Witness:	Brent Walke	Brent Walker		
Photo #	2	Of	6		Date:	10/25/2011	Time:	12:32
Description: Inside the wet well of the Birch Street pump station.

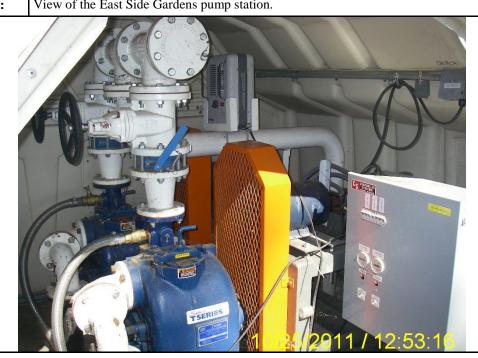
Water Division NPDES Photographic Evidence Sheet								
Location:	Location: City of Trumann, WWTP								
Photograph	ner:	Michae	el Greenv	ay Witness: Brent Walker					
Photo #	3	Of	6		Date:	10/25/2011 Time: 12:53			
Description: View of the East Side Gardens pump station.

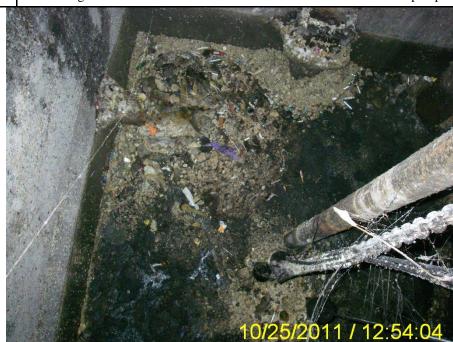
Photo #
 4
 Of
 6
 Date:
 10/25/2011
 Time:
 12:54

Excessive grease and solids in the wet well of the East Side Gardens pump station.
