On January 31 and February 01, 2012, David Long, USEPA Region 6, Ronald Smith, ADEQ District 10 Water Inspector, and I performed a routine compliance inspection of the facility in accordance with the provisions of the Federal Clean Water Act, the Arkansas Water and Air Pollution Control Act, and the regulations promulgated thereunder. This inspection revealed the following:

ADEQ Water NPDES Inspection	AFIN: 02-00013	Permit #: AR0001210

Georgia-Pacific LLC: Crossett Paper Operations

Response to Inspections #064300 and #064303

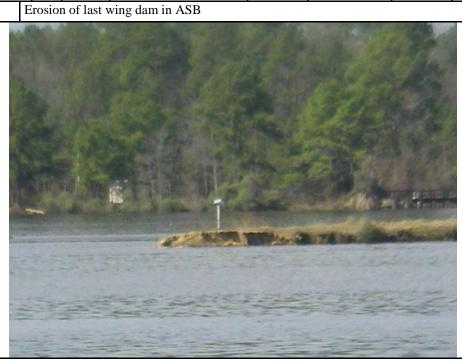
Water Division NPDES Photographic Evidence Sheet											
Location: Georgia Pacific LLC, Crossett												
Photograph	er:	John L	amb		Witness:	Ronald Smith						
Photo #	1	Of	5		Date:	01/31/2012	Time:	11:55				
Description	:	Erosio	n of last v	wing dam in ASB

<u>Section C, Item 2</u>: The last wing levee in the Aeration Stabilization Basin (ASB) had excessive erosion on it. See photos 1 and 2.

The last wing levee in the Aeration Stabilization Basin (ASB) had excessive erosion on it. This is a violation of Part III.B.1.a of the permit.

This wing levee has been stabilized with large ballast rock and concrete to prevent further erosion from occurring. A more recent photo is attached. Once again, all before pictures are taken from the inspection report received from the Arkansas Department of Environmental Quality.

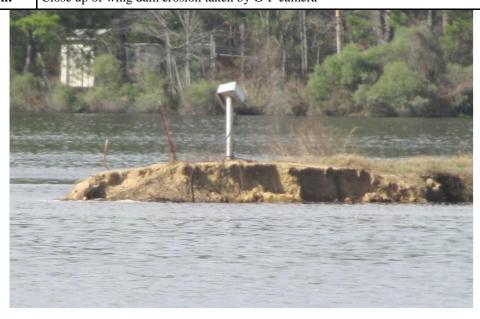
Photograph	ner: I	Richard	d Freema	n, G-P	Witness:	John Lamb		
Photo #	2	Of	5		Date:	01/31/2012	Time:	11:55

Description: Close up of wing dam erosion taken by G-P camera

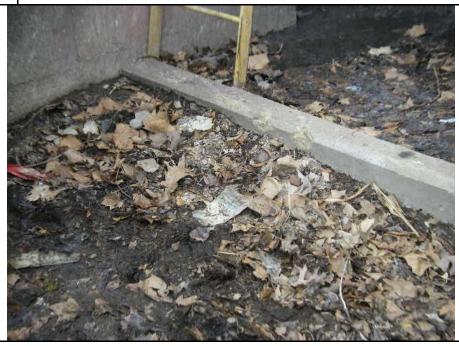
Water Division NPDES Photographic Evidence Sheet										
Location: Georgia Pacific LLC, Crossett											
Photographe	r: J	ohn La	amb		Witness:	Ronald Smit	h				
Photo #	3	Of	5		Date:	01/31/2012	Time:	13:15

The bar screen had excessive solids on the ground on both sides which needed to be cleaned up. See photos 3-5.

Description: East side of bar screen showing excessive solids on the ground.

The bar screen area had excessive solids on both sides of the ground. This area needed better housekeeping. This is a violation of Part III.B.1.a of the permit.

The area around the bar screen has been cleaned up and better housekeeping practices have been implemented and communicated to affected employees. A more recent photo is attached. Please note that all before pictures are taken from the inspection report received from the Arkansas Department of Environmental Quality.

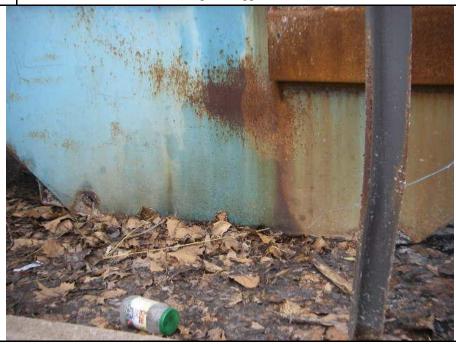
Photo #
 4
 Of
 5
 Date:
 01/31/2012
 Time:
 13:15

Description: East side of bar screen at the dumpster hopper. Solids need to be removed more frequently.

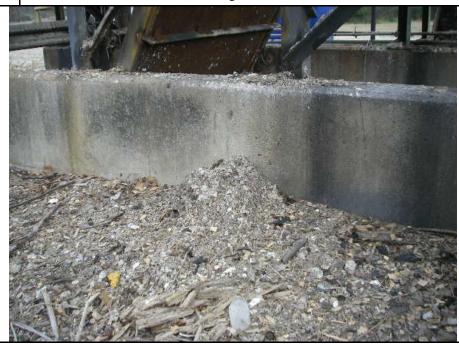
Water Division NPDES Photographic Evidence Sheet												
Location:	Cocation: Georgia Pacific LLC, Crossett											
Photograph	ner:	: John Lamb			Witness:	Ronald Smith						
Photo #	5	Of	5		Date:	01/31/2012	Time:	13:15

Description: West side of bar screen, solids on the ground

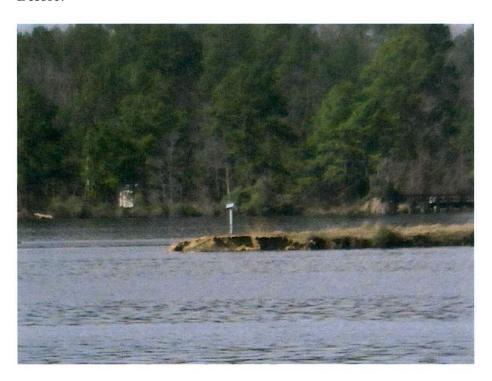
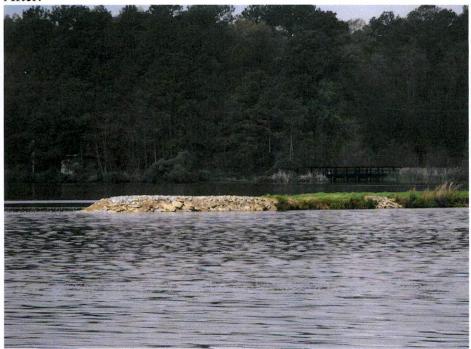
Photo # 1 of 5

Description: Erosion of last wing dam in ASB.

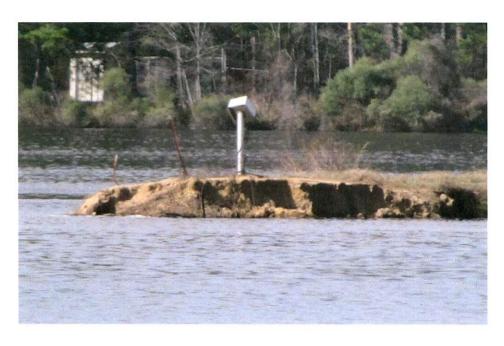
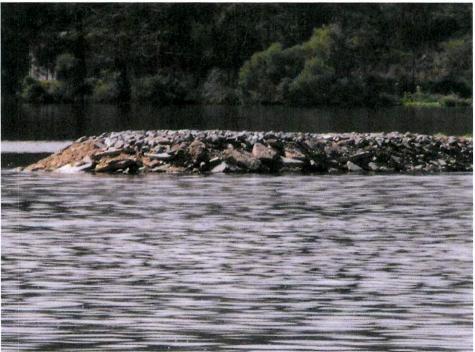
Photo # 2 of 5

Description: Close up of wing dam erosion taken by G-P camera.

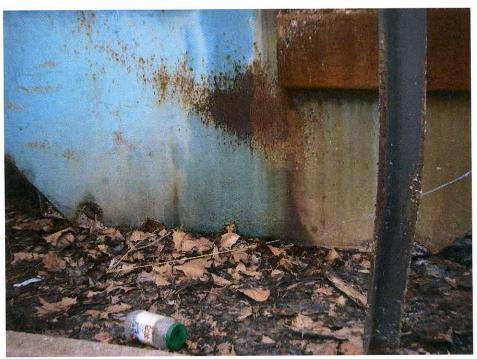
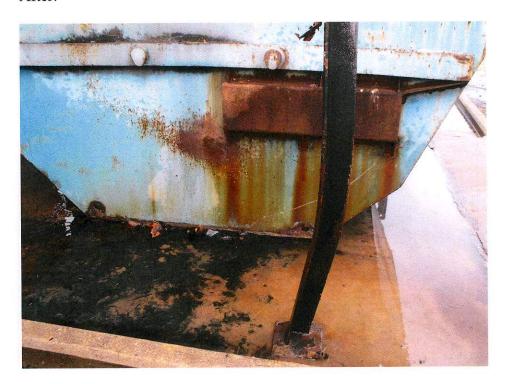
Photo # 4 of 5

Description: East side of bar screen at the dumpster hopper. Solids need to be removed more frequently.

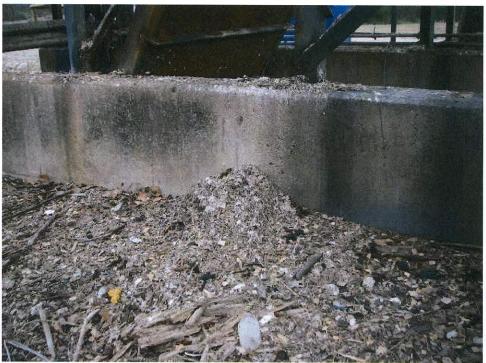
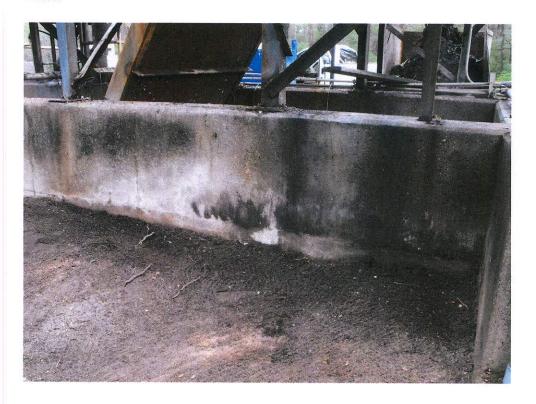
Photo # 5 of 5

Description: West side of bar screen, solids on the ground.
