RE: Discharge of sludge from the Waste Water Treatment Plant
AFIN: 69-00011, NPDES Permit No.: AR0020117

NPDES Compliance Inspection Report

Water Division NPDES Photographic Evidence Sheet

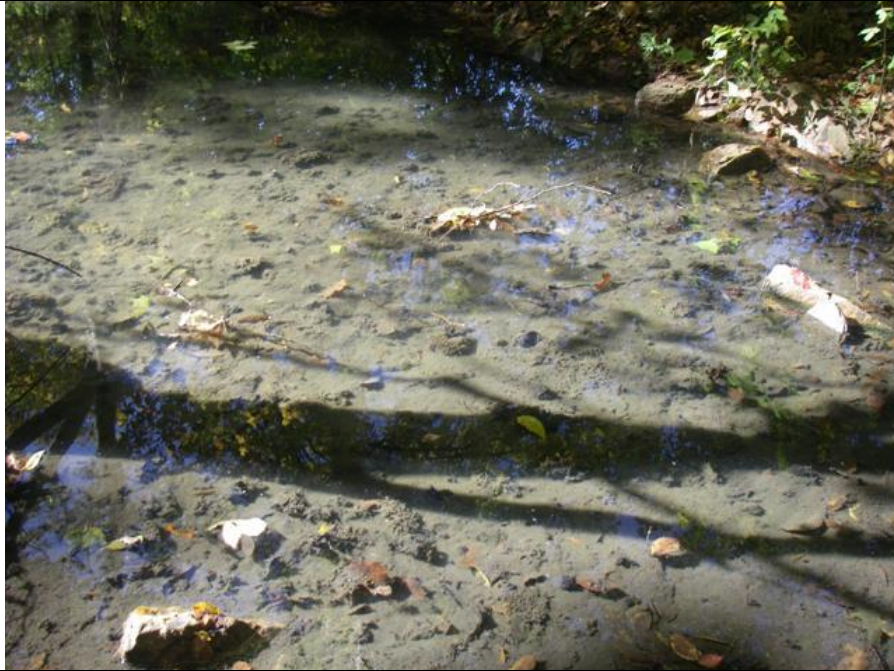
Photo # 1 **Of** 4 **Date:** 10/15/12 **Time:** 10:03

1. Part I, Section A of the permit states there should be no discharge of distinctly visible solids, scum, or foam of a persistent nature, nor shall there be any formation of slime, bottom deposits, or sludge banks. During the site inspection sludge banks were observed in the receiving stream. This material is making it through the treatment system and being discharged to the receiving stream in violation of Part I, Section A of the permit, and Ark. Code Ann. § 8-4-217(a)(2) which states, "It shall be unlawful for any person to place or cause to be placed any sewage, industrial waste, or other wastes in a location where it is likely to cause pollution of any waters of the state."

Description: Activated sludge in a pool within Hughes Creek.

The above items require your immediate attention. You must immediately cease the discharge of partially treated wastewater to Hughes Creek. Furthermore, you must submit a written response to the above findings to the attention of the Water Division Inspection Branch of ADEQ at the address listed on this letter head. This written response should contain detailed documentation describing the course of action taken to correct the violations noted. This corrective action should be completed as soon as possible, and the written response shall be submitted to the Department by **November 6, 2012**.

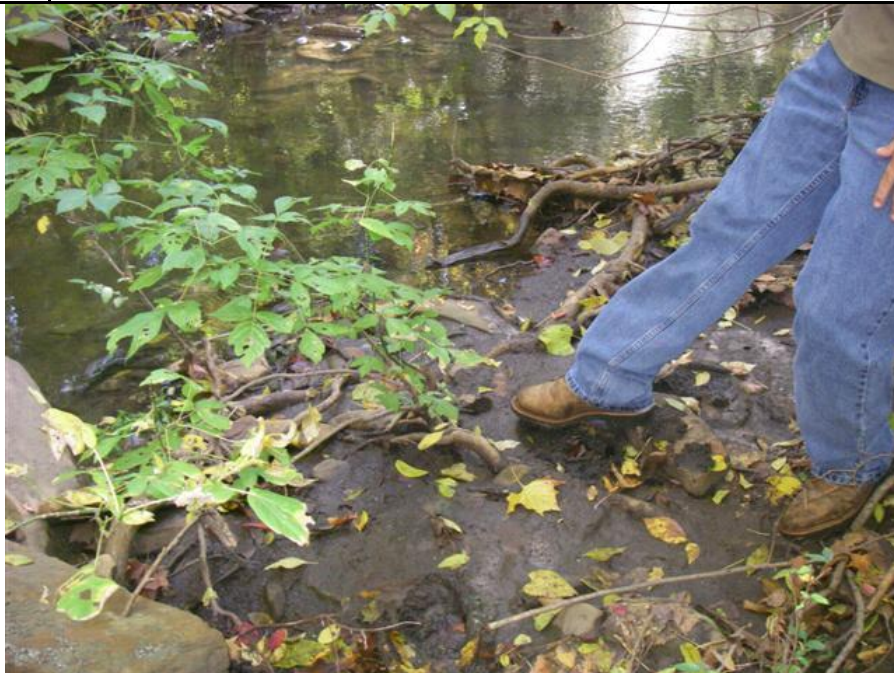
Photo # 2 **Of** 4 **Date:** 10/15/12 **Time:** 10:09

- This site visit was the result of a citizen complaint concerning sludge in Hughes Creek.
- The complaint was found to be valid.
- There are operational problems at the treatment plant. Large volumes of sludge are being discharged to the receiving stream.
- The discharge of distinctly visible solids and the formation of bottom deposits and sludge banks is a violation of the permit.

Description: Sludge coating the stream bed of Hughes Creek below the Mountain View POTW.

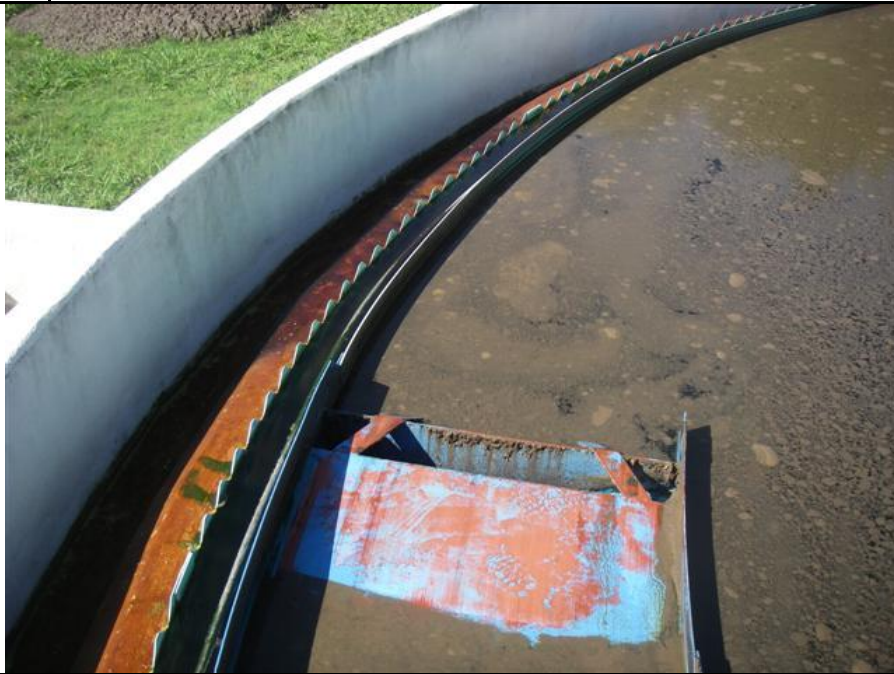
Location:							
Photographer: Tony Morris				Witness: Sean Saunders			
Photo #	3	Of	4	Date:	10/15/12	Time:	10:36
Description: The final clarifier with floating, unsettled sludge on the surface.

Agreed, that any solids discharge is unacceptable from the Treatment Plant discharge outfall or from the Treatment Plant site. From our field inspection on October 31, we did find fine pin floc coming over the weirs and unsettled sludge floating on top of the clarifier.

1. Get the Activated Sludge Plant back to operating normally by December 1st
 - a. This includes restoring a proper sludge age and F/M ratio to get the sludge back to settling properly in clarifier.
 - b. Begin a systematic wasting schedule to be followed based on the amount of incoming flow and the biomass health and amount of solids in the oxidation ditch. See attached WAS rate.
 - c. Review of grease traps and required Pretreatment Ordinances to protect the Plant from the grease that is interfering with drying bed operations.
 - d. Additional sampling to determine Influent BOD, TSS loading, MLSS concentrations, RAS concentrations and WAS concentrations.
2. Additional training for the operators by January 1st, on how to handle large hydraulic wet weather influxes to retain the solids with in the Treatment Plant's Oxidation Ditch, Clarifier and Digester.

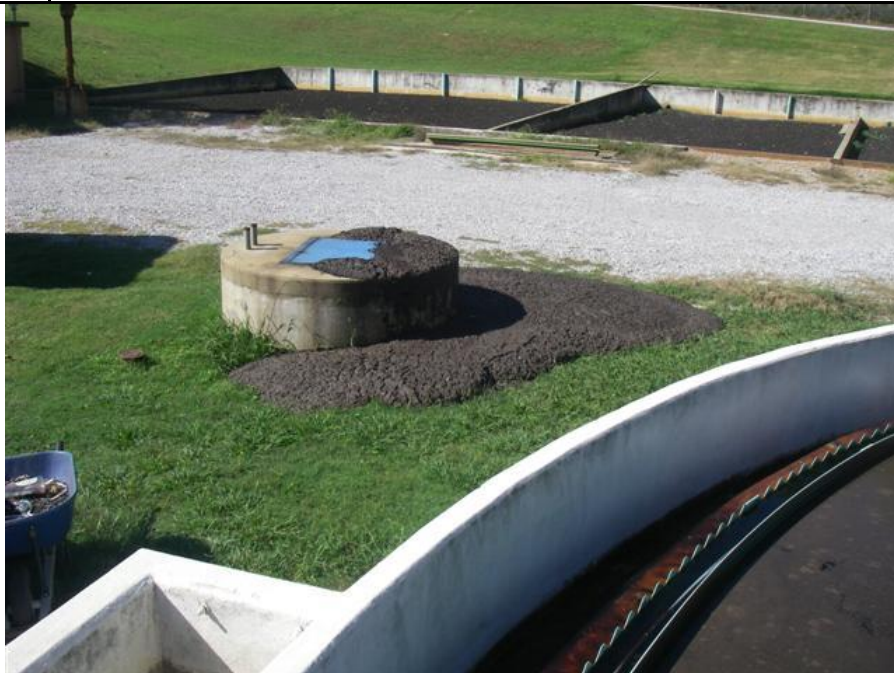
Photographer: Tony Morris				Witness: Sean Saunders			
Photo #	4	Of	4	Date:	10/15/12	Time:	10:39
Description: Recently spilled sludge within the plant with drying beds visible in the background.

The sludge shown in your pictures within the Plant grounds was at the Clarifier manhole from the oxidation ditch and the sludge came from a large hydraulic rainfall event that caused the floating sludge to spill out of the manhole during the rain event.
