NPDES Compliance Inspection Report

| Name and Location of Facility Inspected (For industrial users discharging to POTW, also include POTW name and NPDES permit number) City of Pocahontas WWTP ~0.4 mi. south of Swan Cove intersection with Black River Pocahontas, AR Randolph Co. | Entry Time/Date 1330 4/1/2013 | Permit Effective Date 4/1/2009 |

Water Division NPDES Photographic Evidence Sheet

Location: Sewer line for 2317 Hospital Dr., Pocahontas, AR

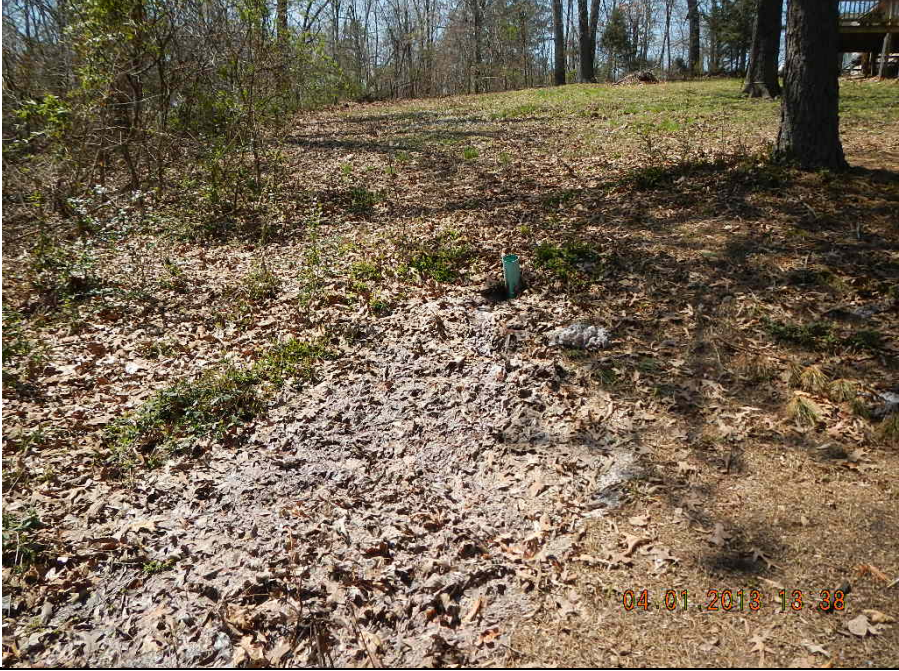
Photo # 1 **Of** 4 **Date:** 4/1/2013 **Time:** 1338

This reconnaissance inspection was conducted in response to a complaint alleging an overflow of sewage behind a property located at 2315 Hospital Dr., Pocahontas, AR. During the course of the inspection it was determined that the source of the overflow was a blockage in the service line for the adjacent property resulting in an overflow through an open cleanout to the surface of the ground. This matter was referred to the city code enforcement officer.

Description: Evidence of overflow from customer cleanout.

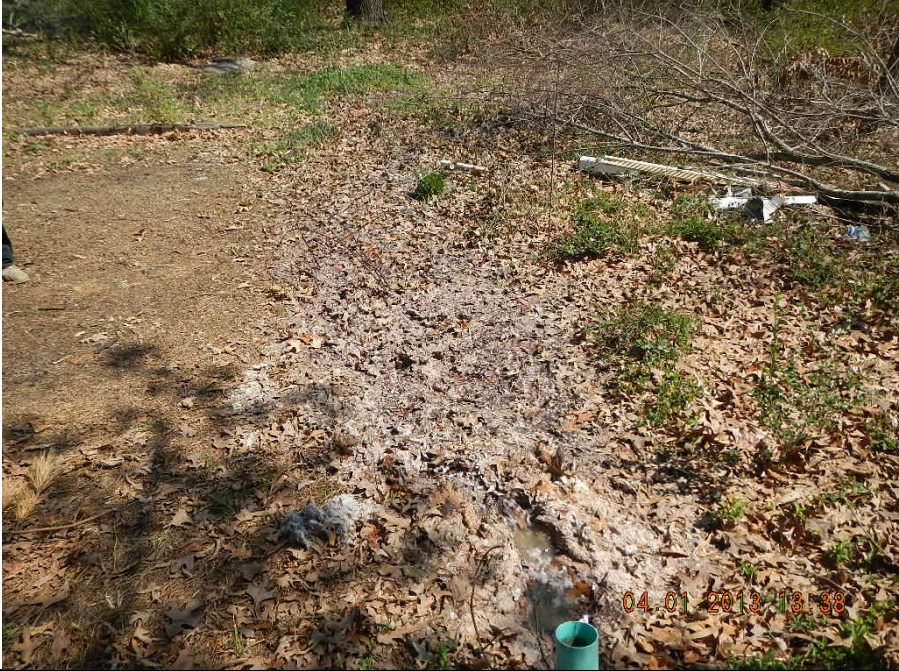
Photo # 2 **Of** 4 **Date:** 4/1/2013 **Time:** 1338

Description: Evidence of overflow from customer cleanout.

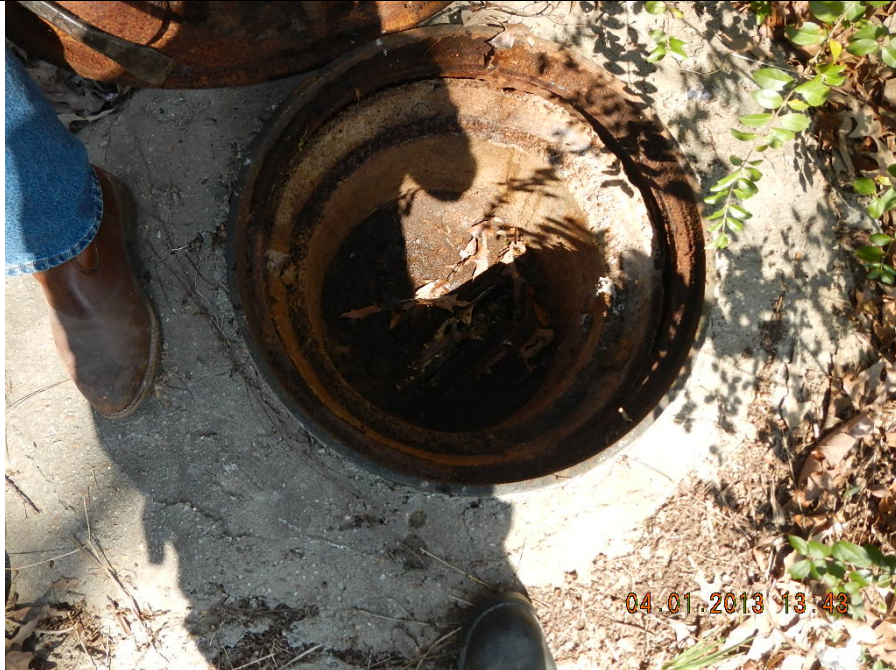
| Photo # | 3 | Of | 4 | Date: | 4/1/2013 | Time: | 1343 |

No evidence of overflows or other malfunctions of the city sewer system were noted. No letter will be sent.

| Description: | View into manhole showing system flowing properly. | | | | | | |

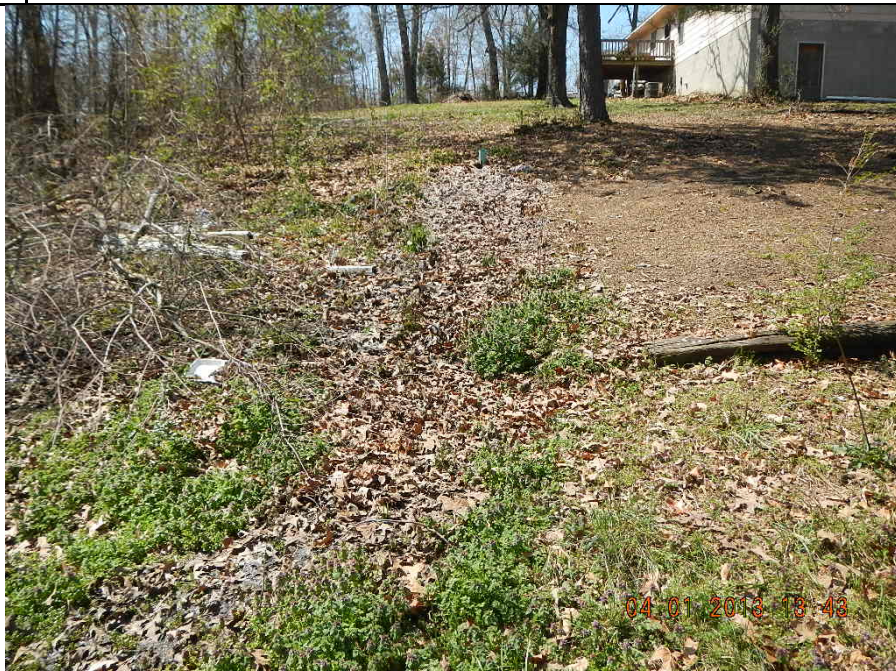
| Photo # | 4 | Of | 4 | Date: | 4/1/2013 | Time: | 1343 |

| Description: | View from manhole facing uphill toward customer cleanout. | | | | | | |
