Jason Henson
C & H Hog Farms
HC 72 Box 10
Mt. Judea, AR 72655

Form Approved
OMB No. 2040-0003
Approval Expires 7-31-85

Comments on Laboratory: _____

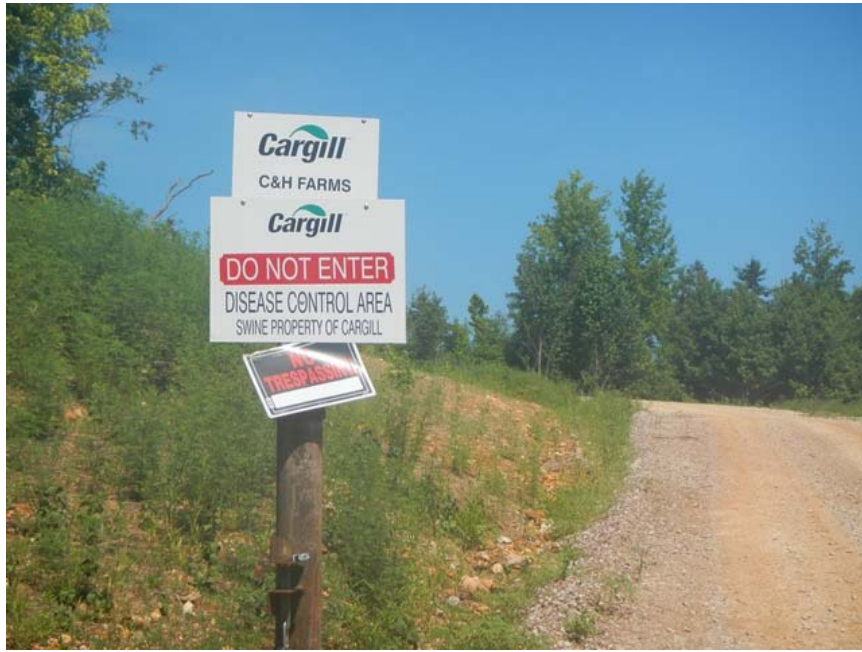
Water Division NPDES Photographic Evidence Sheet

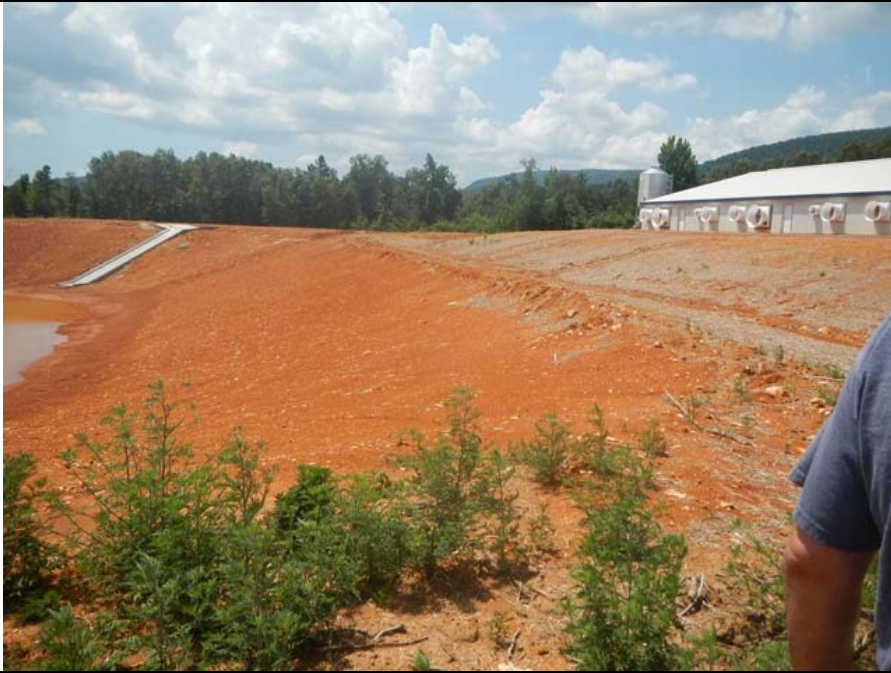
Water Division NPDES Photographic Evidence Sheet

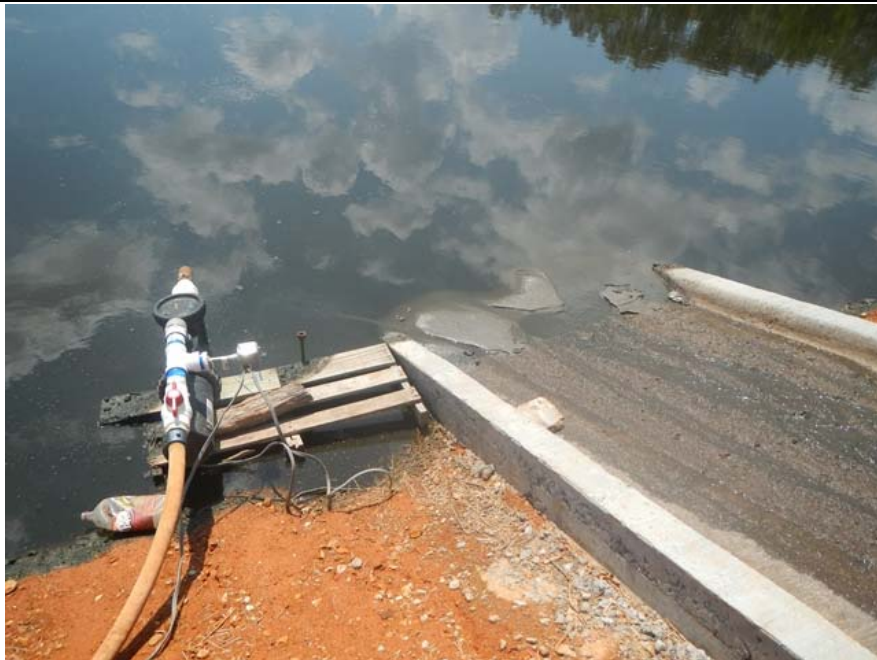
- The farm has been fully populated with sows which are presently being bred; no pigs are presently being shipped from the facility.
- The Settling Basin is collecting wastewater but is not currently discharging to the Holding Pond.

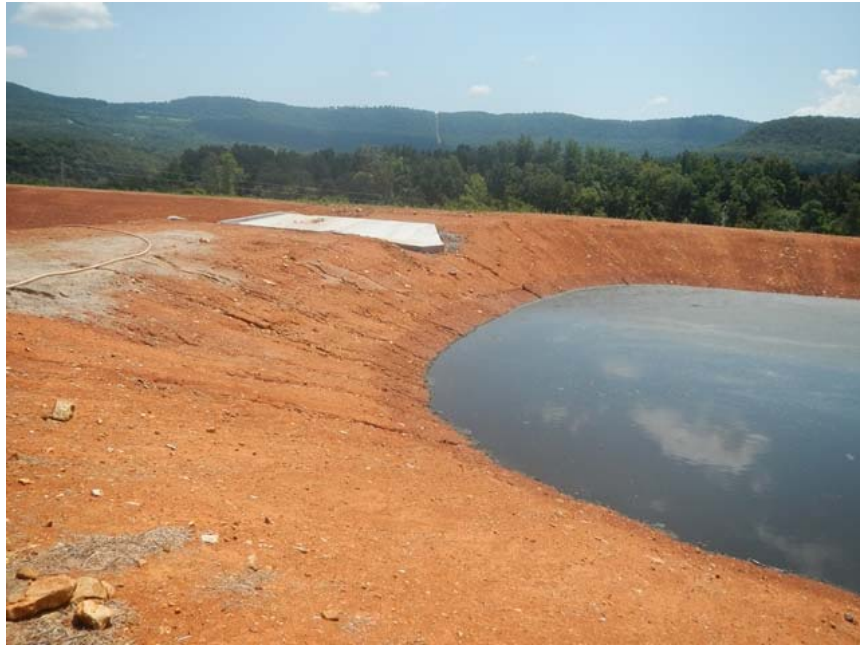
- 1.) A copy of the site-specific Nutrient Management Plan (NMP) was not available upon request per Part 3.2.2.2 of the permit.
- 2.) No means of managing farm mortality was observed onsite. The facility NMP calls for composting and rendering; however, no equipment or structures for managing this waste stream was observed onsite. Since the farm will soon be in full production and will be generating a steady waste stream of dead pigs and afterbirth, the composting and/or rendering equipment mentioned in the NMP must be onsite and capable of managing such waste.

Water Division NPDES Photographic Evidence Sheet

been clear that we were being asked to do so. C & H Hog Farms considers this action item complete.

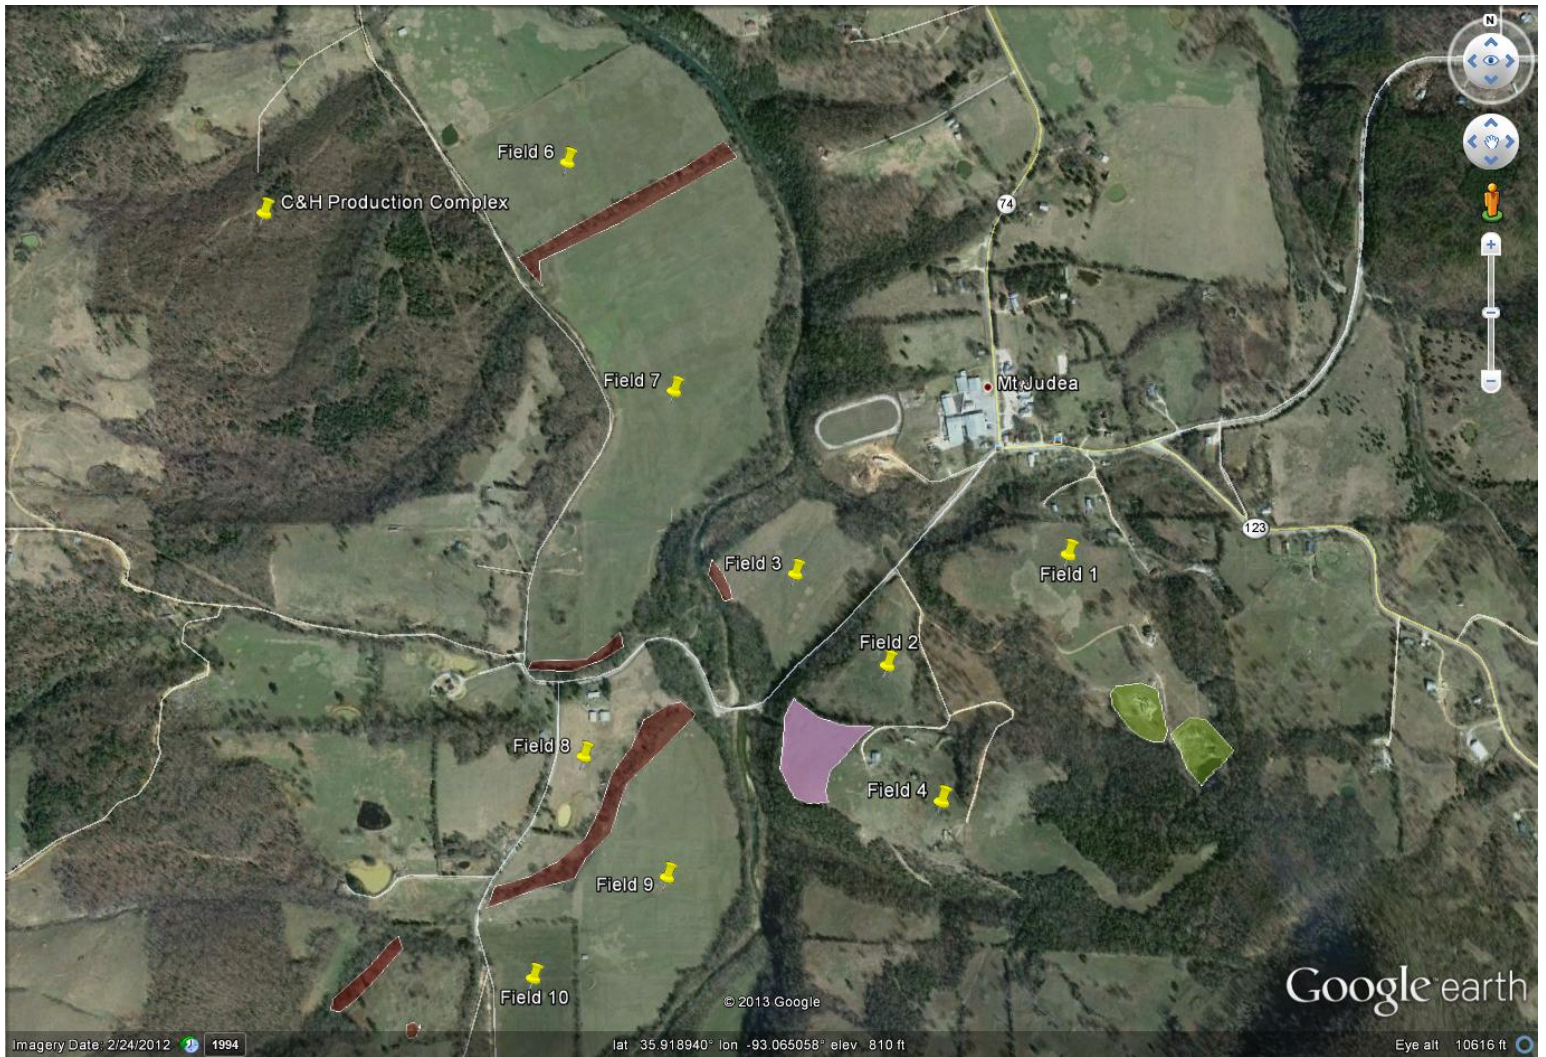
than 100 feet to any down gradient surface waters, open tile line intake structures, sinkholes, agricultural well heads, or other conduits to surface waters; 300 feet of Extraordinary Resource Waters (ERW) as defined by the Department's Regulation No. 2; within 50 feet of property lines; or 500 feet of neighboring occupied dwellings. Attached to the inspection checklist are images of the land application fields with identified drainage features which were lacking buffers zones on the aforementioned map (see attachments 1-3). You may wish to flag or mark buffers and setbacks prior to land application activities.

- 5.) A review of the "Overall Site Map" found in Section F of the NMP did not appear to include buffer zones around all ponds, streams, and drainages. Per Condition 4.2.1.5 of the permit, please ensure all manure, litter, and process wastewater is not applied closer

- 5.) C & H Hog Farms is aware of the buffer zone requirements outlined in the permit and will adhere to said requirements during land application activities. C & H Hog Farms considers this action item complete.
