RE: Quarterly Inspection; AFIN 18-00094; Permit Number 0245-S1-R1.

### Class 1 Landfill Inspection

<b>Site Name</b>	Crittenden County Class I	<b>County</b>	Crittenden	<b>AFIN</b>	18-00094
<b>Facility Address</b>	South off Hwy 70	<b>Phone Number</b>	LF: 870-732-4290 Off: 870-732-6580	<b>Permit Number</b>	0245-S1-R1
<b>Permittee Address</b>	Crittenden Co. Judge	<b>E-Mail Address</b>	arredllc@swb.net	<b>PDS #</b>	074197
<b>Date</b>	10-14-13	<b>Entry Time</b>	10:40 AM	<b>Exit Time</b>	12:00 PM

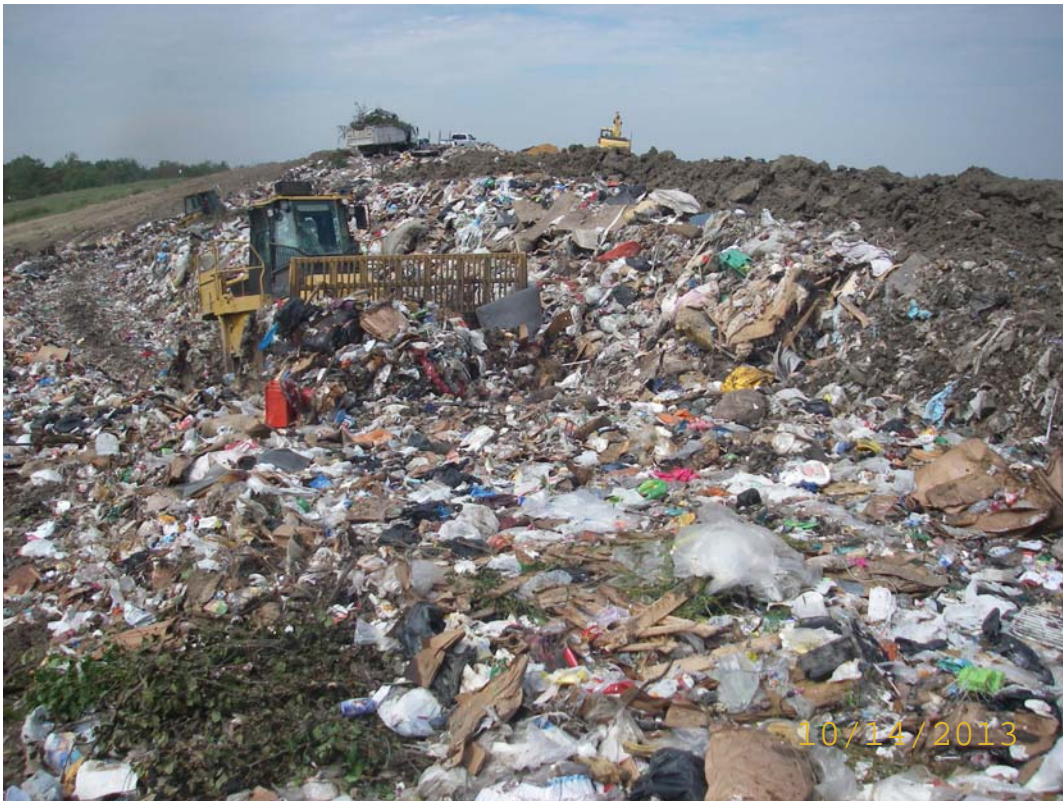
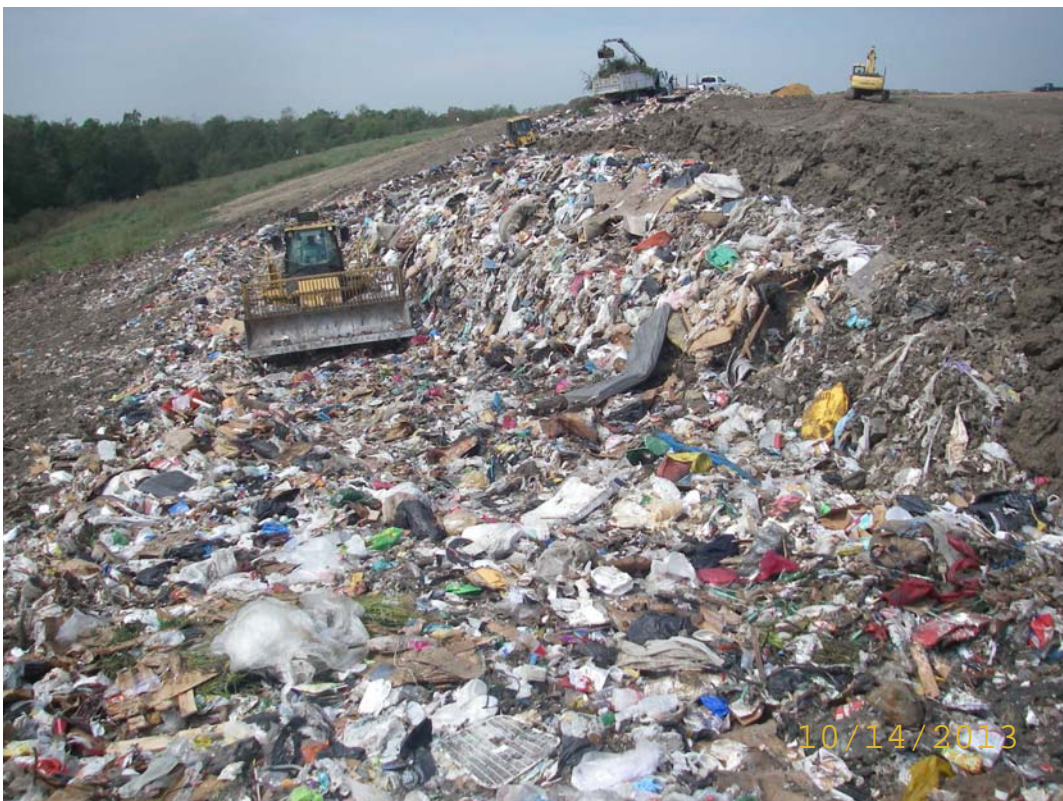
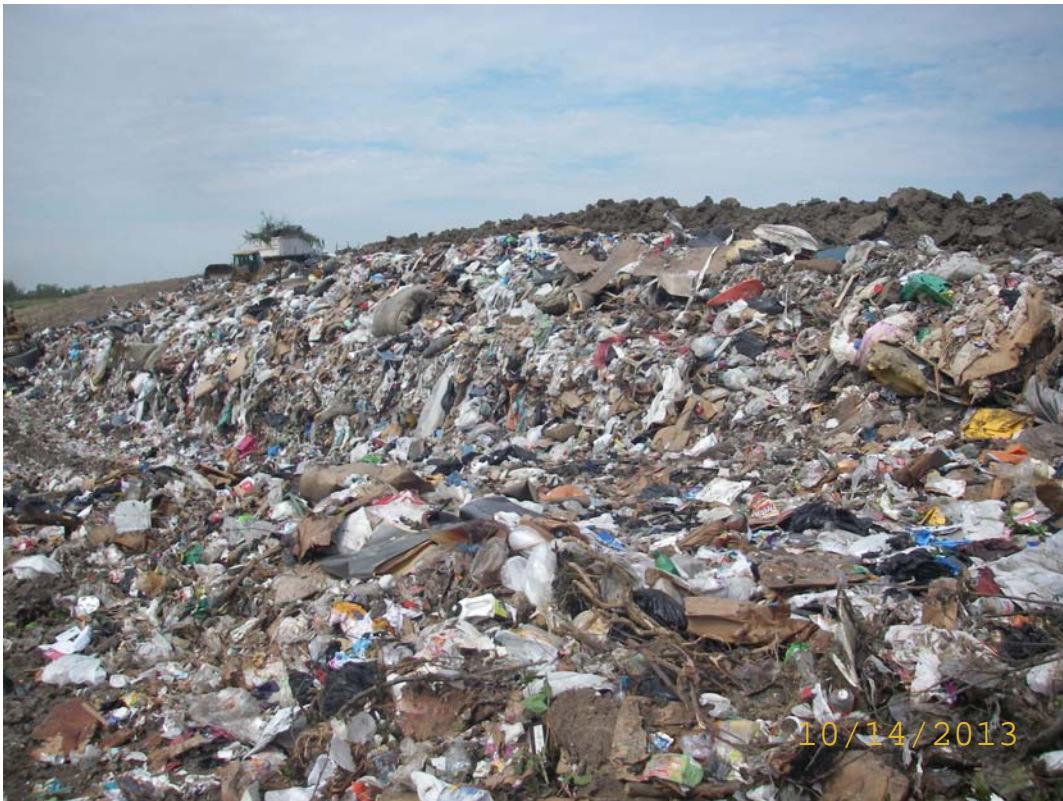
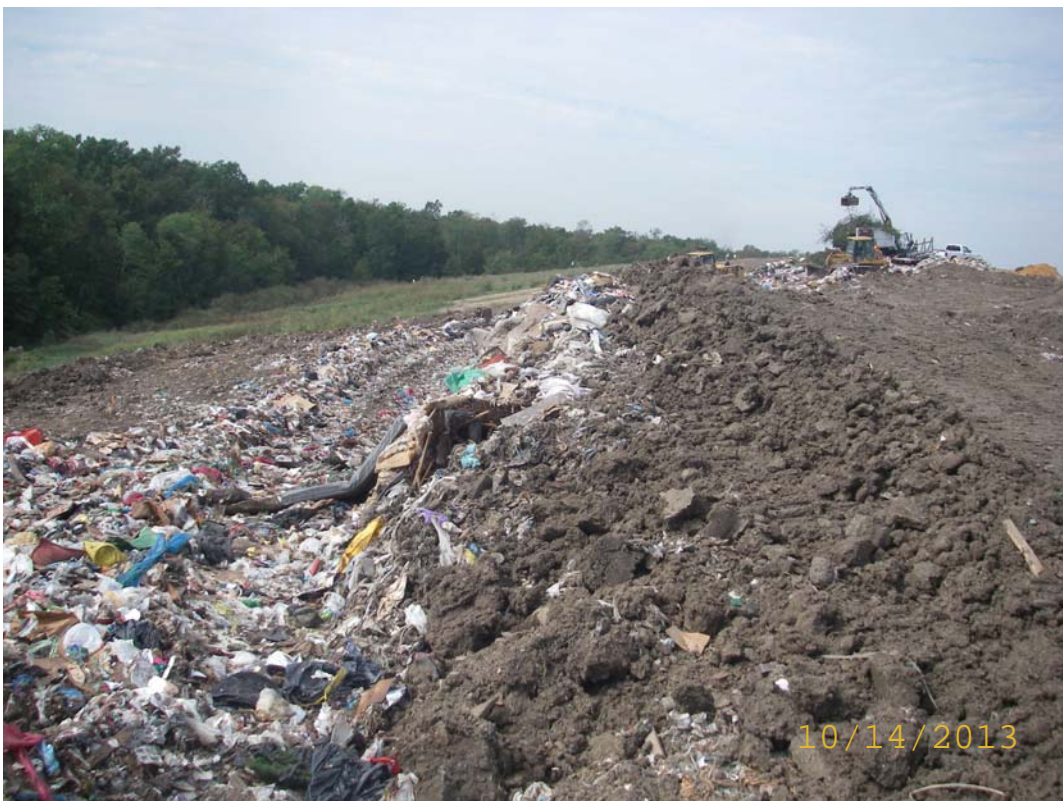
0245-S1-R1 1 & 2

X	Depicts Violation	Category 1	
R	Repeat Violation		
	Regulation	Item Description	Comments
	411(l)	Adequate employee facilities	
	421(a)(b)	Record keeping meets requirements specified by regulations	
	417	Access requirements	
	411(j)	Adequate provisions for backup equipment	
	421(d)	Waste receipt records, ticket system maintained	
	411(k)	Telephone system & written emergency response plan on site	
	423(b)	Annual compliance inspection by registered professional engineer	
	422	Facility implements operating plan and narrative	
	421(f)	Leachate disposal/recirculation records	
	421(g),701	Special waste disposal and procedures records	
X	Depicts Violation	Category 2	
R	Repeat Violation		
	Regulation	Item Description	Comments
	411(a)	Operations in accordance with permit documents	
	417(c)	Adequate all weather operational roads	
X	411(c)	Smallest practical area, unloading supervised, single working face	Noted The active working face was not a practical working size. Photos 1-4

Please refer to the attached inspection report to note the specific allegations. A written response for the noted allegations, describing the corrective action taken or to be taken, must be submitted to my attention at the address listed below within thirty (30) days from the date hereof. Failure to submit the written response shall be construed as an admission of any allegations. Any items noted that are neglected and/or persistent may warrant formal enforcement action.

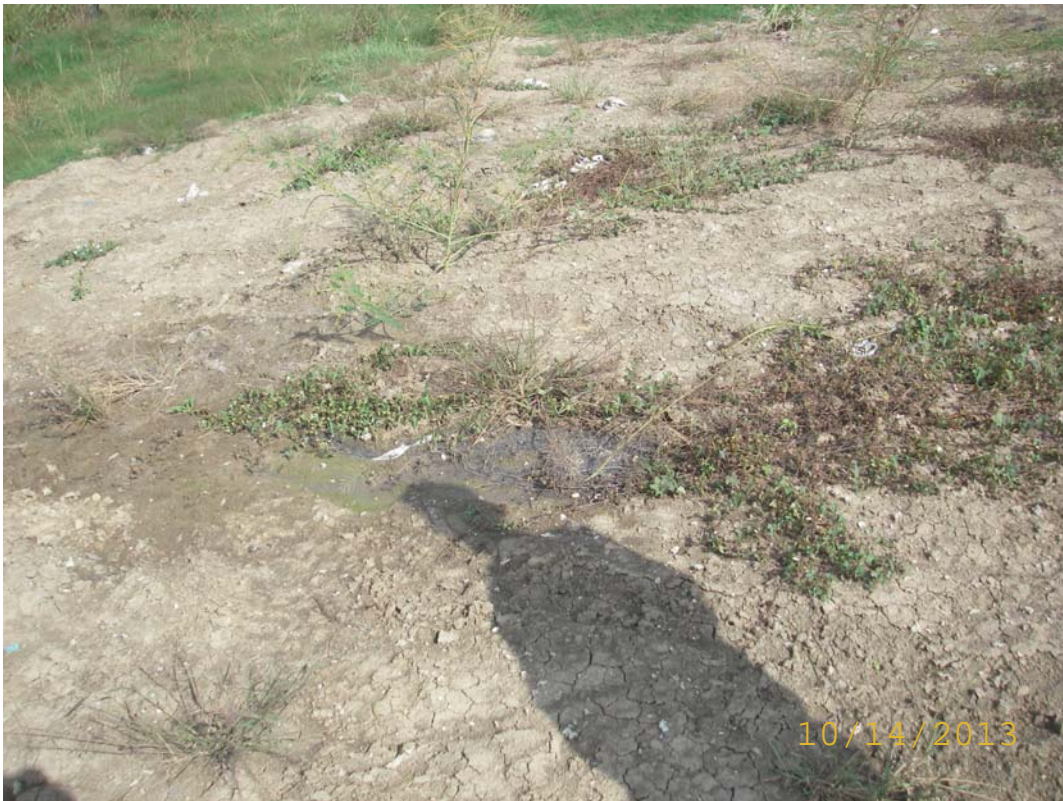
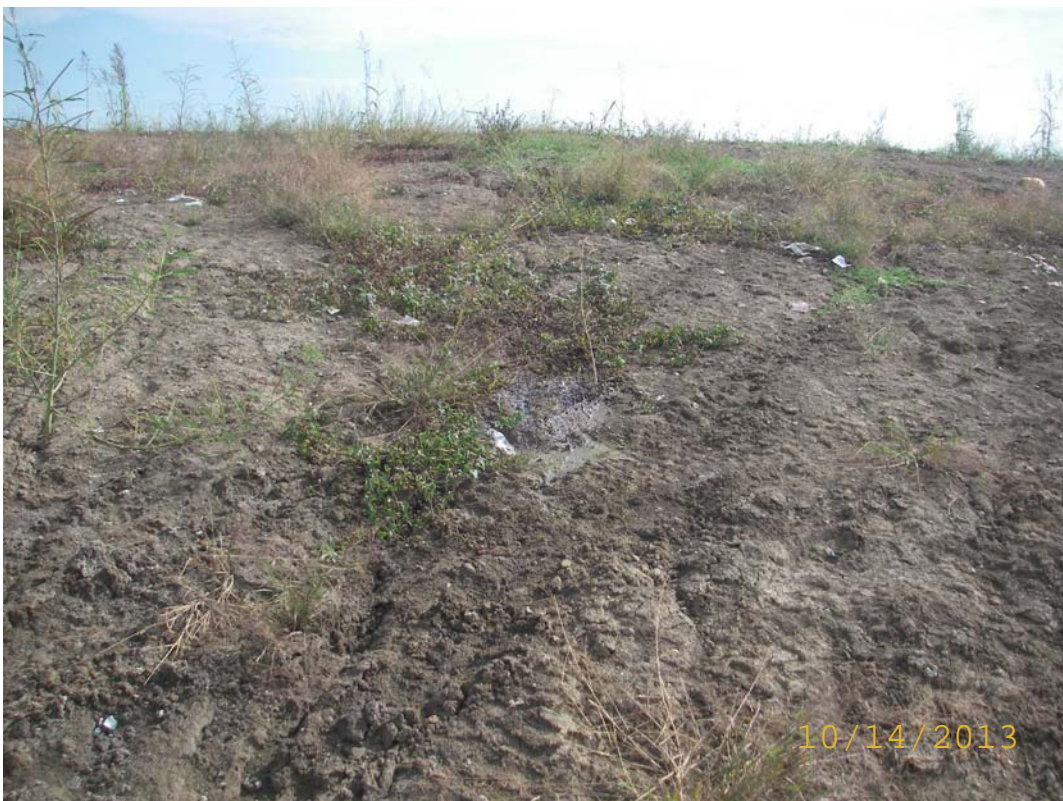
0245-S1-R1 9 & 10

413(a)(b)	Satisfactory daily/alternative cover										
X	413(c)	Satisfactory intermediate cover	Noted exposed waste on west slope of cell AB-7 due to inadequate intermediate cover. Photos 9-12									
	416(b),411(f)(4)	Open burning prohibited										
	419	Cause discharge/leachate discharge leaving landfill										
	411(f)(3),419(a)(4)	Depositing waste in standing water prohibited										
	411(o)	Erosion or other cover defects resulting in exposed refuse										
	309(c)	Overfill/Off lined area										
Regulation 22 - Records												
421(a)(8), 1203(k)	Date of last groundwater monitoring report		9-30-13									
423(b)	Date of last engineering report		March 2013									
428	Liner construction in progress	Yes/No	No	Notice of liner construction	Yes/No	No	Third party CQA on-site during construction		Yes/No	No		
412(a)	Date of last random inspection for unauthorized waste		September	Total # for month	21
