**RE:** Compliance Inspection (Carroll Co)

AFIN: 08-00036 NPDES Permit No.: AR0021865

On February 21, 2014, I performed a routine compliance inspection of the wastewater treatment plant in accordance with the provisions of the Federal Clean Water Act, the Arkansas Water and Air Pollution Control Act, and the regulations promulgated thereunder.

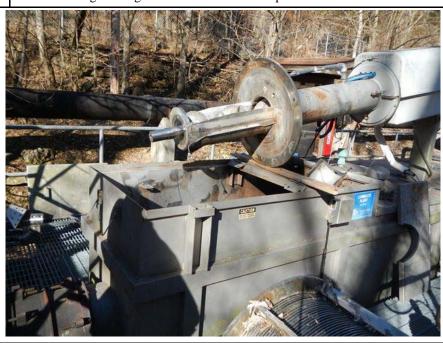
Water Division NPDES Photographic Evidence Sheet										
Location:	Location: Eureka Springs POTW									
<b>Photographer:</b>		Tony Morris			Witness:	City of Eureka Springs personnel				
Photo #	1	Of	6		Date:	02/21/14	Time:	10:29		
Description:	<b>Description:</b> The Lakeside grit and grease removal unit at the plant head works was down for repairs.

I was disappointed to find the Lakeside grit and grease unit was out of service due to a breakdown. Hopefully, it will be repaired in the near future. I also noted conspicuous sludge banks within eddies of the receiving stream below the permitted outfall. According to the operator, an upset occurred in which the decant pipe dropped too deep and discharged from the sludge blanket rather than the supernatant. An upset report will be submitted with the February 2014 DMR.

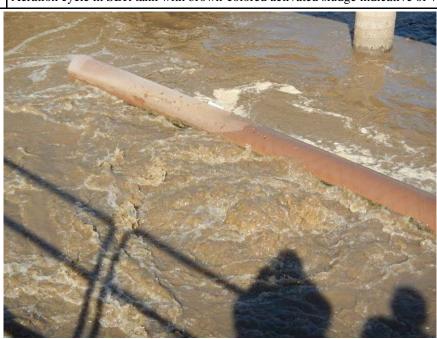
Photographer:		Tony N	Morris		Witness:	City of Eureka Springs personnel		
Photo #	2	Of 6			Date:	02/21/14	<b>Time:</b> 11:15	
Description	:	Aeratio	on cycle i	n SBR tank with brown-c	olored activ	ated sludge ind	icative of v	igorous bacteria.

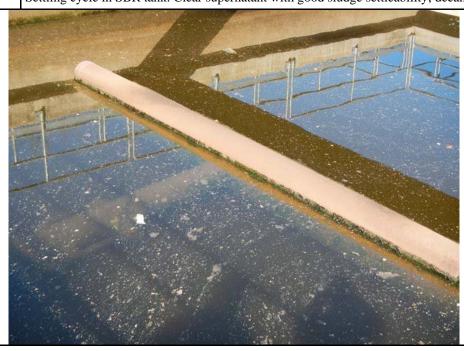
Water Division NPDES Photographic Evidence Sheet										
Location: Eureka Springs POTW											
Photograph	er: T	Tony Morris			Witness:	City of Eureka Springs personnel					
Photo #         3         Of         6         Date:         02/21/14         Time:         11:08						11:08					
<b>Description:</b> Settling cycle in SBR tank. Clear supernatant with good sludge settleability: decant pipe vis

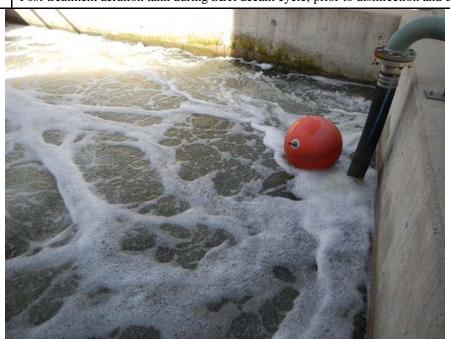
Photographer:Tony MorrisWitness:City of Eureka Springs personnelPhoto #4Of6Date:02/21/14Time:10:59

**Description:** Post-treatment aeration tank during SBR decant cycle; prior to disinfection and discharge.
