RE: Quarterly Inspection; AFIN 18-00094; Permit Number 0245-S1-R1.

Arkansas Department of Environmental Quality

Class 1 Landfill Inspection

Site Name	Crittenden County Class I	County	Crittenden	AFIN	18-00094
Facility Address	South off Hwy 70	Phone Number	LF: 870-732-4290 Off: 870-732-6580	Permit Number	0245-S1-R1
Permittee Address	Crittenden Co. Judge	E-Mail Address	arredllc@swb.net	PDS #	076547
Date	3-11-14	Entry Time	10:30 AM	Exit Time	11:40 AM

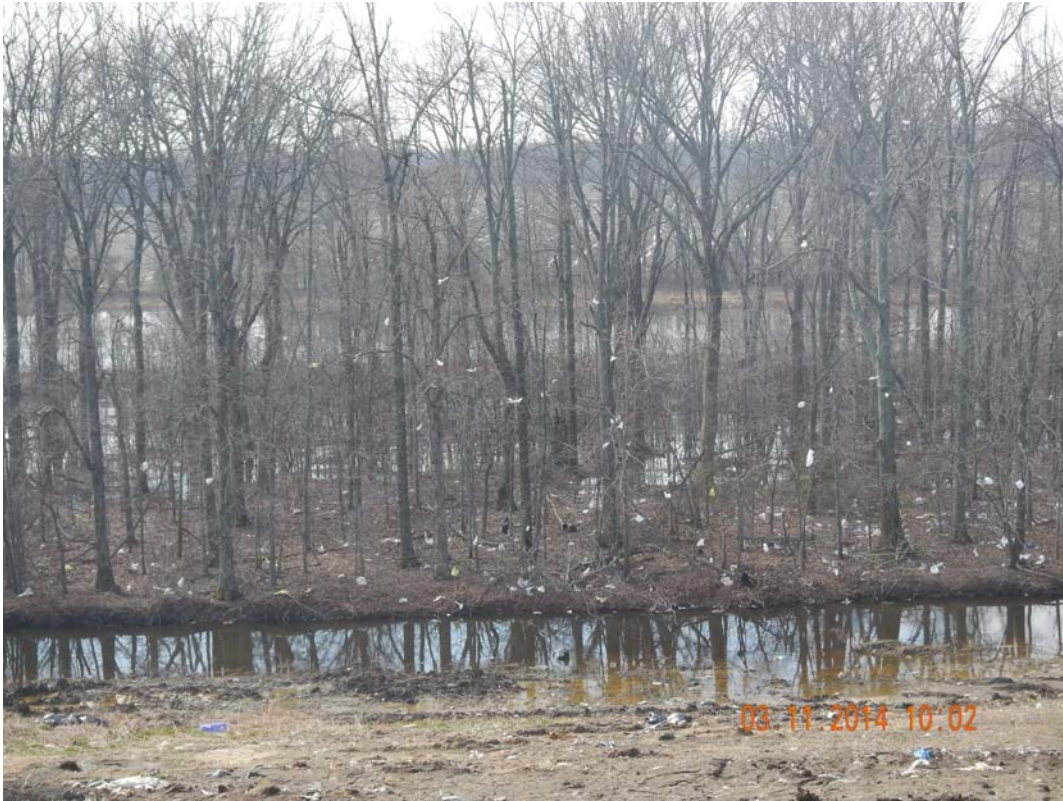
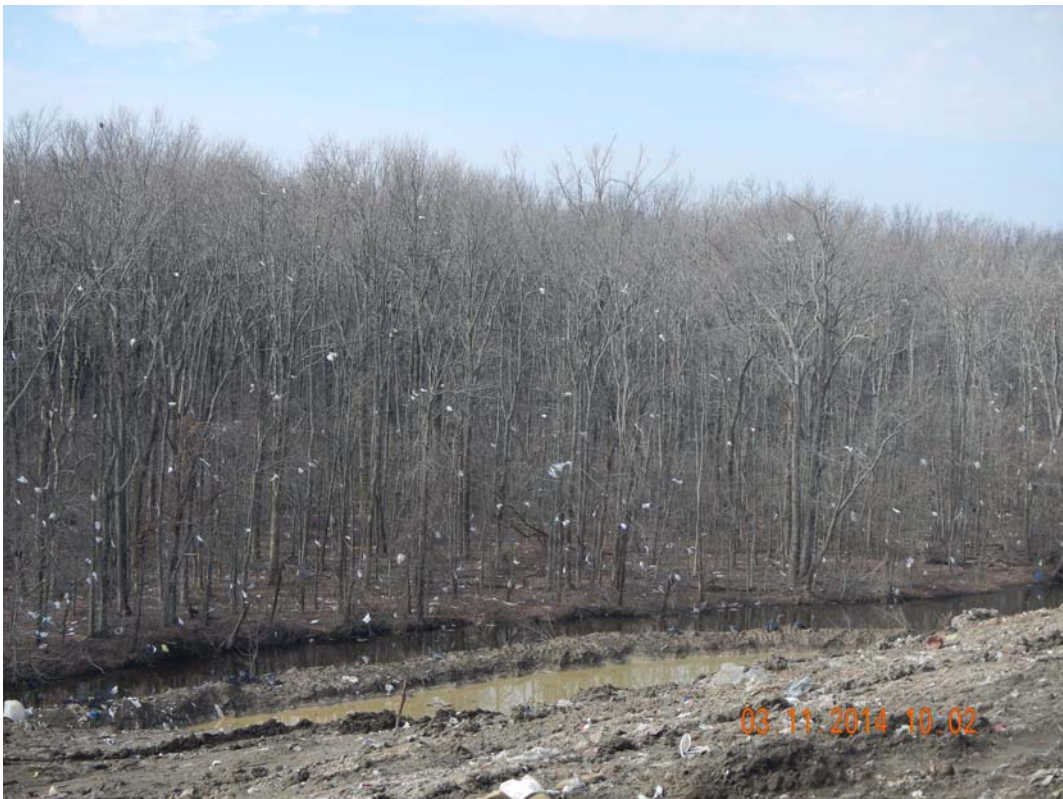
0245-S1-R1 3 & 4

411(e)	Salvage operations meet approved conditions	
	411(f)(1)	Scavenging of waste prohibited	
	411(p)	Proper wet weather repairs	
	411(b)	Operations by licensed on-site personnel at all times	
	411(d)	Waste spread and compacted as unloaded	
X	411(g)	Litter control provisions maintained	Noted inadequate litter control at the active working face. Photos 3-4
	414(a)	Disease vectors controlled

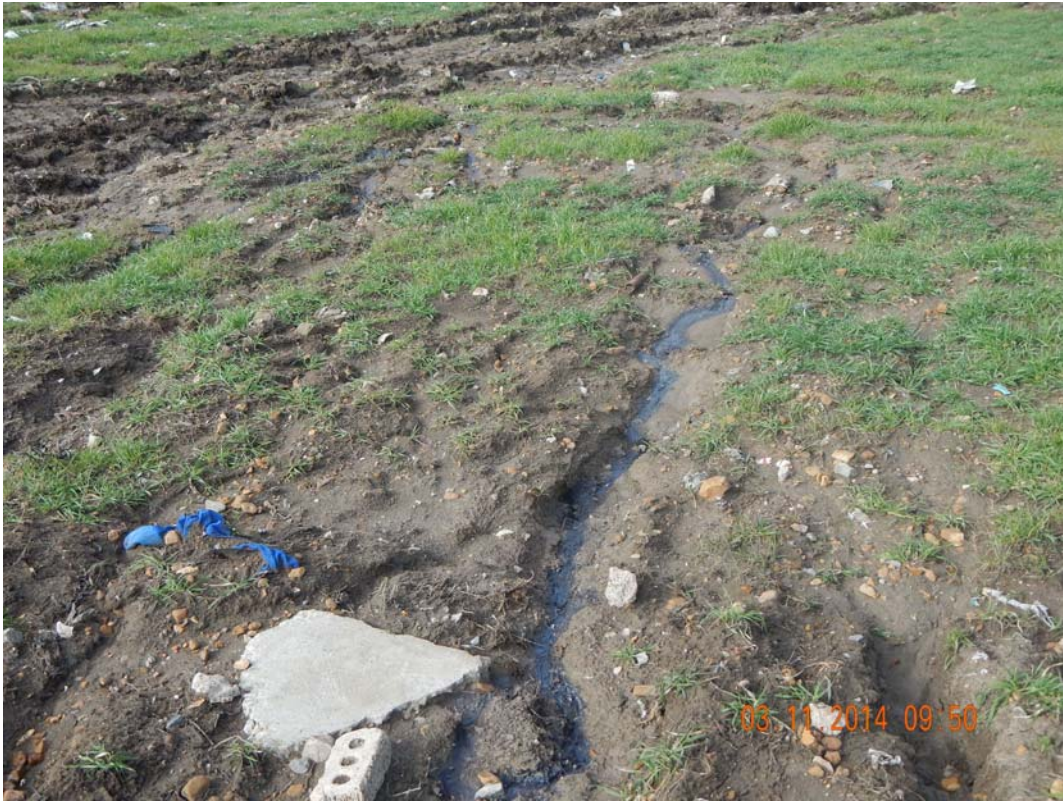
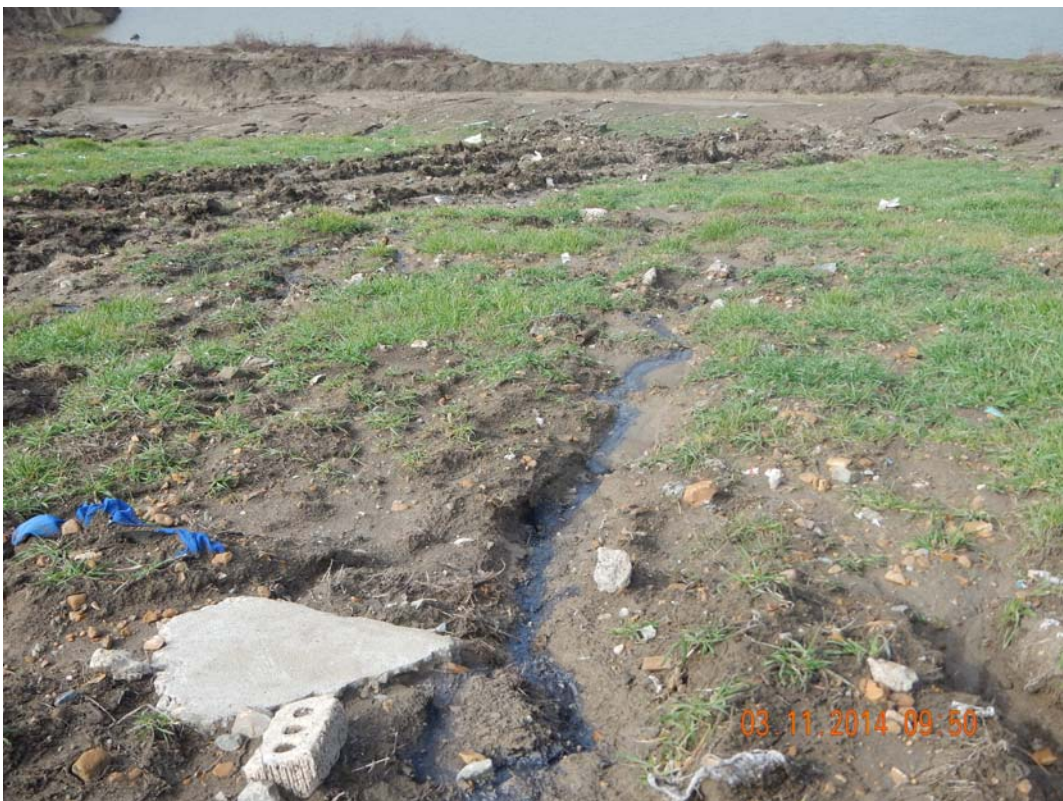
0245-S1-R1 9 & 10

413(a)(b)	Satisfactory daily/alternative cover												
X	413(c)	Satisfactory intermediate cover	Noted exposed waste on west slope of cell AB-10 due to inadequate intermediate cover. Photos 9-10											
	416(b),411(f)(4)	Open burning prohibited												
	419	Cause discharge/leachate discharge leaving landfill												
	411(f)(3),419(a)(4)	Depositing waste in standing water prohibited												
X	411(o)	Erosion or other cover defects resulting in exposed refuse	Noted erosion of cover with exposed refuse on north slope of cell J4 and west slope of cells AB-10 and AB-13. Photos 11-14											
	309(c)	Overfill/Off lined area												
Regulation 22 - Records														
421(a)(8), 1203(k)	Date of last groundwater monitoring report		2-28-14											
423(b)	Date of last engineering report		March 2014											
428	Liner construction in progress	Yes/No	No	Notice of liner construction	Yes/No	No	Third party CQA on-site during construction	Yes/No	No
