Inspection Report: Big Creek WWTP, AFIN: 14-00059, Permit #: AR0043613

Listed below is the corrective actions taken to the Compliance Inspection of the City of Magnolia Big Creek WWTP performed on April 15, 2014 by Michael Young.

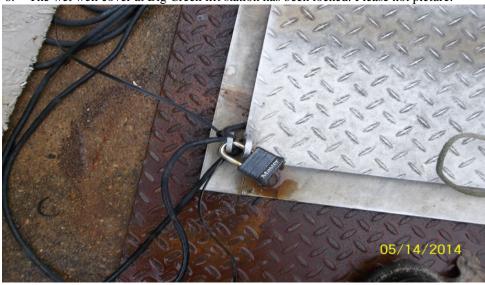
The wet well cover at Big Creek lift station has been locked. Please not picture.

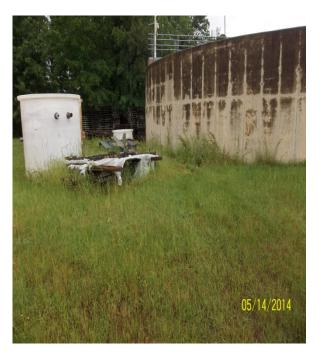
- 8. The open container which contained metal has been carried to Tin Man Recycling and is no longer on premises.
- 9. In reference to Mr. Young's comment on industrial equipment stored outside and photo #2, the plastic tanks and light fixtures were removed from the Sludge building by the contractor while the new equipment is being installed. The lights in the picture have been removed and taken to Tin Man Recycling yard in Magnolia.

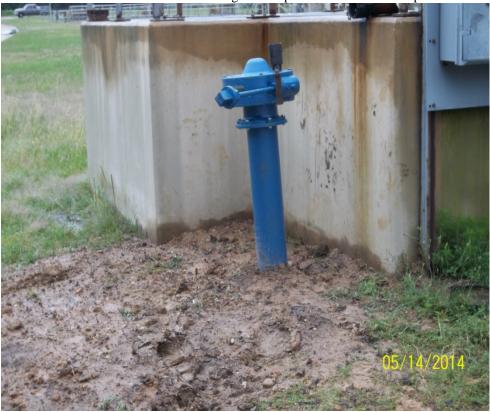
10. The oil sheen that was found in water around a valve that was dug up for repair was cleaned with absorbent pads while Mr. Young was on premise and shown in his photograph. The oil sheen did not come from the valve but from the asphalt that had been packed around the valve as well as from the asphalt street located by the valve. We believe that the oil sheen on the water leached out from the surrounding black top. The valve has been repaired and hole filled in.

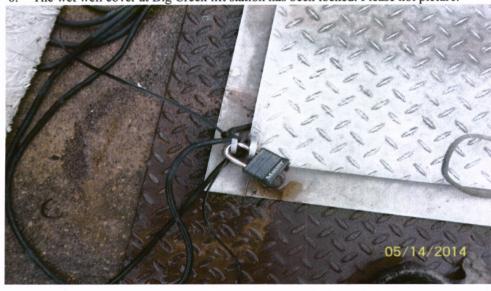
6. The wet well cover at Big Creek lift station has been locked. Please not picture.

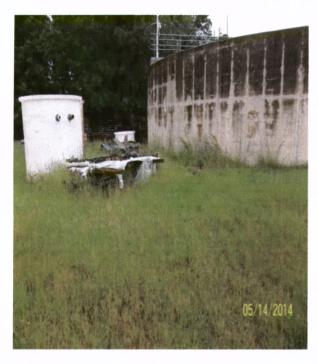
- 8. The open container which contained metal has been carried to Tin Man Recycling and is no longer on premises.
- 9. In reference to Mr. Young's comment on industrial equipment stored outside and photo # 2, the plastic tanks and light fixtures were removed from the Sludge building by the contractor while the new equipment is being installed. The lights in the picture have been removed and taken to Tin Man Recycling yard in Magnolia.

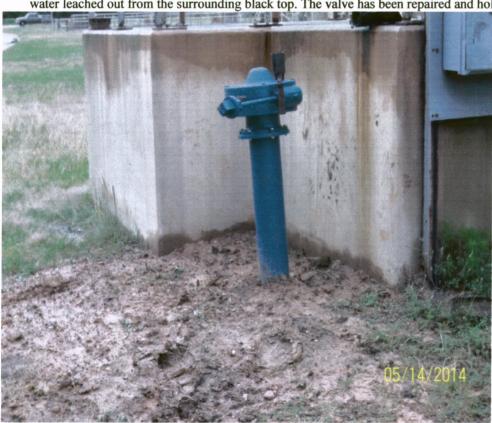
10. The oil sheen that was found in water around a valve that was dug up for repair was cleaned with absorbent pads while Mr. Young was on premise and shown in his photograph. The oil sheen did not come from the valve but from the asphalt that had been packed around the valve as well as from the asphalt street located by the valve. We believe that the oil sheen on the water leached out from the surrounding black top. The valve has been repaired and hole filled in.
