WATER DIVISION INSPECTION REPORT

NAME:
City of Nashville WWTP

This inspection was initiated at the request of the Enforcement Branch due to the City reporting that the two-cell stabilization pond was overflowing. At the time of the inspection, the two-cell stabilization pond was still overflowing through the spillways. It was estimated to be 1-2 inches. The overflow was being reported to ADEQ.

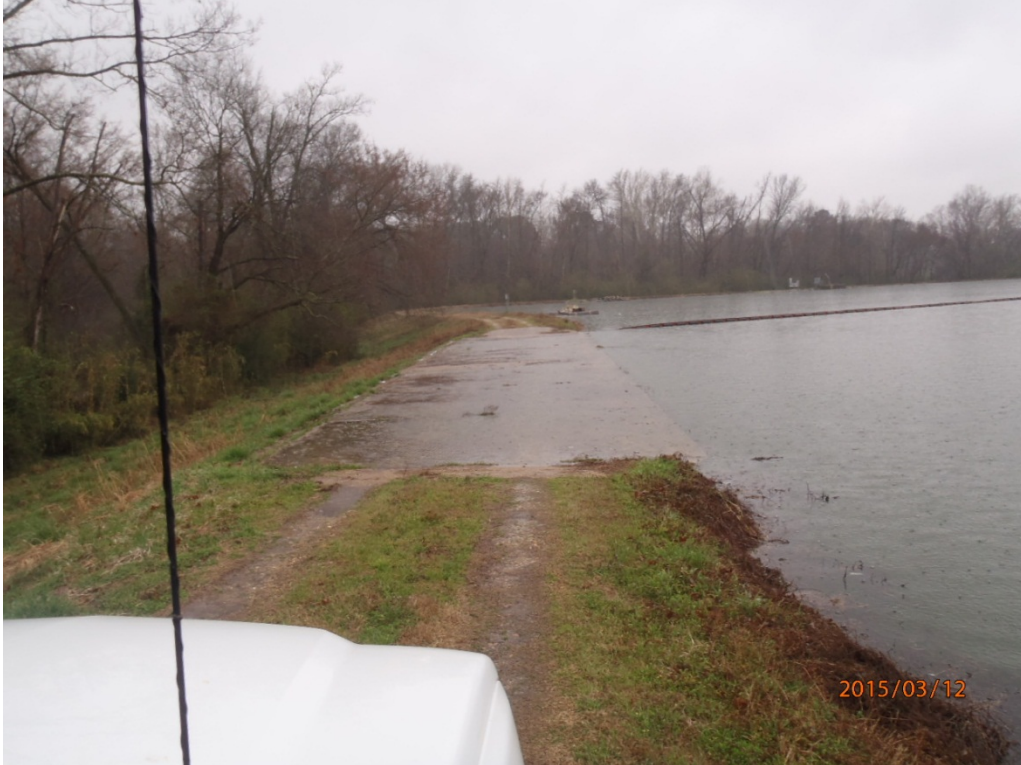
Location:	City of Nashville WWTP				
Photographer:	Red Smith	Date:	3/12/2015	Time:	1129
Witness:	Chip Colston / Chief Operator Nashville WWTP			Photo #:	1
Description:	Eastern spillway (33.914177; -93.859655); estimated 1-2 inch flow.

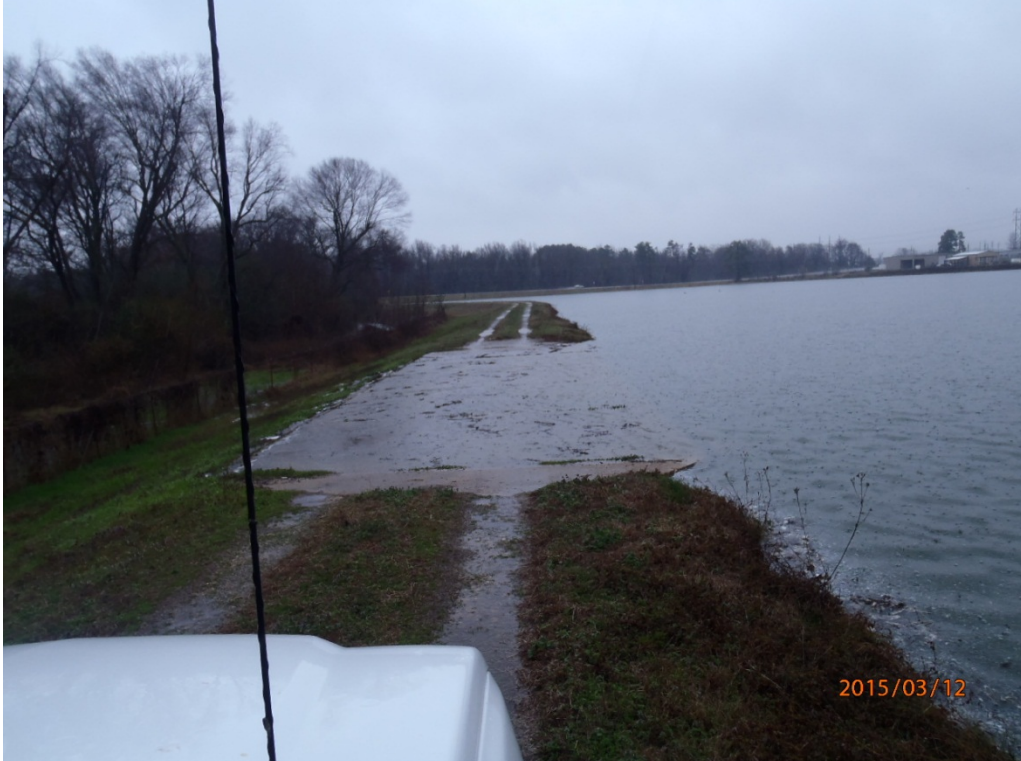
Photographer:	Red Smith	Date:	3/12/2015	Time:	1133
Witness:	Chip Colston / Chief Operator Nashville WWTP			Photo #:	2
Description:	Southern spillway (33.915238; -93.862727); estimated 1-2 inch flow.

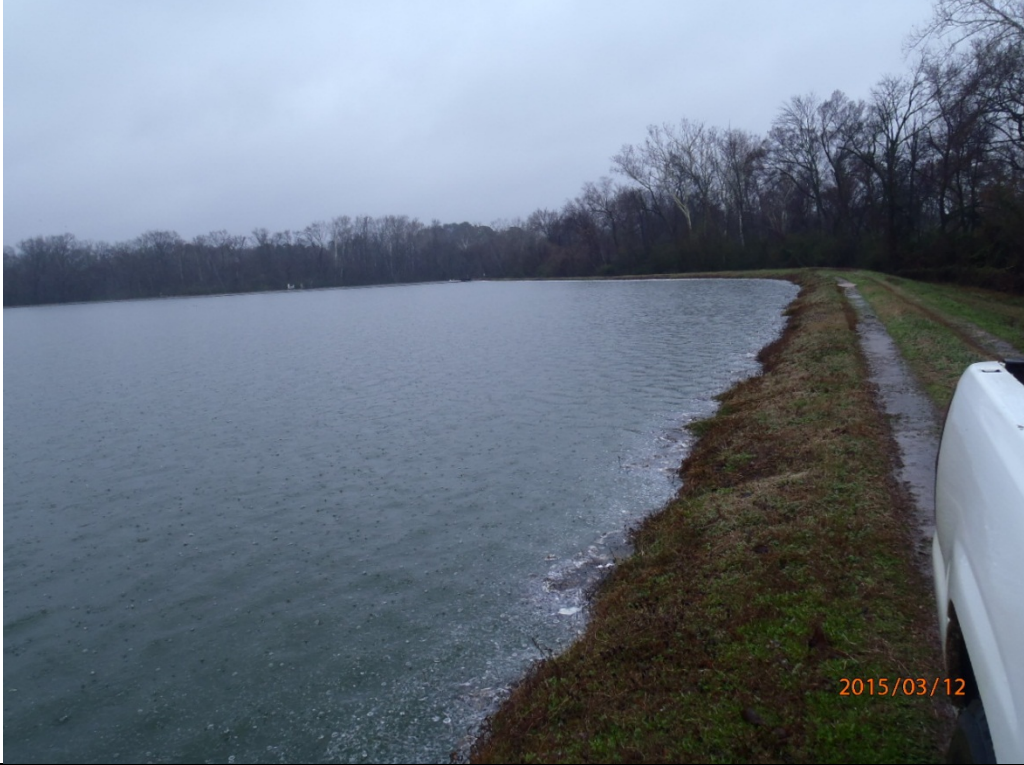
Location:	City of Nashville WWTP				
Photographer:	Red Smith	Date:	3/12/2015	Time:	1133
Witness:	Chip Colston / Chief Operator Nashville WWTP			Photo #:	3
Description:	Looking at the overall freeboard estimated to be 2 feet.

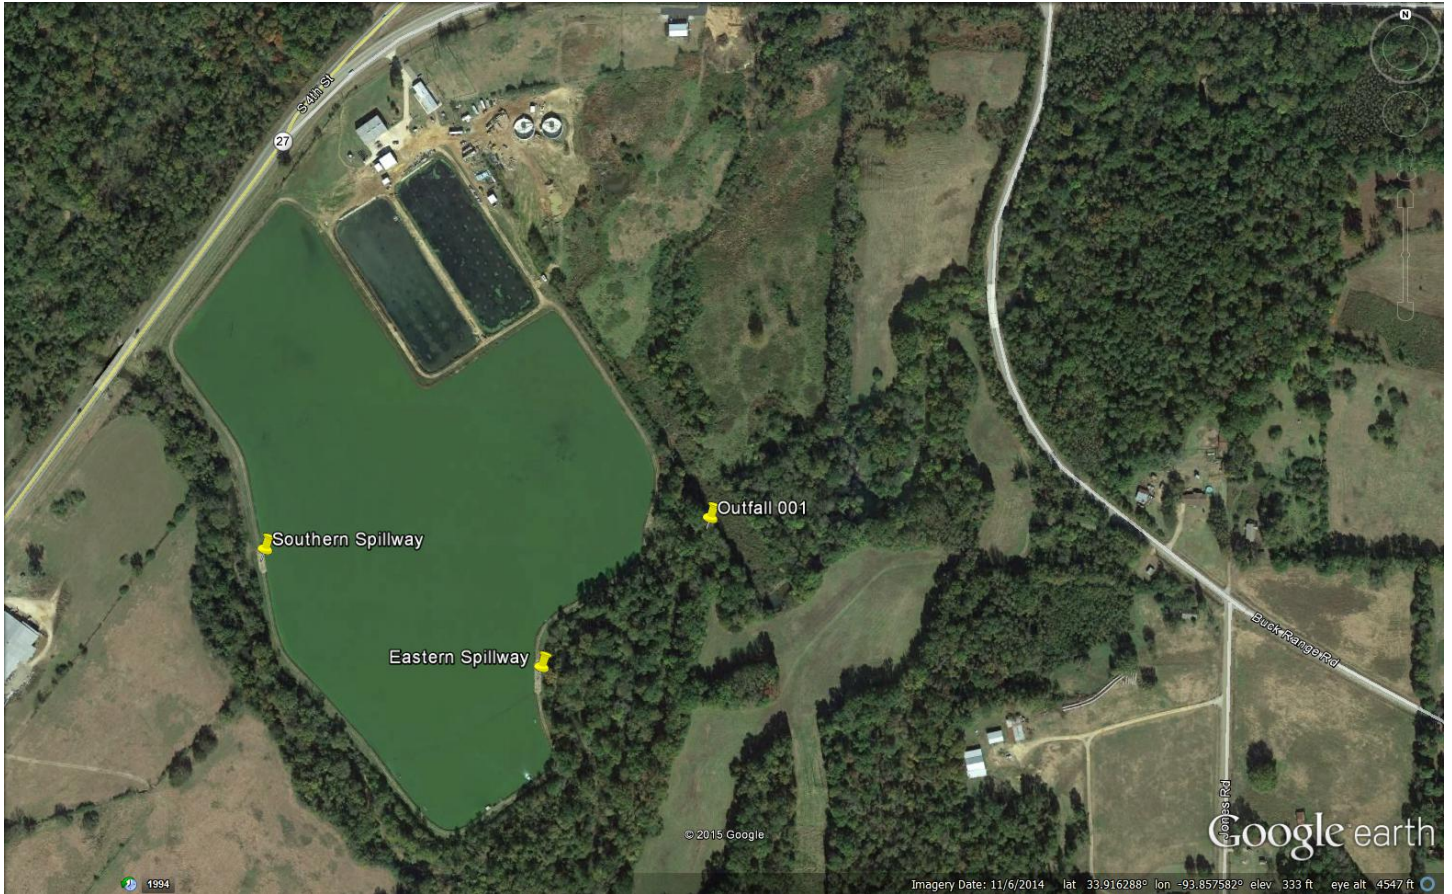
Figure 1. Google Earth image dated Nov 6, 2014 of Nashville WWTP, permitted outfall, and two spillways.
