RE: City of Nashville WWTP Inspections (Howard Co)

AFIN: 31-00036 Permit No.: AR0021776

V DEO		WATER	DIVISION I	NSF	PECT	ΓΙΟΝ	I RE	PORT
	ADLQ	AF	IN: 31-00036 P	ERMIT #: AR002	1776		1	DATE: 7	//27/2015
A	RKANSAS	CC	DUNTY: 31 Howa	rd	PDS	#: 0860)31		MEDIA: WN
Dep	partment of Environmental Quality	GP	S LAT: 33.91993	8 LONG: -93.861	286 L	OCATI	ION: E	ntrance	
	FACILITY INFORMAT	ION		IN	SPEC	TION II	NFORI	MATION	l
Cit	y of Nashville WWTP			FACILITY TYPE: 1 - Municipal	8402	TOR ID#: 22 S - S			
	Hwy 27 South			FACILITY EVALUATION RATIN 2 - Marginal	G:		Comp		Evaluation
	shville, AR			(-7	TRY TIME: 9:45	EXIT T			FECTIVE DATE:
	RESPONSIBLE OFFIC	CIAL		1/2//2015 0	3.43	13.	30	7/1/20 PERMIT EX	114 PIRATION DATE:
	: / TITLE							6/30/2	019
COM	rry Dunaway / Public Works Dire	Ctor		FAYETTEVILLE	SHAL	E REL	ATED:	N	
	y of Nashville			FAYETTEVILLE SHALE VIOLATIONS: N					
	ng address: 5 North Main St			INSPECTION PARTICIPANTS					
	STATE, ZIP:			NAME/TITLE/PHONE/FAX/EMAIL/ETC.:					
Na	shville AR 71852			Larry Dunaway/Public Works Director/(870) 845-4015

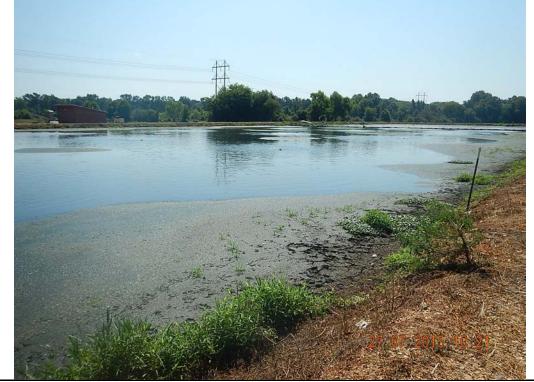
Water Division Photographic Evidence Sheet Location: City of Nashville WWTP Photographer: Kerri McCabe Date: July 27, 2015 Time: 1022 Witness: Chip Colston Photo#: 5 Description: West aerated activated sludge basin; note excessive stored sludge (looking West).

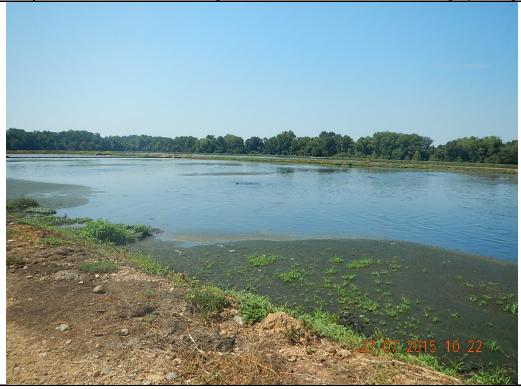
Photographer:	Kerri McCabe	Date:	July 27, 2015	Time:	1032
Witness: Chip	Colston			Photo #:	6

Description: Flow EQ basin; note excessive algae (green color of water).

- b. A shade cover will be installed to protect the secondary flow measuring device and electronics from the sun and rain.
- c. The algae are being addressed by adding a coagulant to aid in flocculation and settling. ADEQ has been notified.

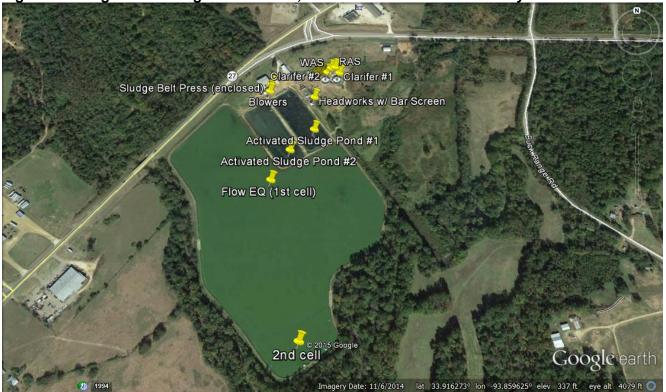
Figure 1. Google Earth image dated Nov 6, 2014 of the overview of the City of Nashville's WWTP.

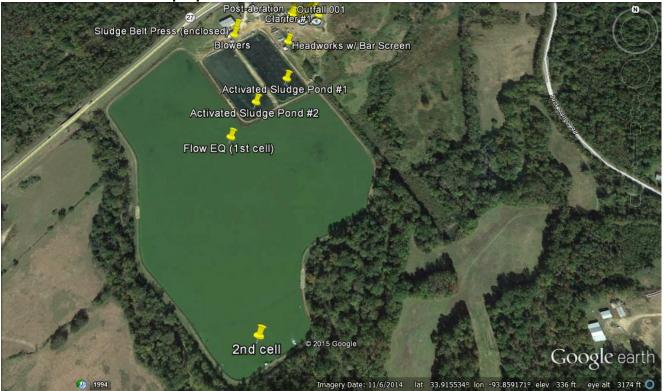
Figure 2. Google Earth image dated Nov 6, 2014 of the older components of the City of Nashville's WWTP that have been repurposed.

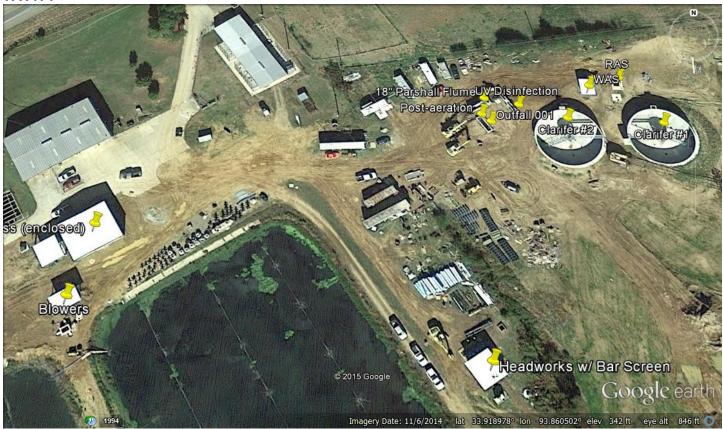
Figure 3. Google Earth image dated Nov 6, 2014 of the newer components of the City of Nashville's WWTP.
