RE: City of Nashville WWTP Inspection (Howard Co)
AFIN: 31-00036 NPDES Permit No.: AR0021776

A R K A N S A S Department of Environmental Quality	WATER DIVISION INSPECTION REPORT				
	AFIN: 31-00036	PERMIT #: AR0021776	DATE: 10/13/2015		
	COUNTY: 31 Howard	PDS #: 087333	MEDIA: WN		
	GPS LAT: 33.919938 LONG:	LOCATION: Entrance			
FACILITY INFORMATION		INSPECTION INFORMATION			
NAME: City of Nashville WWTP LOCATION: 743 Hwy 27 South CITY: Nashville, AR		FACILITY TYPE: 1 - Municipal INSPECTOR ID#: 84022 S - State FACILITY EVALUATION RATING: N INSPECTION TYPE: Reconnaissance			
RESPONSIBLE OFFICIAL		DATE(S): 10/13/2015 ENTRY TIME: 09:30 EXIT TIME: 10:30 PERMIT EFFECTIVE DATE: 7/1/2014 PERMIT EXPIRATION DATE: 6/30/2019			
NAME: / TITLE Larry Dunaway / Public Works Director COMPANY: City of Nashville MAILING ADDRESS: 426 North Main St CITY, STATE, ZIP: Nashville AR 71852 PHONE & EXT: / FAX: 870-845-4015 / EMAIL: larry19211@gmail.com		FAYETTEVILLE SHALE RELATED: N FAYETTEVILLE SHALE VIOLATIONS: N

Water Division Photographic Evidence Sheet

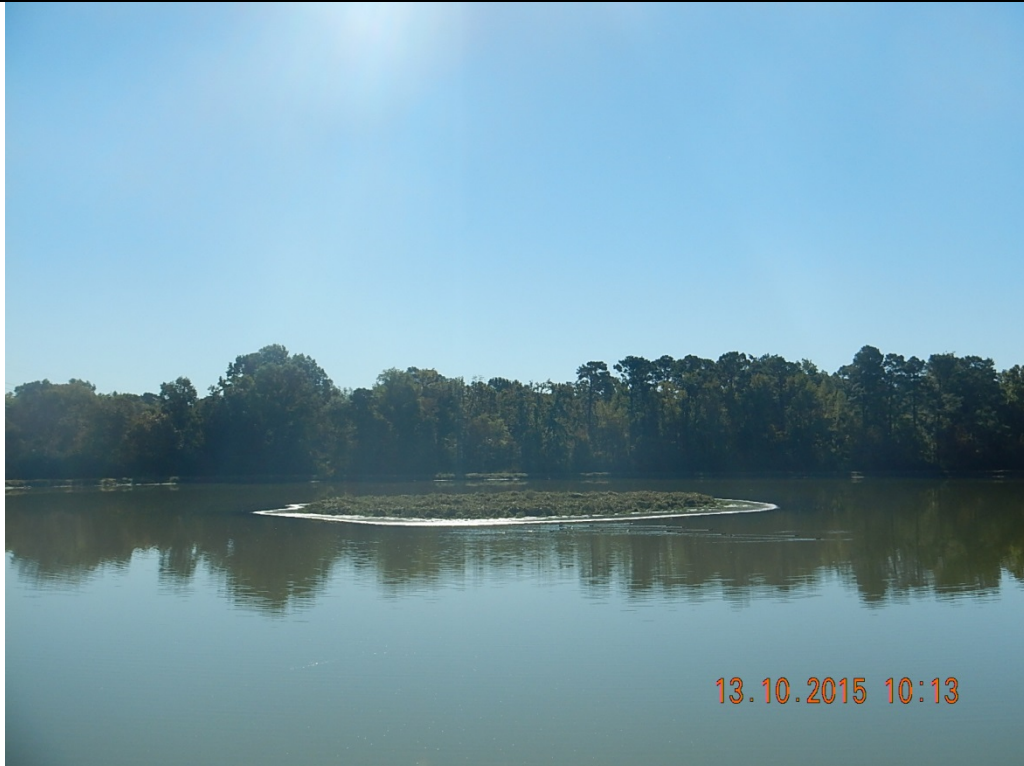
Location:	City of Nashville WWTP		
Photographer:	Kerri McCabe	Date:	Oct 13, 2015
Time:	1013	Witness:	Chip Colston and Larry Dunaway
Photo #:	1	Description:	Sludge island outside Pond #1; vegetation consists of wetland species.

The City was working on resolving the sludge buildup when I arrived onsite. They stated that they would be removing the vegetation (mechanical means only; no pesticides in EQ basin) and utilizing a boat to break up the sludge islands, and that it would take a couple of days for each sludge island.

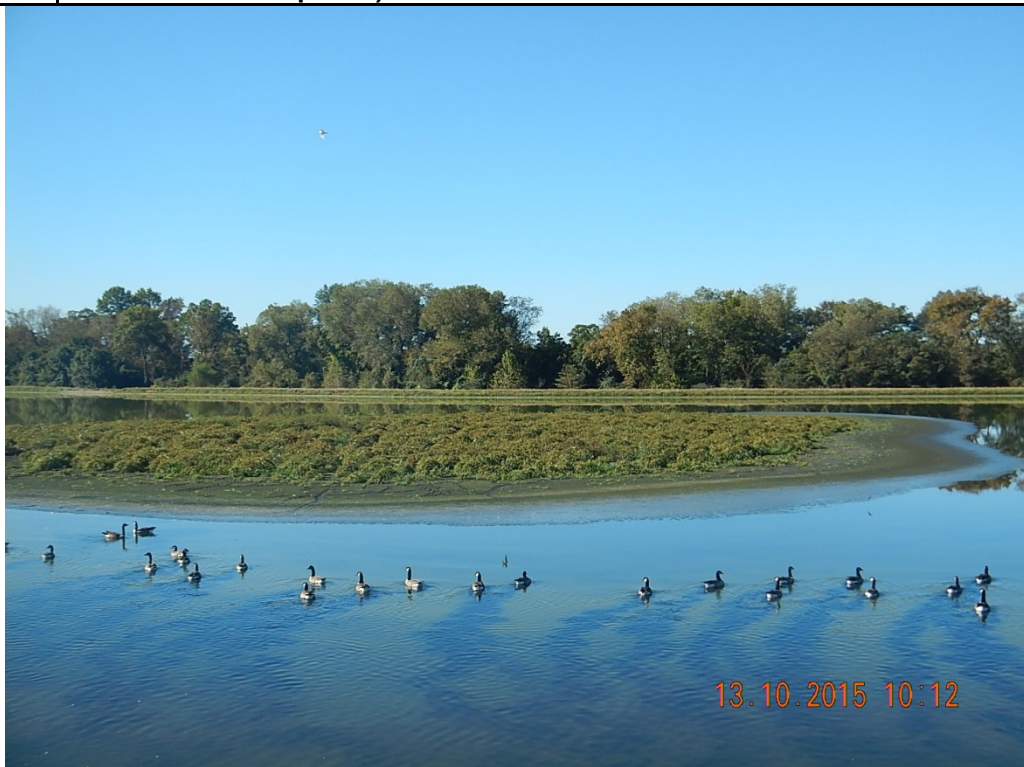
Photographer:	Kerri McCabe	Date:	Oct 13, 2015
Time:	1012	Witness:	Chip Colston and Larry Dunaway
Photo #:	2	Description:	Sludge island outside Pond #2; EQ basin volume very low (Canada Geese leaving trails in bottom deposits).

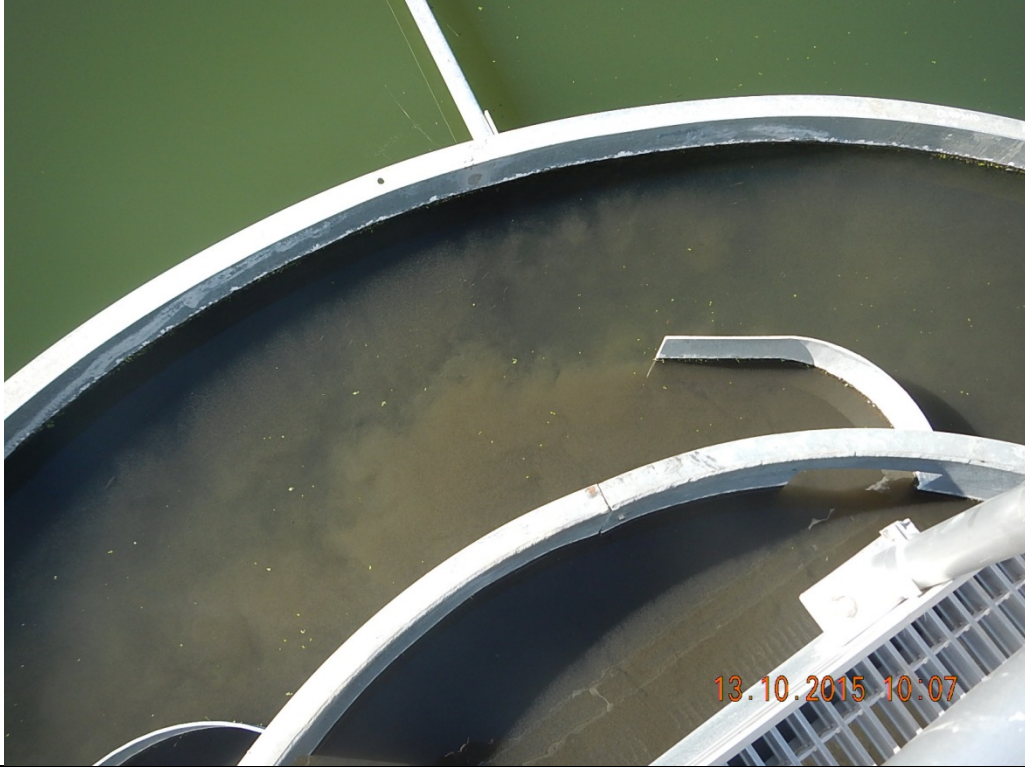
The City is still working on removing the accumulated sludge and excess vegetation in the converted aeration basins. This will ensure that sludge routed to the clarifiers is suitable for secondary treatment as well as sufficient for RAS back to the aeration basins. Pin floc (indicative of old sludge) is still present in both clarifiers. The sludge blankets in both clarifiers are increasing, but the City has not accumulated enough sludge to waste.

Location:	City of Nashville WWTP				
Photographer:	Kerri McCabe	Date:	Oct 13, 2015	Time:	1007
Witness:	Chip Colston and Larry Dunaway			Photo #:	3
Description:	Sludge at clarifier; note pin floc.

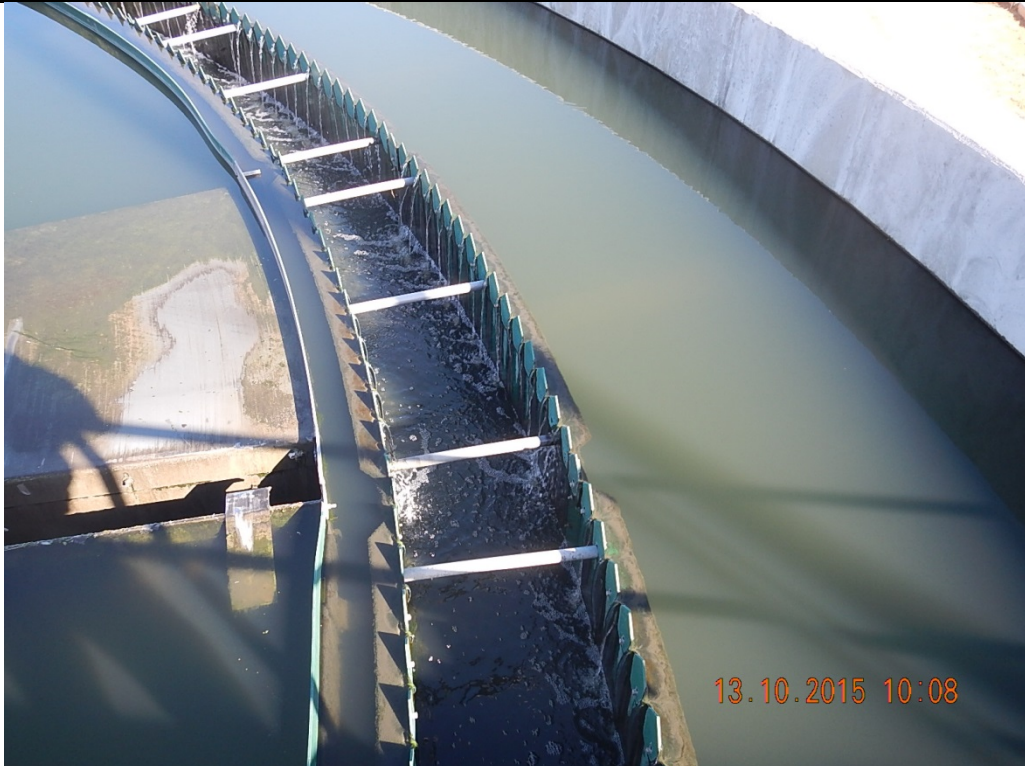
Photographer:	Kerri McCabe	Date:	Oct 13, 2015	Time:	1008
Witness:	Chip Colston and Larry Dunaway			Photo #:	4
Description:	Effluent clarity at clarifier weir.

Excessive algae remain problematic. The City has started adding polymer prior to the clarifiers to control algae and settle sludge, and the City historically utilized DAF units prior to the plant conversion. City is looking at chemical (without Cu) and ultrasonic algae control.

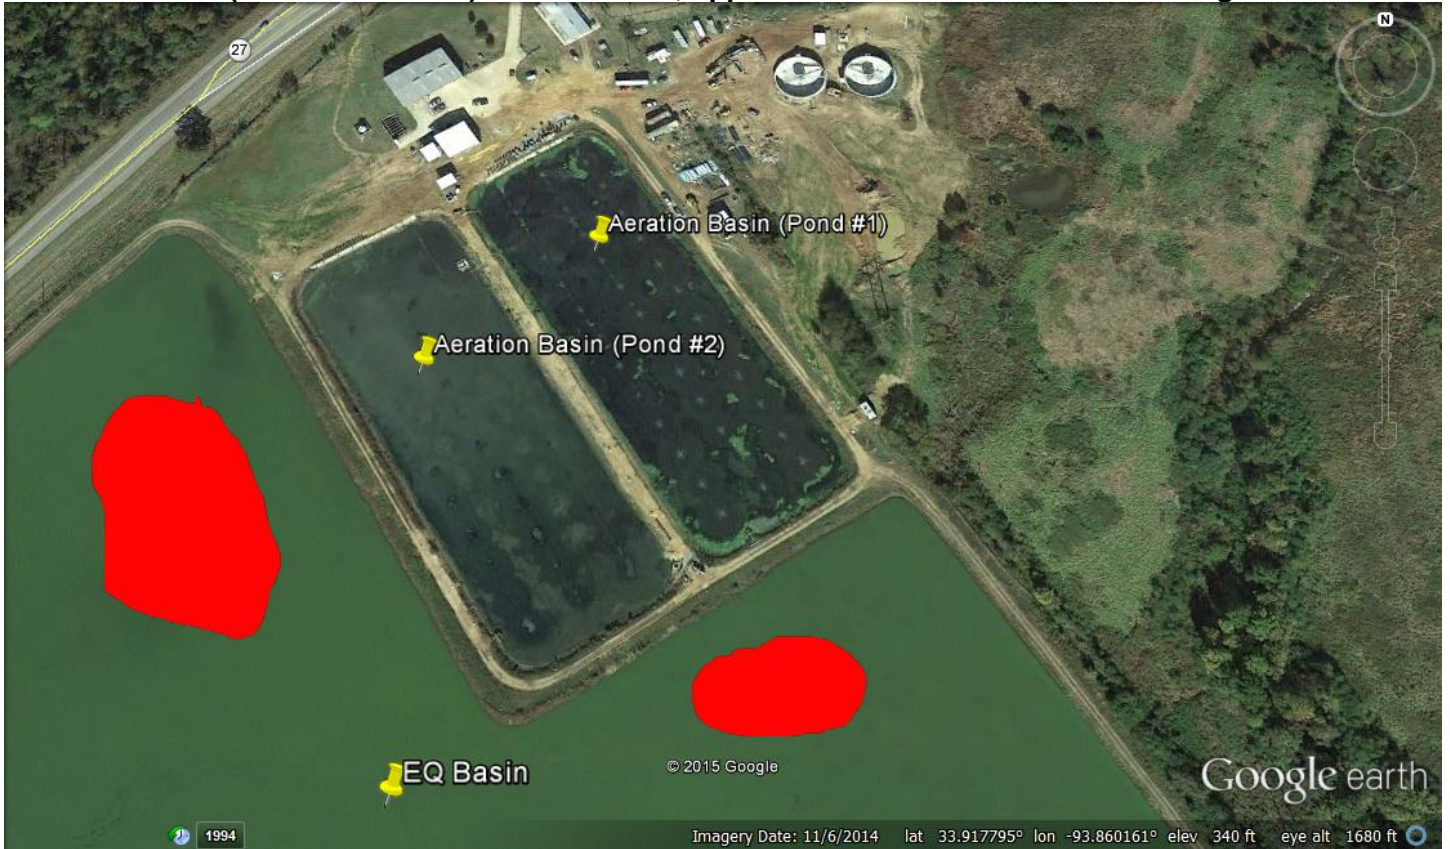
The City recently brought new components of the WWTP online (July 2015). This included brand new components as well as converted components. The plant's three-cell facultative lagoon had been converted into two activated sludge basins and an EQ basin. In order to install the aeration system in the two converted activated sludge basins, the City has had to remove accumulated sludge from Pond #1 and Pond #2. The City diverted the excess sludge to the EQ basin. This resulted in sludge accumulating at the gates of the two ponds. Vegetation consisting of wetland species (i.e., rushes) had grown on the two sludge "islands" in the EQ basin. Water volume in the EQ basin was at a seasonal low, and this had increased the visibility of the sludge from the highway.

Figure 1. Google Earth image dated Nov 6, 2014 showing the converted three-cell lagoon into two aeration basins (Ponds #1 and #2) and EQ basin; approximate size and location of sludge islands.
