RE: C&H Hog Farms Inspection
AFIN: 51-00164 Permit No.: ARG590001

A R K A N S A S Department of Environmental Quality	WATER DIVISION INSPECTION REPORT				
	AFIN: 51-00164	PERMIT #: ARG590001	DATE: 12/30/2015		
	COUNTY: 51 Newton	PDS #: 088608	MEDIA: WN		
	GPS LAT: 35.923155 LONG: -93.073633 LOCATION: Entrance				
FACILITY INFORMATION		INSPECTION INFORMATION			
NAME: C&H Hog Farms LOCATION: County Rd. 41 CITY: Mt. Judea		FACILITY TYPE: 2 - Industrial INSPECTOR ID#: 83321 S - State FACILITY EVALUATION RATING: 4 - Satisfactory INSPECTION TYPE: Compliance Evaluation			
RESPONSIBLE OFFICIAL		DATE(S): 12/30/2015 ENTRY TIME: 09:20 EXIT TIME: 10:45 PERMIT EFFECTIVE DATE: 8/3/2012 PERMIT EXPIRATION DATE: 10/31/2016			
NAME / TITLE: Jason Henson / Owner COMPANY: C&H Hog Farms MAILING ADDRESS: HC 72 Box 10 CITY, STATE, ZIP: Mt. Judea AR 72655 PHONE & EXT: / FAX: / EMAIL:		FAYETTEVILLE SHALE RELATED: N FAYETTEVILLE SHALE VIOLATIONS: N			
CONTACTED DURING INSPECTION: Yes		INSPECTION PARTICIPANTS

Water Division Photographic Evidence Sheet

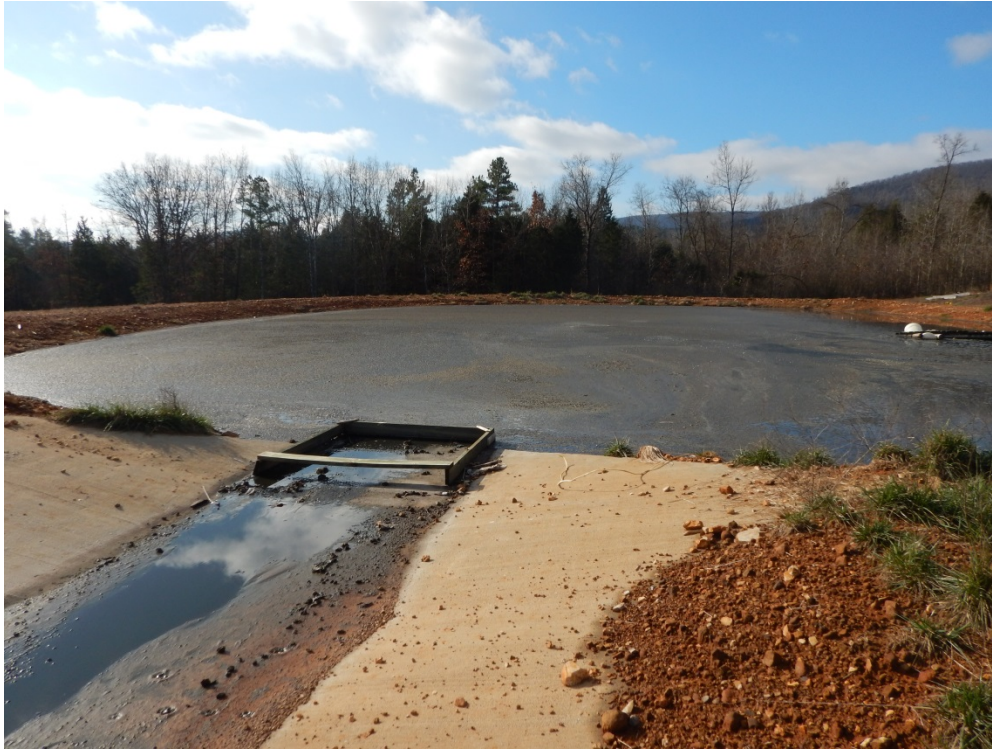
4. Waste Storage Pond (WSP) #1 was full but no flowing over the spillway and into WSP #2 at the time of the visit (Photograph #1). The level of WSP #2 was approximately 1 foot below the Must Pump Down level (Photograph 3).

Location:	C&H Hog Farms		
Photographer:	Jason Bolenbaugh	Date:	12/30/2015
Witness:	Keith Waters	Time:	
		Photo #:	1
Description:	Standing between WPS #1 and #2 looking toward WPS #1. Wastewater was not flowing from WPS #1 into WPS #2 at the time of the inspection.

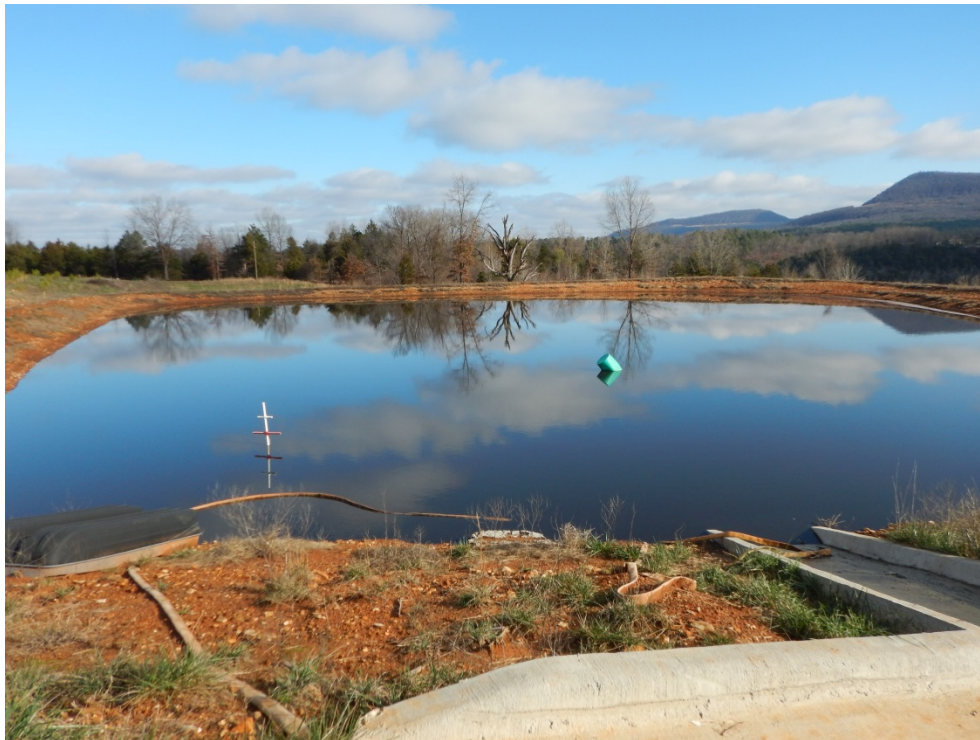
Photographer:	Jason Bolenbaugh	Date:	12/30/2015
Witness:	Keith Waters	Time:	
		Photo #:	2
Description:	WPS #2 showing adequate amount of freeboard and the depth gauge which marks (red line) the Must Pump Down level.

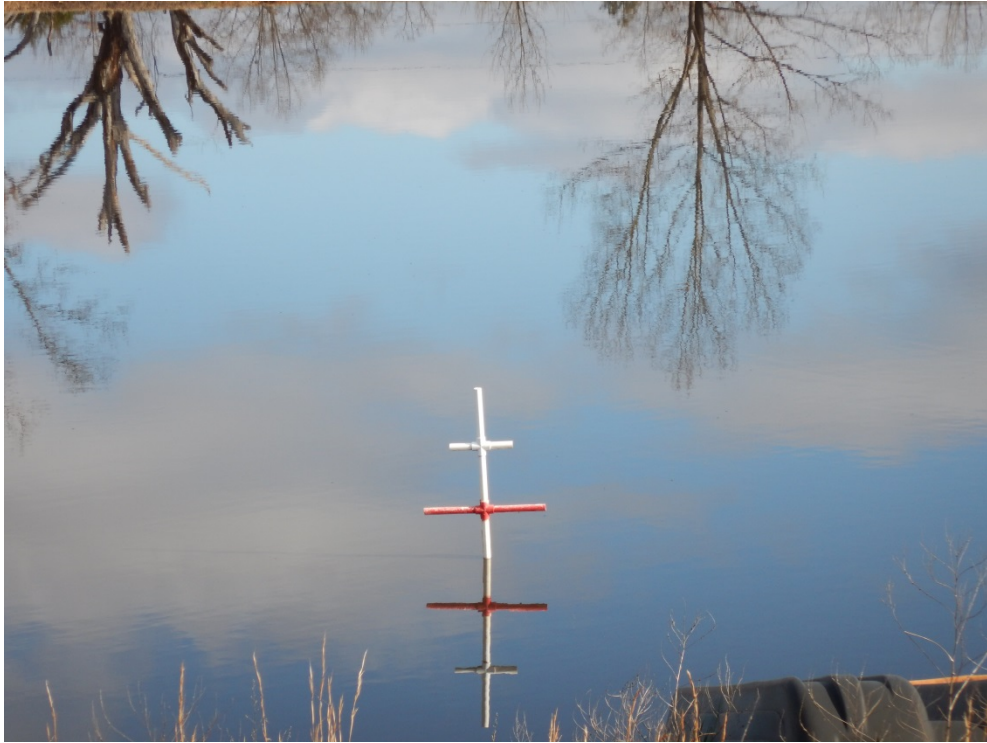
Location:	C&H Hog Farms				
Photographer:	Jason Bolenbaugh	Date:	12/30/2015	Time:	
Witness:	Keith Waters	Photo #:	3		
Description:	Staff Gauge in WPS #2. Red line indicates Must Pump Down level.

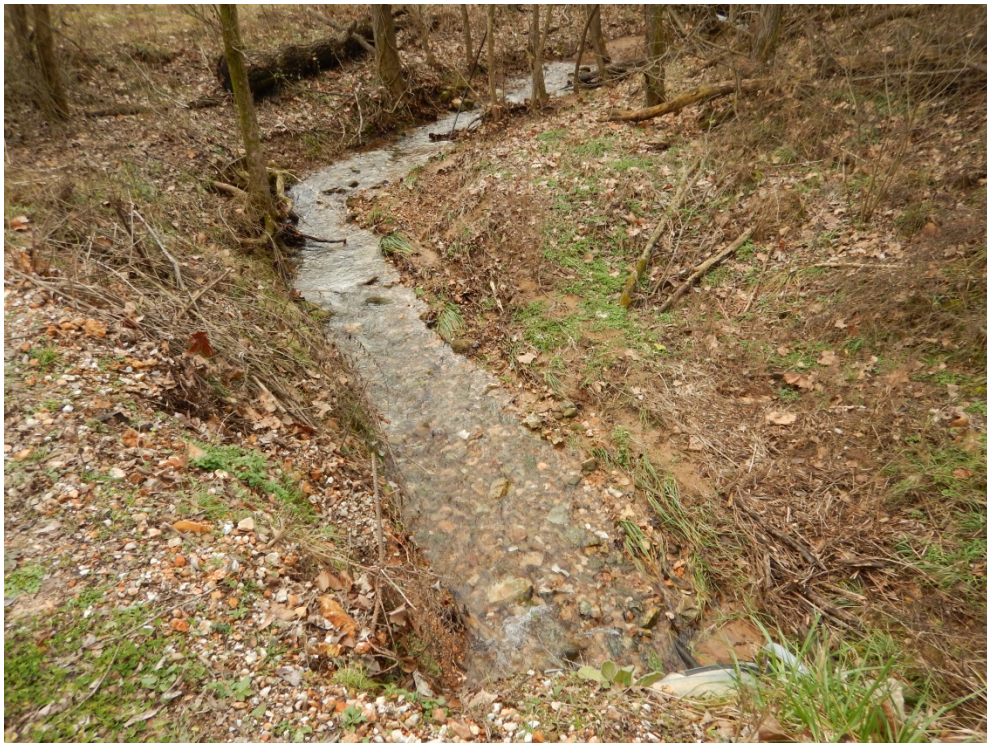
Photographer:	Jason Bolenbaugh	Date:	12/30/2015	Time:	
Witness:	Keith Waters	Photo #:	4		
Description:	Unnamed tributary directly below C&H Hog Farm.
