RE: Georgia Pacific, LLC-Crossett Inspection (Ashley Co)
AFIN: 02-00013 NPDES Permit No.: AR0001210

WATER DIVISION INSPECTION REPORT

AFIN: 02-00013	PERMIT #: AR0001210	DATE: 4/6/2016
COUNTY: 02 Ashley	PDS #: 090207	MEDIA: WN
GPS LAT: 33.138517 LONG: -91.979876 LOCATION: General Area

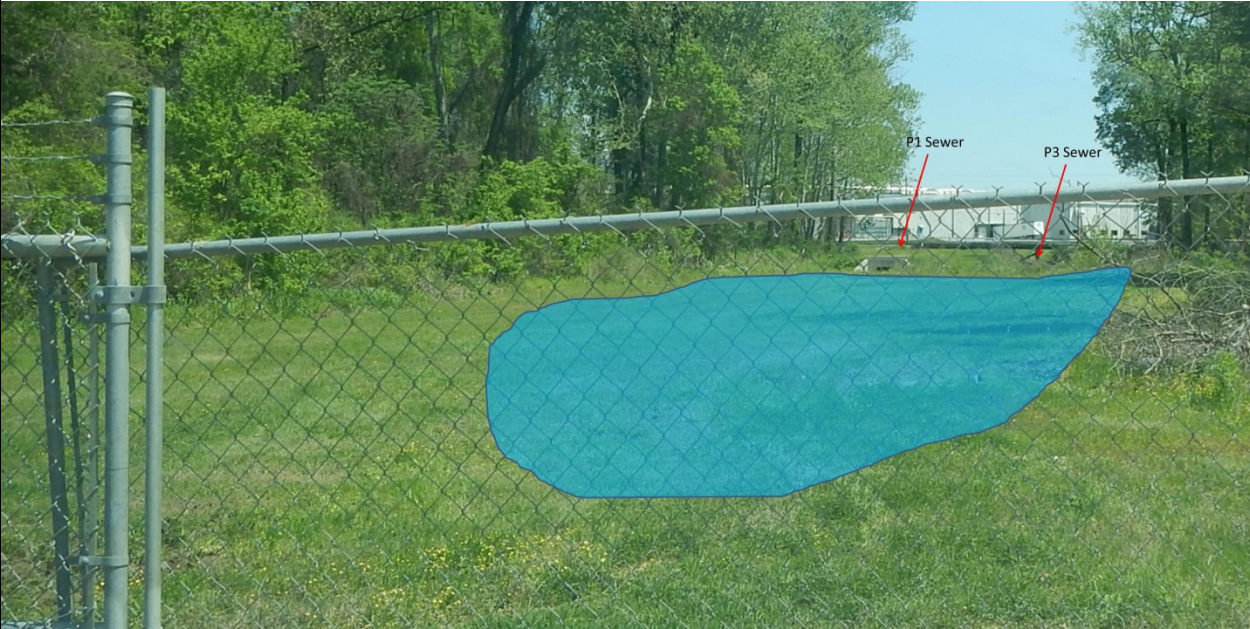
Water Division Photographic Evidence Sheet			
Location:	Georgia Pacific, LLC-Crossett		
Photographer:	Michael Young	Date:	04/06/2016
Time:	13:28		Photo #:
Witness:	Sarah Ross; Rachel Johnson		1
Description:	Image from gate on Hancock Road looking east toward GP facility. P1 and P3 sewer locations are indicated. Blue shading is area stated to be under water.

Figure 1. Overview of area directly west of Georgia-Pacific Crossett, LLC. The P1 and P3 sewer channels are labeled with arrows and the area shaded in blue was the area that was stated to have some inundation from flooding. It was unknown if commingled stormwater and untreated effluent made it off G-P property.

Ms. Ross and Ms. Johnson stated that on March 9, 2016 an unknown amount of stormwater and process water inundated an area that had not been observed to be flooded prior to this event. The G-P facility has two waste streams that exit the west-side of the facility. The P1 waste stream exits the facility and travels under Hancock Road and Highway 82 and is routed to the clarifier. The P3 waste stream exits the facility and travels parallel to P1 but bypasses the clarifier and travels directly to the ash settling basin. According to the e-mail to ADEQ Enforcement Branch, the area in Photo 1 was completely inundated and it is probable that untreated effluent commingled with stormwater and may have traveled off of G-P property (see Figure 1).

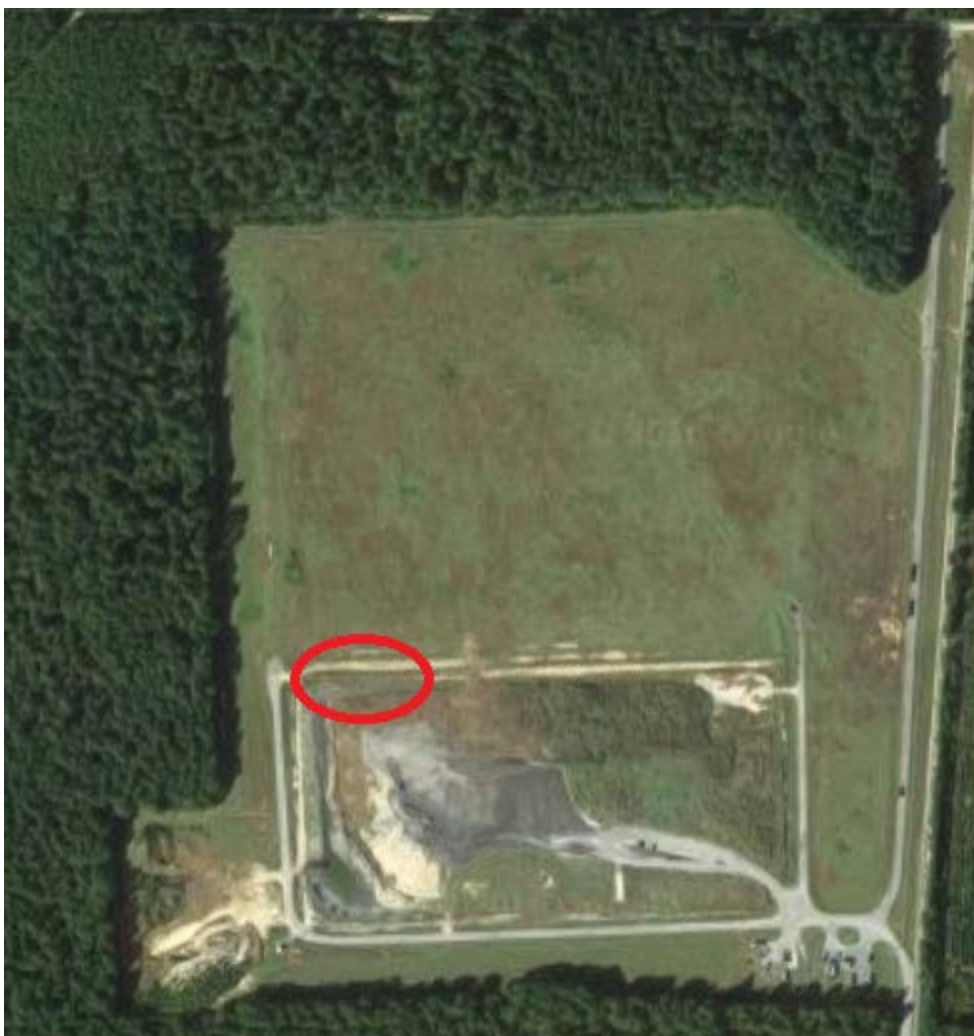
I am sending this email in follow up to our phone conversation earlier today. Georgia-Pacific Crossett LLC (NPDES Permit #AR0001210) did have an unpermitted discharge beginning this morning following a very large storm event. The mill's North Landfill has a leachate collection system which collects leachate from the active cell of the landfill and pumps it back to the wastewater treatment system for treatment. Due to the extremely heavy rains we are receiving in the area, the leachate system was overwhelmed with stormwater this morning and overflowed the berm on the north west corner of the landfill cell (in the area designated on the attached aerial photo). This water will

flow across a large open field before eventually flowing to an unnamed tributary of Brushy Creek. Samples have been collected and results will be reported to you as soon as they are available. At this time we do not believe it poses any impacts to health or the environment due to the heavy rains and high flows in the streams in the area.
