**RE: City of Mena Wastewater Plant Inspections (Polk Co)**  
**AFIN: 57-00423** **Permit No.: AR0036692**  
**ARR000145**  
**AR0036692C**  
**ARR150000**  
**57-00290** **5207-W**

<b>A R K A N S A S</b> Department of Environmental Quality		<b>WATER DIVISION INSPECTION REPORT</b>					
		AFIN: 57-00423		PERMIT #: AR0036692		DATE: 5/6/2016	
		COUNTY: 57 Polk			PDS #: 090883		MEDIA: WN
		GPS LAT: 34.556208 LONG: -94.188032 LOCATION: Entrance					
<b>FACILITY INFORMATION</b>				<b>INSPECTION INFORMATION</b>			
NAME: <b>Mena Wastewater Plant</b> LOCATION: <b>323 Polk 53</b> CITY: <b>Mena, AR</b>				FACILITY TYPE: <b>1 - Municipal</b>		INSPECTOR ID#: <b>84022 S - State</b>	
				FACILITY EVALUATION RATING: <b>2 - Marginal</b>		INSPECTION TYPE: <b>Compliance Evaluation</b>	
<b>RESPONSIBLE OFFICIAL</b>				DATE(S): <b>4/6/2016</b>		ENTRY TIME: <b>09:30</b>	
				EXIT TIME: <b>13:45</b>		PERMIT EFFECTIVE DATE: <b>3/1/2012</b>	
NAME / TITLE: <b>Mike Spencer / Wastewater Supervisor</b> COMPANY: <b>City of Mena</b> MAILING ADDRESS: <b>323 Polk 53</b> CITY, STATE, ZIP: <b>Mena AR 71953</b> PHONE & EXT: / FAX: <b>479-234-2592 /</b> EMAIL: <b>menawwtp@gmail.com</b> CONTACTED DURING INSPECTION: <b>

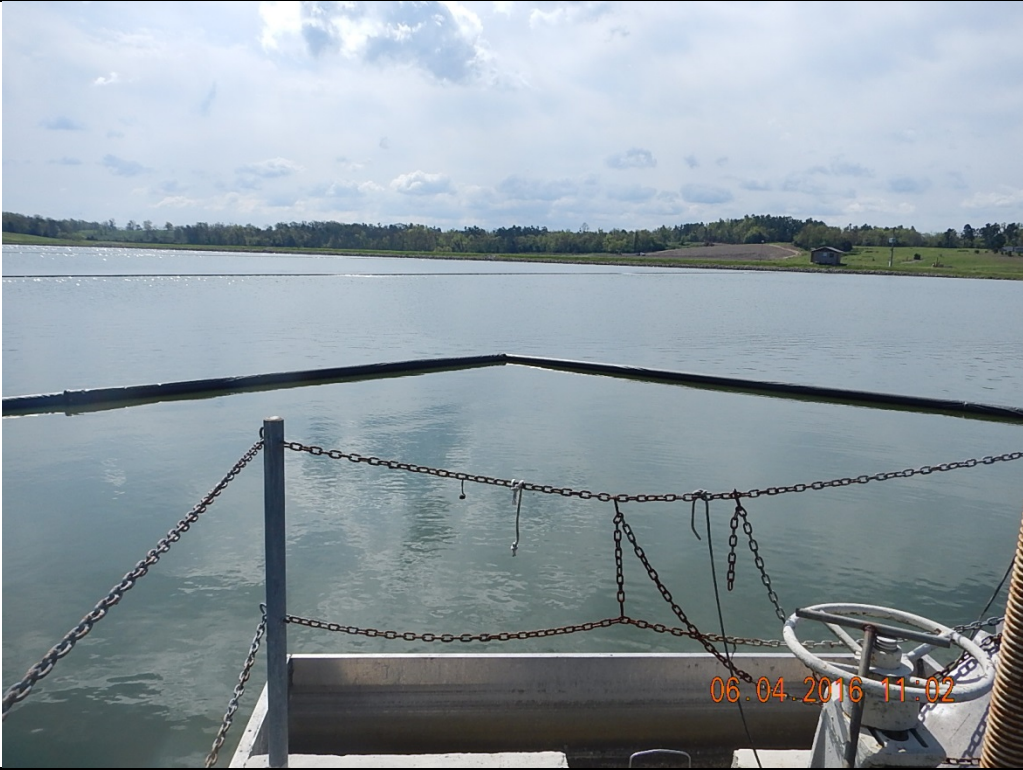
Water Division Photographic Evidence Sheet					
Location:	<b>Mena Wastewater Plant</b>				
Photographer:	<b>Kerri McCabe</b>	Date:	<b>April 6, 2016</b>	Time:	<b>1102</b>
Witness:	<b>Mike Spencer</b>			Photo #:	<b>3</b>
Description:	<b>Lagoon #2 at intake with baffles and fine bubble diffusers.</b>

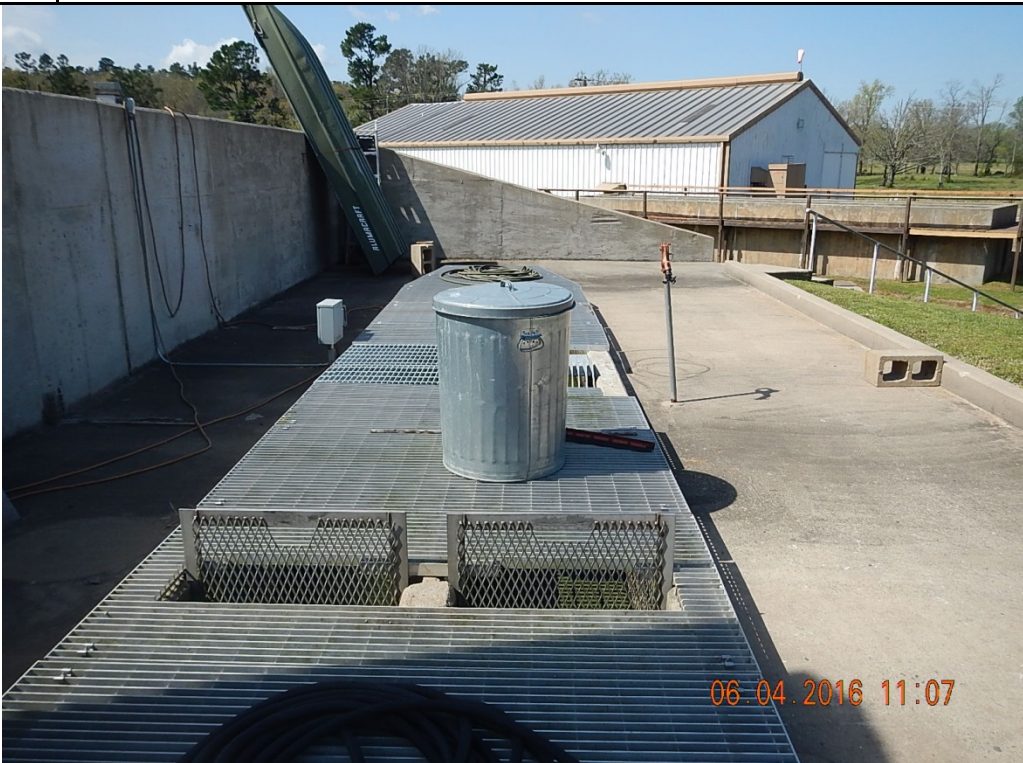
Photographer:	<b>Kerri McCabe</b>	Date:	<b>April 6, 2016</b>	Time:	<b>1107</b>
Witness:	<b>Mike Spencer</b>			Photo #:	<b>4</b>
Description:	<b>Old preliminary components now used to keep fishes from entering rapid sand filters.</b>

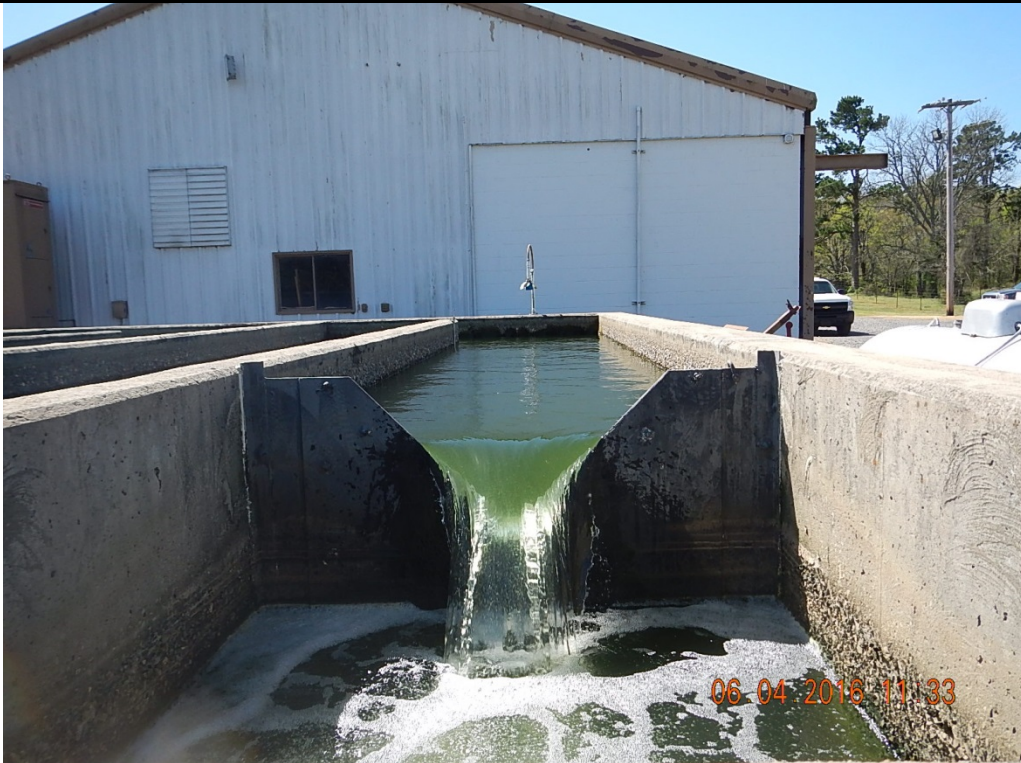
Location:	<b>Mena Wastewater Plant</b>		
Photographer:	<b>Kerri McCabe</b>	Date:	<b>April 6, 2016</b>
Witness:	<b>Mike Spencer</b>	Time:	<b>1133</b>
		Photo #:	<b>7</b>
Description:	<b>Effluent at 90deg V-notch weir and after chlorine disinfection.</b>

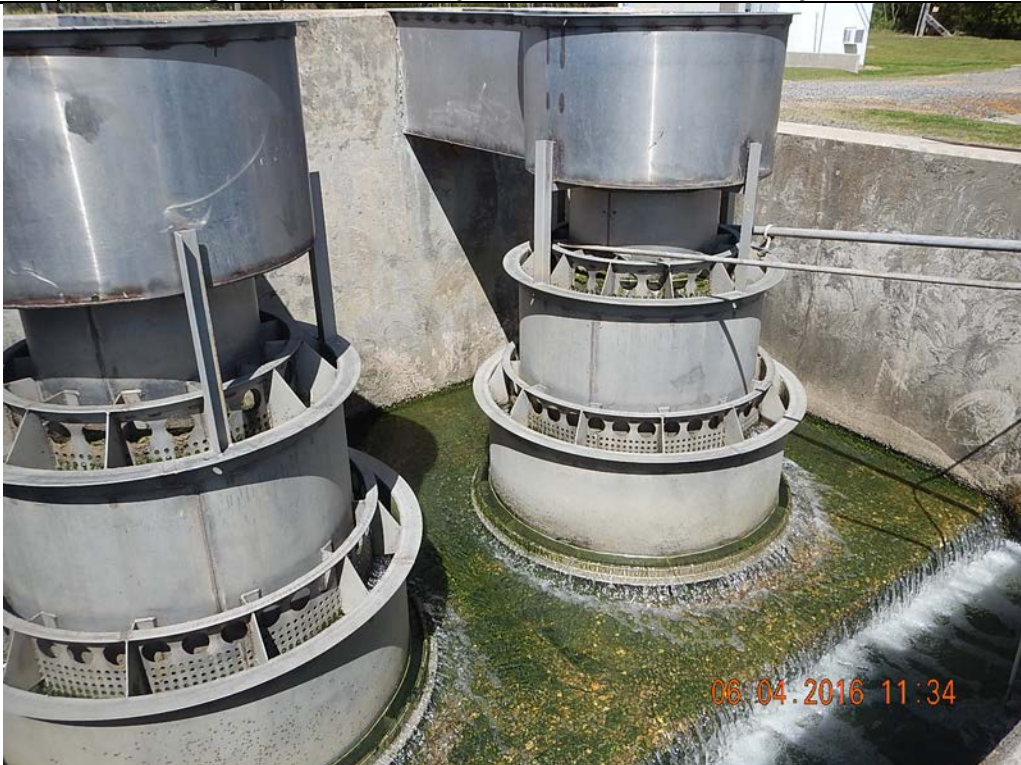
Photographer:	<b>Kerri McCabe</b>	Date:	<b>April 6, 2016</b>
Witness:	<b>Mike Spencer</b>	Time:	<b>1134</b>
		Photo #:	<b>8</b>
Description:	<b>Two static gravity aerators for post-aeration; effluent sampled in corner.</b>

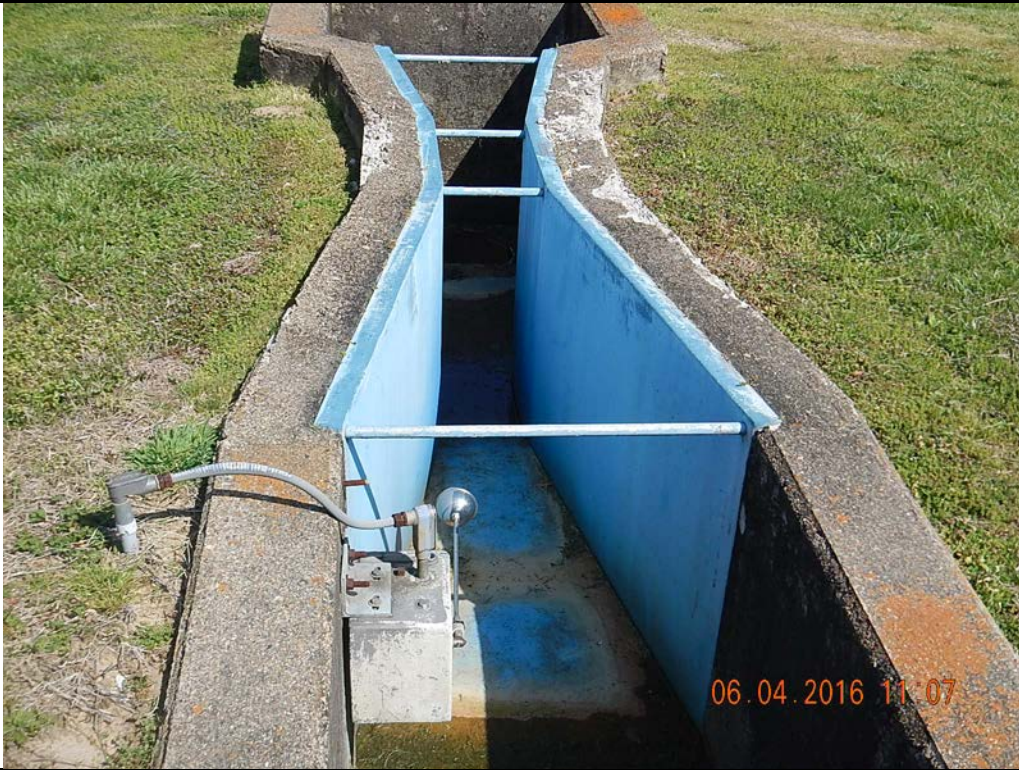
Location:	<b>Mena Wastewater Plant</b>		
Photographer:	<b>Kerri McCabe</b>	Date:	<b>April 6, 2016</b>
Witness:	<b>Mike Spencer</b>	Time:	<b>1107</b>
		Photo #:	<b>9</b>
Description:	<b>Old primary/secondary devices prior to outfall; now used for bypass at Lagoon #2.</b>

*Bypass is locked  
only opened in  
emergencies during  
large drain events.*

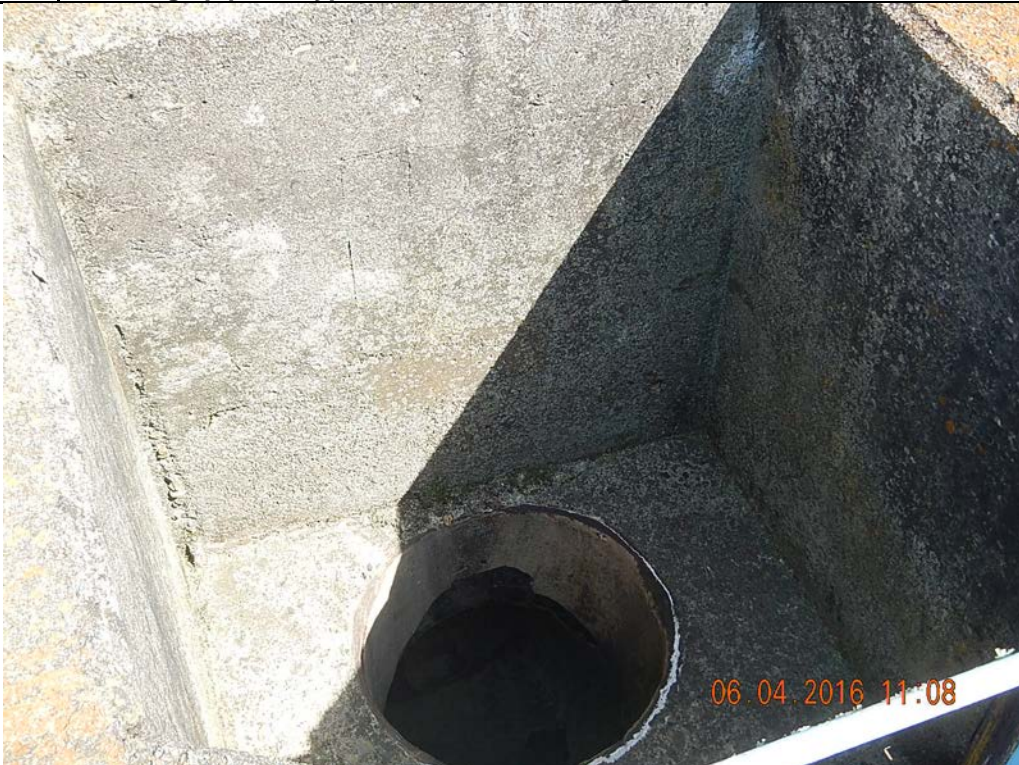
Photographer:	<b>Kerri McCabe</b>	Date:	<b>April 6, 2016</b>
Witness:	<b>Mike Spencer</b>	Time:	<b>1108</b>
		Photo #:	<b>10</b>
Description:	<b>Discharge pipe at bypass structure from Lagoon #2.</b>

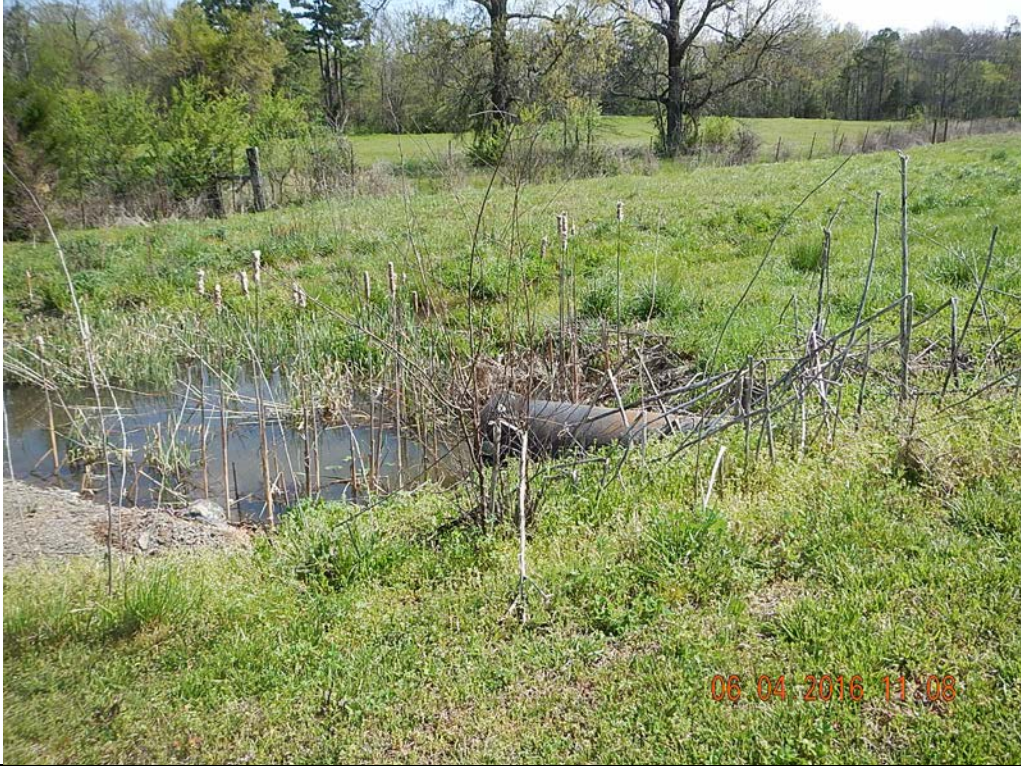
Location:	<b>Mena Wastewater Plant</b>		
Photographer:	<b>Kerri McCabe</b>	Date:	<b>April 6, 2016</b>
Witness:	<b>Mike Spencer</b>	Time:	<b>1108</b>
		Photo #:	<b>11</b>
Description:	<b>Discharge pipe for bypass structure at Lagoon #2; downstream of Outfall 001.</b>

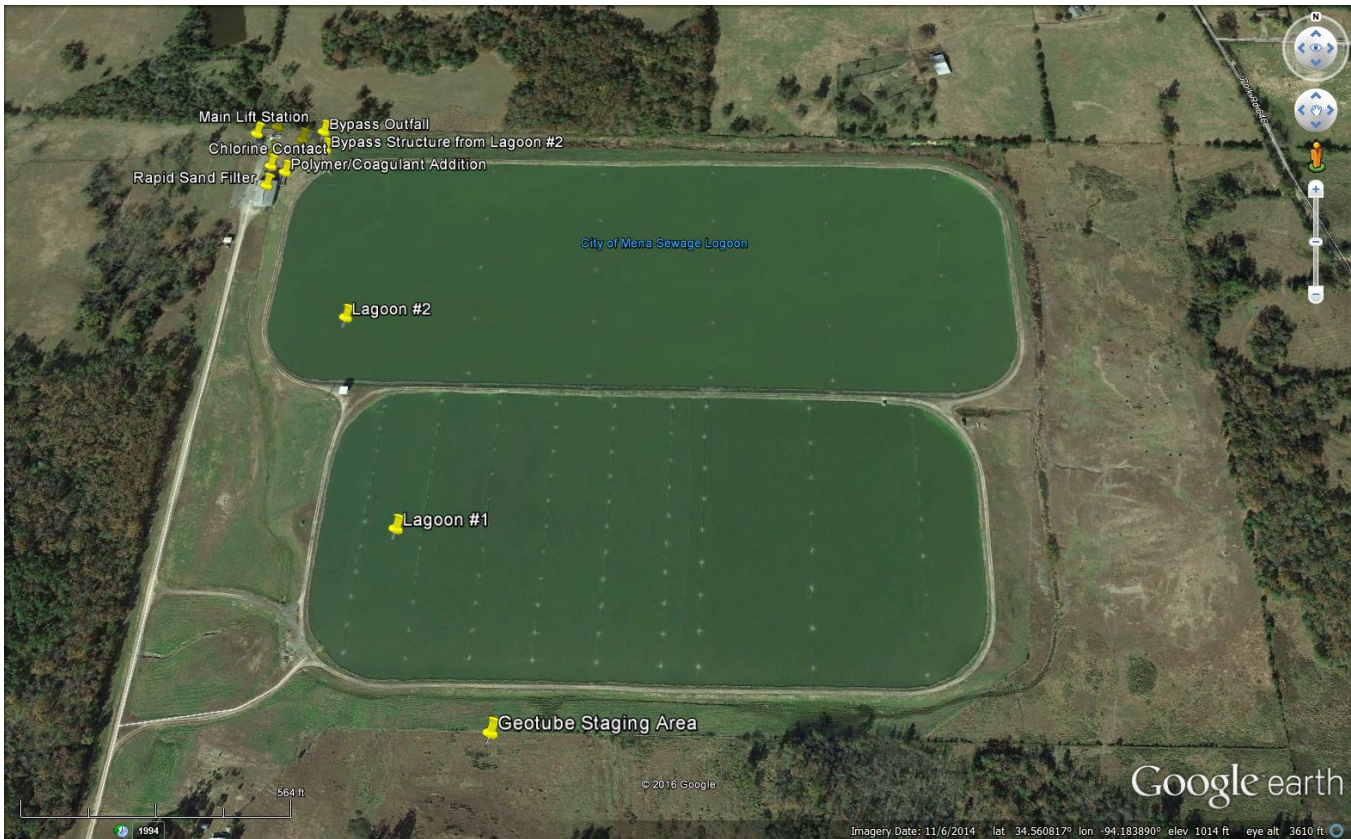
**Figure 1. Google Earth image dated Nov 6, 2016 showing overview of the City of Mena POTW and major structures.**

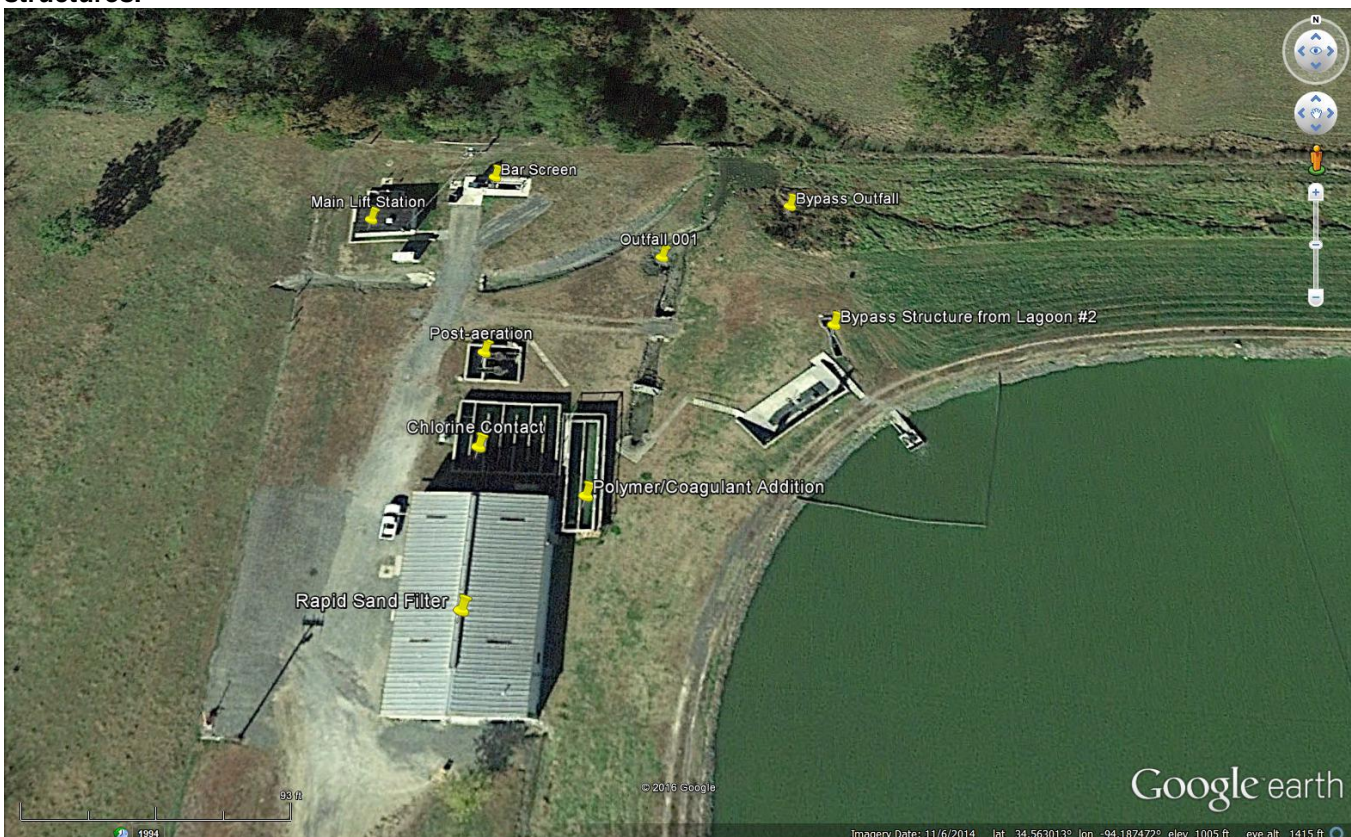
**Figure 2. Google Earth image dated Nov 6, 2016 showing close-up of the City of Mena POTW and major structures.**
