ARKANSAS
Department of Environmental Quality

RE: Blytheville - West WWTP Sewer Line Break and SSO
AFIN: 47-00544 Permit No.: AR0022560

Water Division Photographic Evidence Sheet

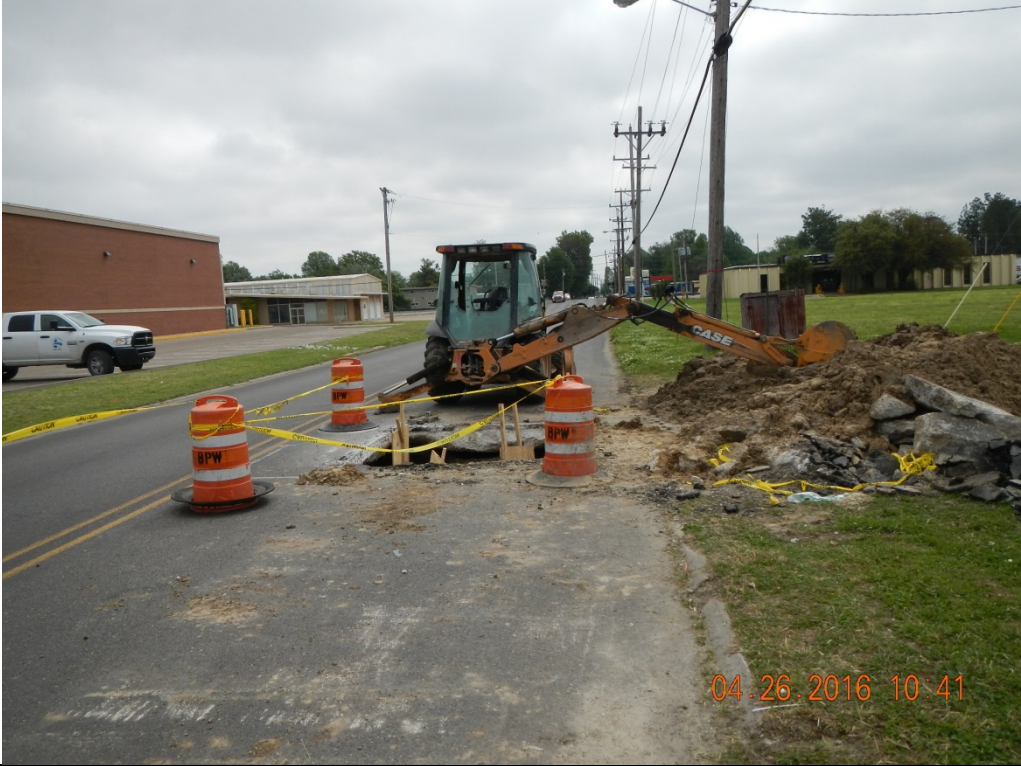
Location:	400 W. Moultrie		
Photographer:	Brent Walker	Date:	4/26/2016
Witness:	None	Time:	1041
		Photo #:	1
Description:	Overview of area where sewer line collapsed.

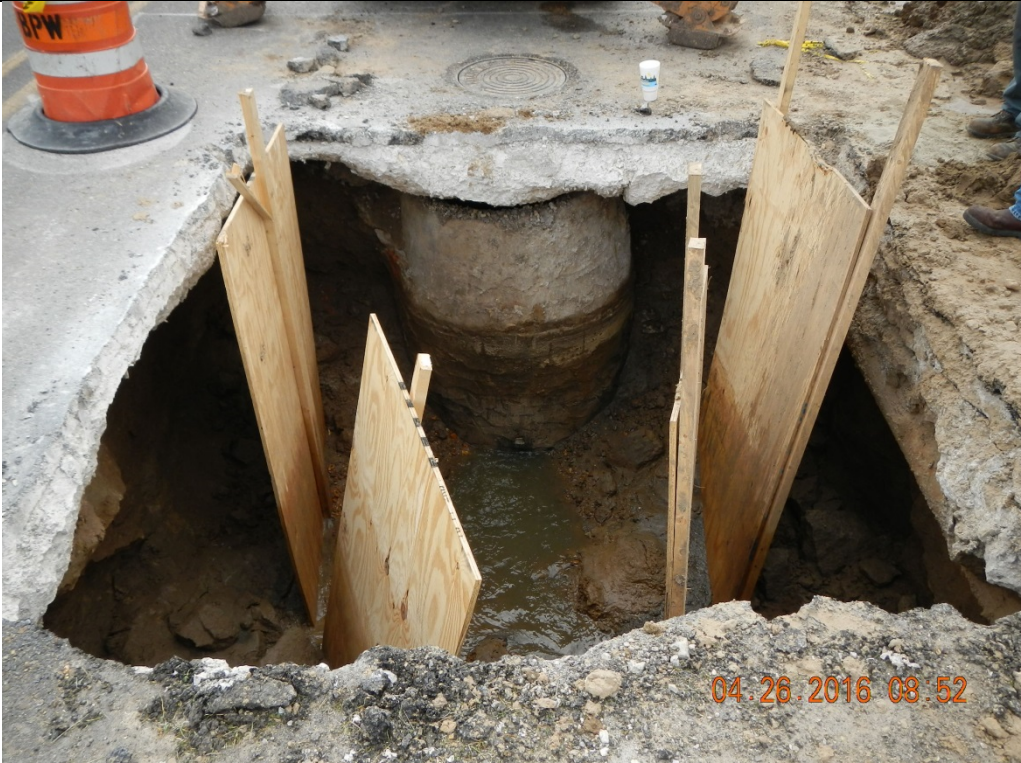
Photographer:	Brent Walker	Date:	4/26/2016
Witness:	None	Time:	0852
		Photo #:	2
Description:	Collapsed sewer line.

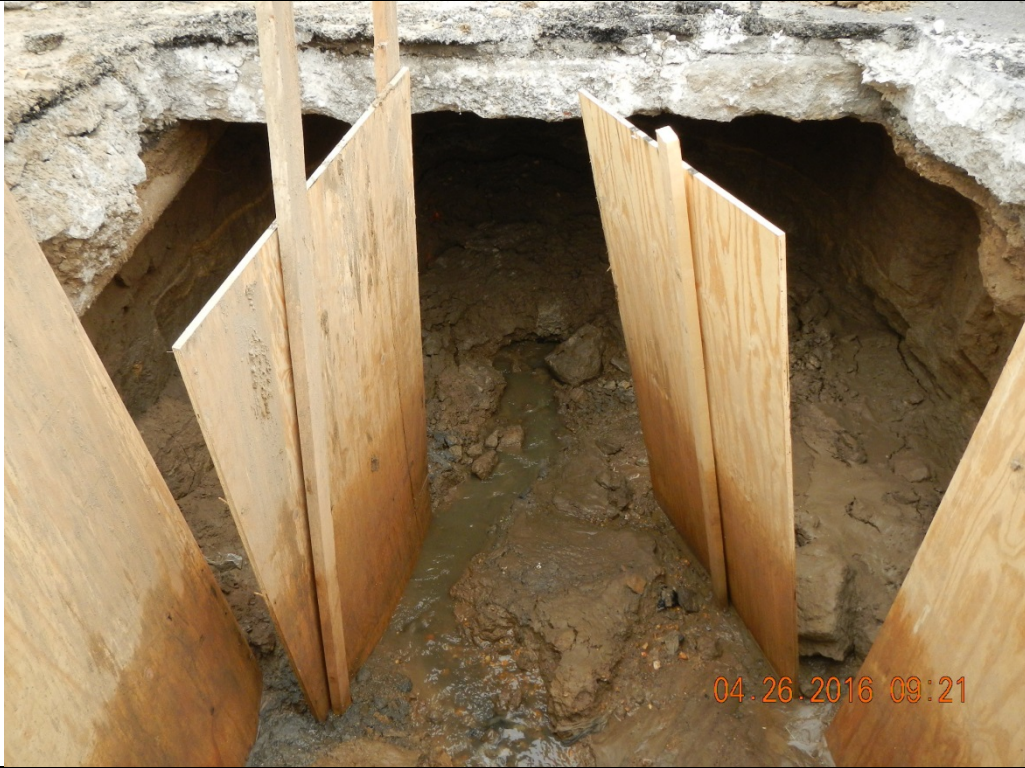
Location:	400 W. Moultrie		
Photographer:	Brent Walker	Date:	4/26/2016
Witness:	None	Time:	0921
		Photo #:	3
Description:	Collapsed sewer line.

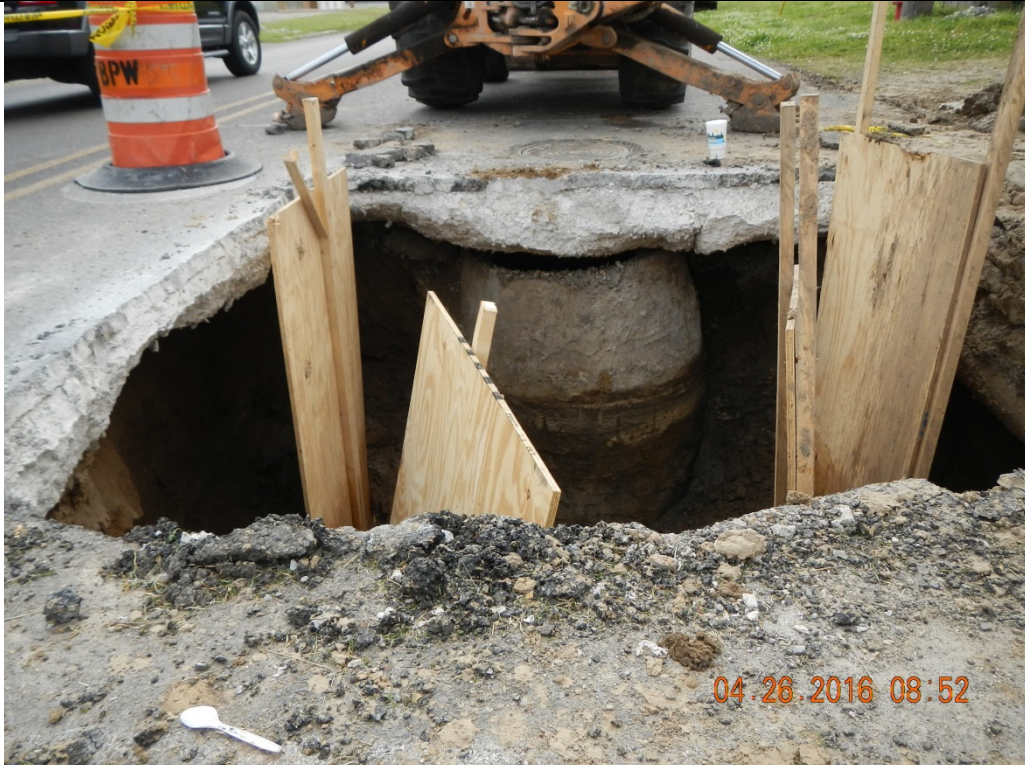
Photographer:	Brent Walker	Date:	4/26/2016
Witness:	None	Time:	0852
		Photo #:	4
Description:	View showing manhole settling below street level.
