**RE:** Berryville POTW Inspections (Carroll Co)

AFIN: 08-00034 NPDES Permit No.: AR0021792

On August 4, 2016 I performed a Compliance Evaluation Inspection, a Collection System Inspection, and a Construction Permit Inspection of the above-referenced facility in accordance with the provisions of the Federal Clean Water Act, the Arkansas Water and Air Pollution Control Act, and the regulations promulgated thereunder. A copy of each of the inspection reports is enclosed for your records.

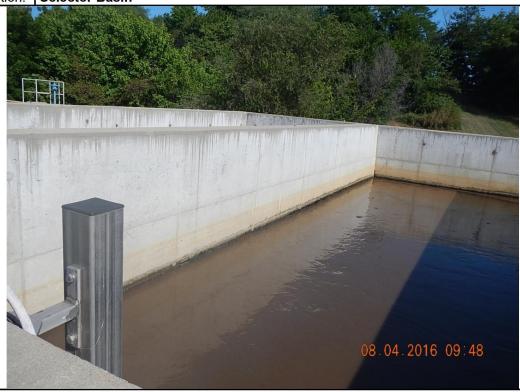
Photographer: Dannielle Gray	Date:	8/4/2016	Time:	0950
Witness: Mike Maynard, Mayo Miller, & Tim Tinsley			Photo #:	4
Description: Ovidation Ditch

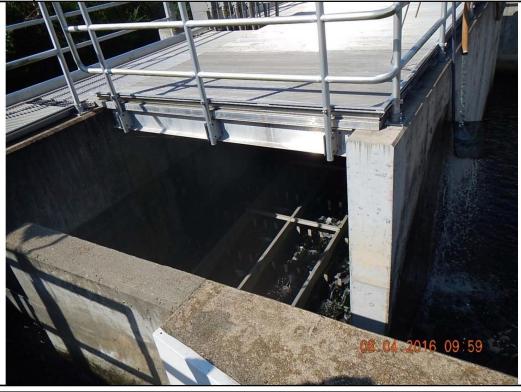
Photographer:Dannielle GrayDate:8/4/2016Time:0954Witness:Mike Maynard, Mayo Miller, & Tim TinsleyPhoto #:10Description:Facing upstream on Mill Branch Creek towards Outfall 001 (plant effluent).

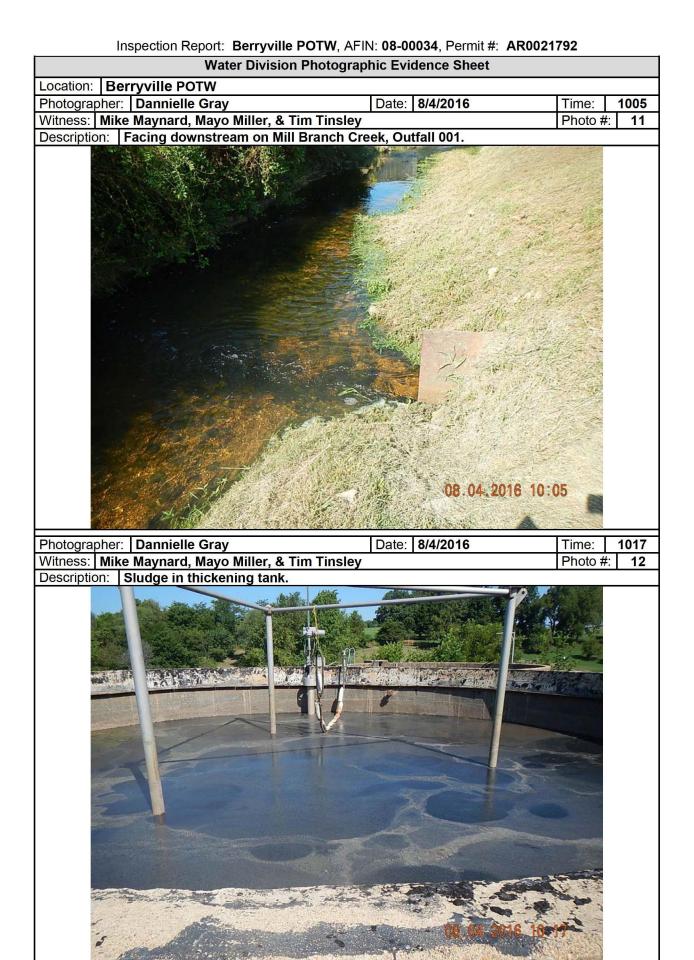
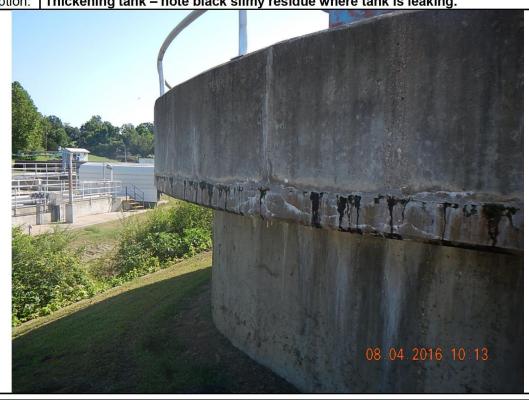
1. The gravity thickening tank is leaking (see Photos 13-16). This is a violation of Part II, Section B.1.a. The thickener is located adjacent to Mill Branch Creek. Therefore, the leak also poses an increased risk of stormwater pollution. This is a violation of Part III, Condition 12.B.7.iii of the permit.

Water Division Photographic Evidence Sheet								
Location: E	Berryville POTW							
Photographe	Photographer: Dannielle Gray Date: 8/4/2016 Time: 101							
Witness: M	ike Maynard, Mayo Miller, & Tim <mark>T</mark>	<b>Tinsley</b>		Photo #:	13			
Description	Thickening tank note block of	imy rociduo w	acre tank is looking

Photographer	: Dannielle Gray	Date:	8/4/2016	Time:	1013
Witness: Mike Maynard, Mayo Miller, & Tim Tinsley					<b>#</b> : <b>14</b>
Description:	Clace up of recidue where thickening	tank ic	looking

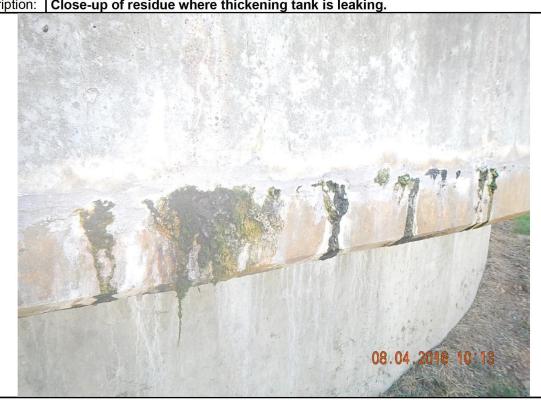
mepesaliti tepeta Dengime i e i i i, i anti e e e e e i, i e i i i i i i i i i i i									
Water Division Photographic Evidence Sheet									
Location: Berryville POTW									
Photographe	er: Dannielle Gray	Date:	8/4/2016	Time:	1013				
Witness: Mike Maynard, Mayo Miller, & Tim Tinsley					15				
Description:	Immediately below Photo 14 above, wastewater from thickener is leaking out onto								
	ground.

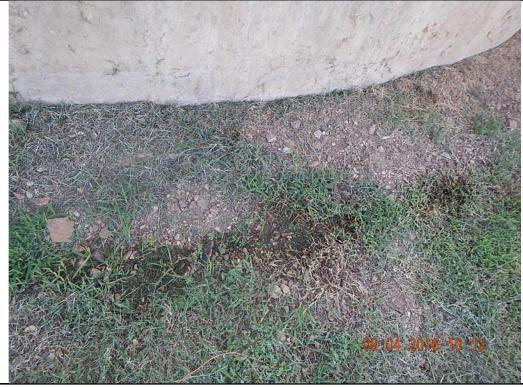
Photographer	: Dannielle Gray	Date:	8/4/2016	Time:	1014
Witness: Mike Maynard, Mayo Miller, & Tim Tinsley		Photo #:	16

1. TREATMENT UNITS PROPERLY OPERATED:	⊠s □m □u □na □ne
2. TREATMENT UNITS PROPERLY MAINTAINED: Thickening tank leaking onto ground.	□S ØM □U □NA □NE
3. STANDBY POWER OR OTHER EQUIVALENT PROVIDED: 750 hp diesel generator.	⊠s □m □u □na □ne

Description: Thickener leak – note residue on tank and wetted area on ground immediately below residue; tank actively leaking during inspection.

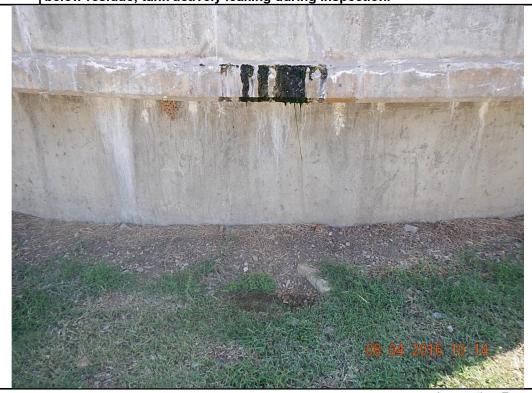
Water Division Photographic Evidence Sheet							
Location: Berryville POTW							
Photographe	r: Dannielle Gray	Date:	8/4/2016	Time:	1021		
Witness: Mike Maynard, Mayo Miller, & Tim Tinsley			Photo #:	17			
Description:	Cludge proce

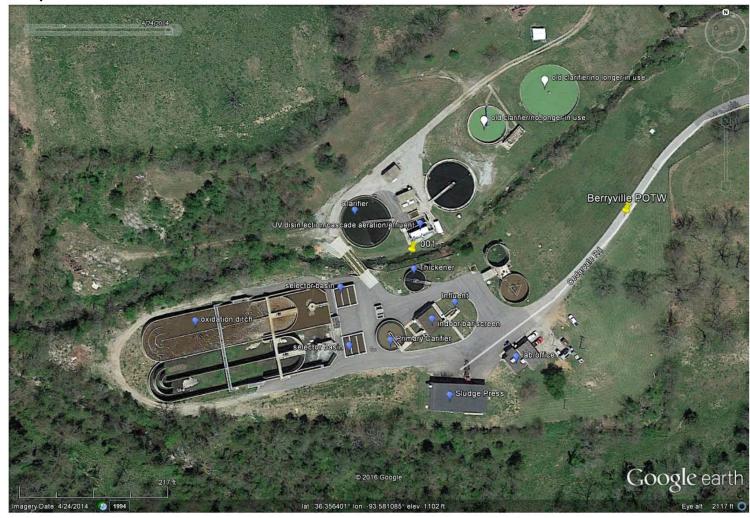
Figure 1. Google Earth image dated April 24, 2014 showing facility overview and major treatment components.
