#### RE: Anthony Forest Products Compan Inspections (Union Co) AFIN: 70-00473 NPDES Permit No.: AR0047384 ARG550398 ARG550540 ARR000977

Inspection Report: Anthony Forest Products Compan, AFIN: 70-00473, Permit #: AR0047384

RE: Anthony Forest Products Company, LLC Compliance Inspection Response AFIN: 70-00473
 NPDES Permit No. AR0047384, Permit Tracking No. ARR000977, Permit Tracking No. ARG550398, and Permit Tracking No. ARG550540

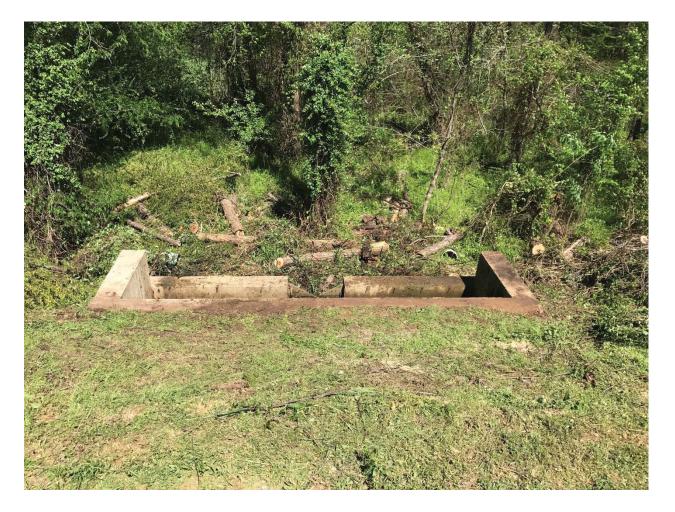
# Attachment 1 Outfall 001 Photo

The flow device at Outfall 001 is not maintained to provide adequate volume of monitored discharges. Materials were observed in the weir box and roots growing up and through the V-notch weir.

Photograph of Outfall 001 weir.

Vines, roots, and debris have been removed from the weir and weir box. Pictures showing the above described corrective actions can be found in Attachment 1.

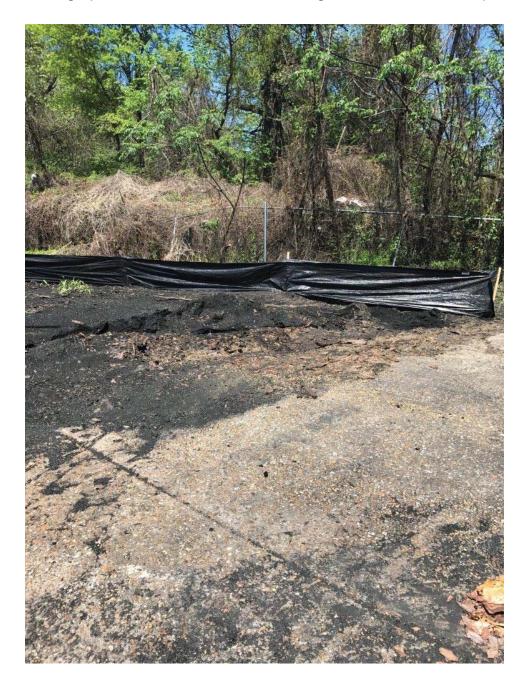
# Attachment 2 Outfall 011 Photos

The facility has kiln ash pile with no control measures that is contributing to pollution of UT of Woodard Creek.

Photograph 1 of silt fence installed down gradient of the kiln ash pile.

Silt fence has been added to the downstream side of the kiln ash pile as a temporary control measure. Pictures showing the above described corrective action can be found in Attachment 2.

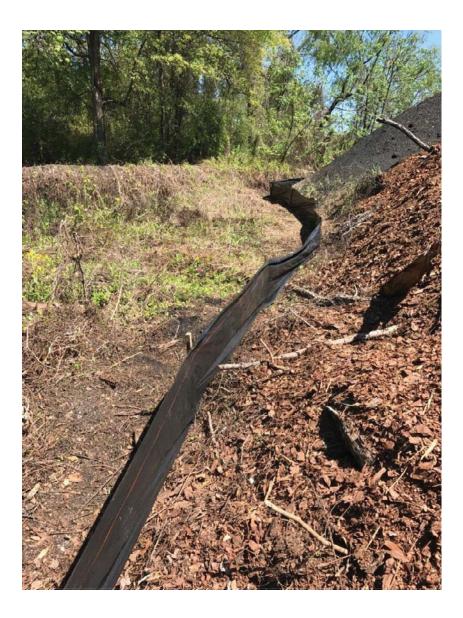
Photograph 3 of silt fence installed down gradient of the kiln ash pile.

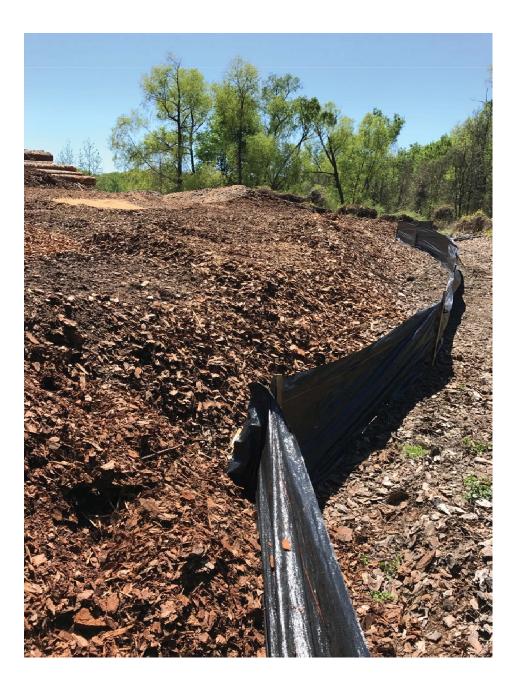
Photograph 4 of silt fence installed down gradient of the kiln ash pile.

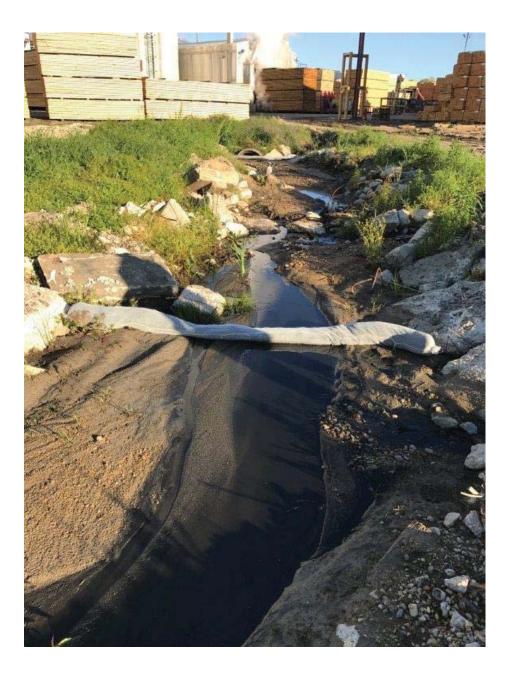
# Attachment 3 Outfall 003 Photos

Oil sheen was observed in the ditch draining to Outfall 003 from the kiln area. The facility needs to adequately use good housekeeping measures and maintain all equipment to prevent the discharge of pollutants in stormwater discharged to receiving waters.

Photograph showing oils booms that were placed in the drainage ditch leading to Outfall 003.

Oil booms have been placed in the drainage ditch leading to Outfall 003, as can be seen in the picture found in Attachment 3. The kiln area and drainage ditch leading to Outfall 003 will be monitored weekly by the EHS manager to ensure good housekeeping practices are being maintained and the oil booms are properly maintained.

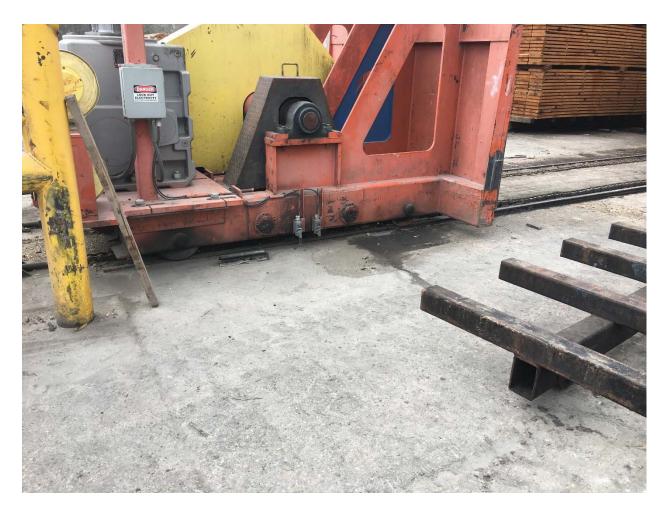
Photograph showing area in the vicinity of the kilns where excess grease has been observed.

Please note that the exact location of the oil and grease noted on the ground that was noted in Photo No. 12 of the ADEQ inspection could not be determined. Attachment 3 contains pictures of the area taken during the quarterly inspection of the general area of the kilns.

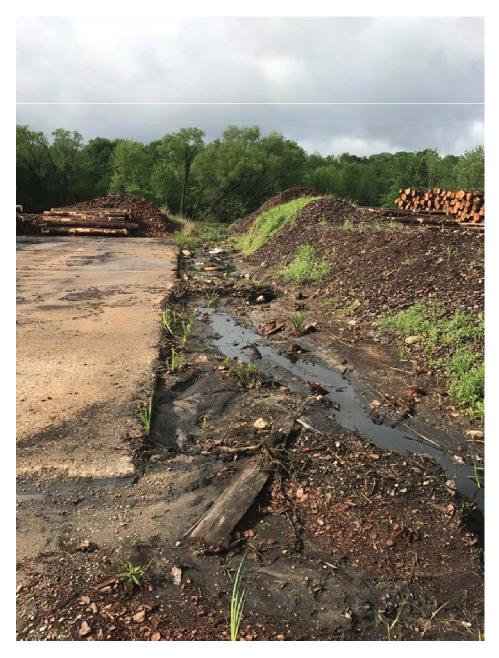
## **Outfall 008 BMP Photos**

Erosion and sediment controls are not being utilized in the ditch that drains Outfall 008.

Photograph showing the upper part of the ditch leading to Outfall 008. Vegetation has been established in the lower part of the ditch and starting to grow in the upper portion.

This ditch is normally vegetated. However, the ditch as clean out as part a major facility cleanup. Natural vegetation is currently being re-established. Rip-rap will be placed in areas where vegetation cannot be established. Pictures showing the above described corrective action can be found in Attachment 4.

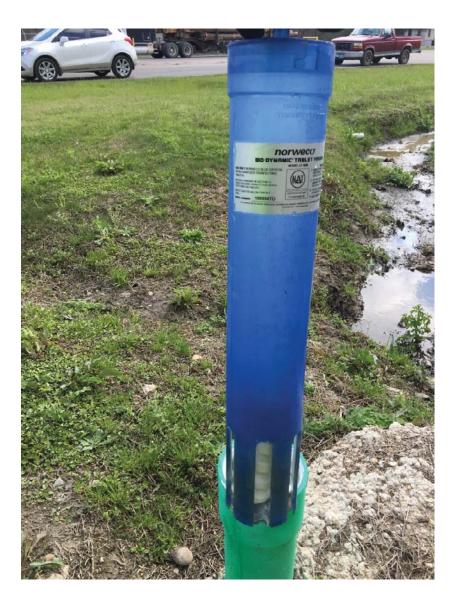
# Attachment 5 ARG55 Photos

The chlorine contact tube did not have any chlorine tablets.

The following photograph shows chlorine tablets that were added to the ARG55 treatment system.

Chlorine tablets have been added to the system. This was verified during a site visit on March 15, 2017. A picture showing the above described actions can be found in Attachment 5.
