RE: City of Flippin POTW Inspections (Marion Co)

> **Permit No.: AR0021717** AFIN: 45-00021

On January 5, 2017, I performed a Compliance Evaluation Inspection, an SSO/Collection System Inspection, and a State WWTP Construction inspection of the above-referenced facility in accordance with the provisions of the Federal Clean Water Act, the Arkansas Water and Air Pollution Control Act, and the regulations promulgated thereunder. Copies of the inspection reports are enclosed for your records.

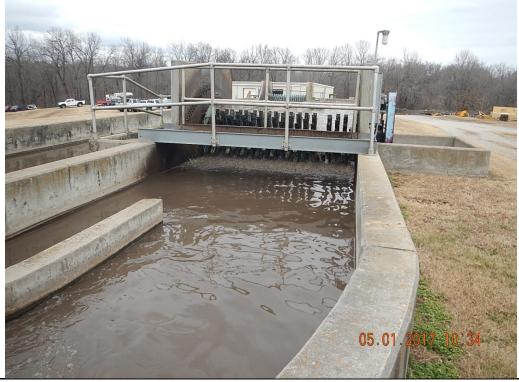
Water Division Photographic Evidence Sheet							
Location: City of Flippin POTW								
Photographe	Photographer: Kerri McCabe Date: Jan 5, 2017 Time: 1034							
Witness: Sk	Witness: Skyler Schlick Photo #: 3							
Description	esseriation. Ovidation disab with return for confess seration

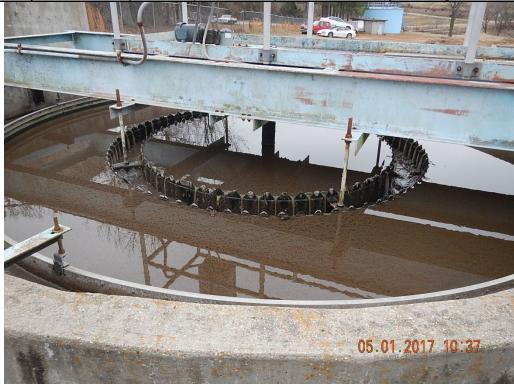
Photographer: Kerri McCabe Date: Jan 5, 2017 Time: 1037
Witness: Skyler Schlick Photo #: 4

Description: First secondary clarifier (ran in series); note consistency of sludge.

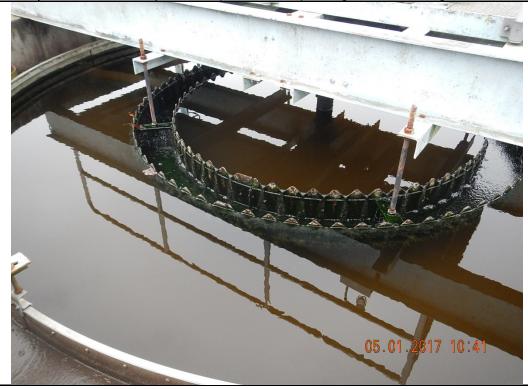
Water Division Photographic Evidence Sheet Location: City of Flippin POTW Photographer: Kerri McCabe Date: Jan 5, 2017 Time: 1041 Witness: Skyler Schlick Photo #: 5 Description: Second secondary clarifier (ran in series); sludge blanket rising due to inflow.

- 2.) The plant's two secondary clarifiers are undersized for the influent flow that comes into the plant during high rain events (design flow is 0.175 MGD). Solids are washing out of the second clarifier (ran in series) onto the intermittent sand filters. Additionally, the plant will not be able to handle additional hookups into the system, which limits the city's ability to economically grow. This is a violation of Part III, Section B, 1, A. of the permit. The city needs to investigate means of correcting the ongoing washout of solids onto the intermittent sand filters.

City personnel are reporting that high rain events (> 5 inches) increase the influent flow into the plant. The secondary clarifiers are under-designed to accommodate this increase in flow, and solids are wasting out onto the intermittent sand filters. The city supplied three years of influent flow data (influent flow is recorded daily). The design flow for the plant is 0.175 MGD; and of the 36 months of influent flow data reviewed, the plant exceeded design flow for 24 months. Even during historically dry weather, the plant was at maximum design flow. This puts limitations on the city's ability to acquire additional hookups, which can negatively impact the city's economic development.

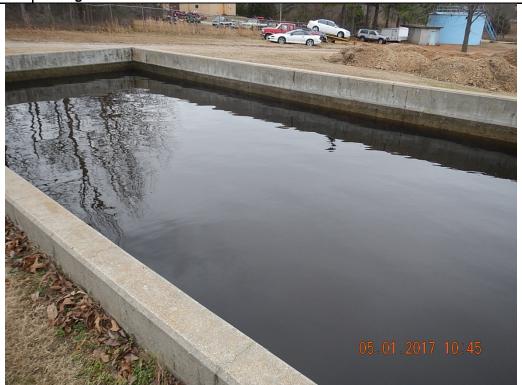
Photographer:Kerri McCabeDate:Jan 5, 2017Time:1045Witness:Skyler SchlickPhoto #:6

Description: Dosing tank

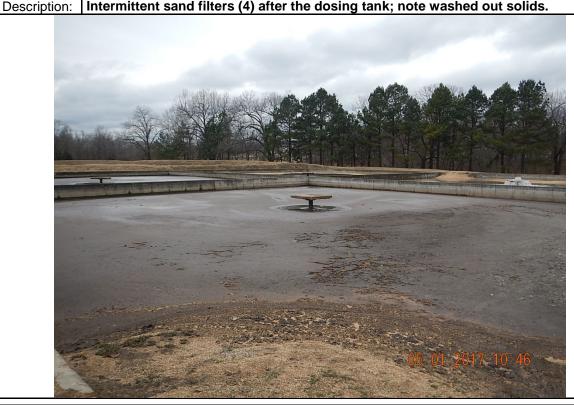
Water Division Photographic Evidence Sheet								
Location: City of Flippin POTW								
Photographer: Kerri McCabe Date: Jan 5, 2017 Time: 104					1046			
Witness: S	Witness: Skyler Schlick Photo #:						7	
Deceription	. 1	ntormittant cand fi	iltore (4) ofter the decine	40	nki noto washad ai	ıt colide

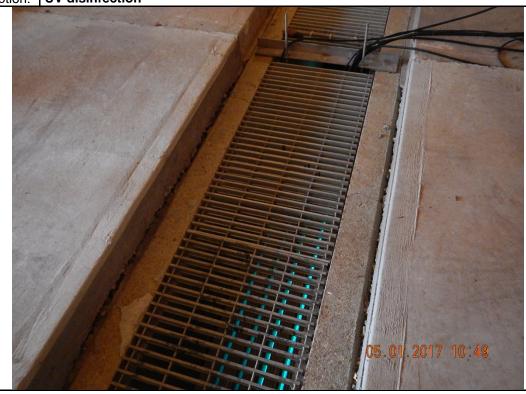
Water Division Photographic Evidence Sheet Location: City of Flippin POTW Photographer: Kerri McCabe Date: Jan 5, 2017 Time: 1049 Witness: Skyler Schlick Photo #: 9 Description: UV disinfection

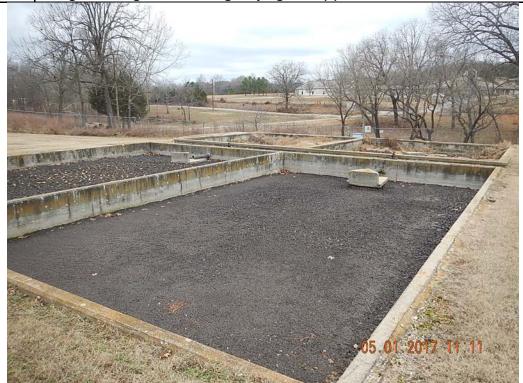
Description: Excessive vegetation in two sludge drying beds needs to be managed.

- 3.) Two of the sludge drying beds contain thick vegetation. This is a violation of Part III, Section B, 1, A. of the permit. Vegetation must be removed from the sludge drying beds.

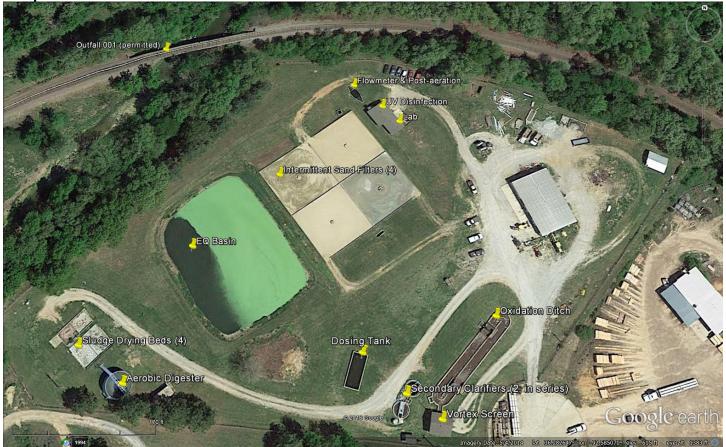
Figure 1. Google Earth image dated May 4, 2014 overviewing the City of Flippin's POTW and major

components identified.
