A R K A N S A S Department of Environmental Quality	WATER DIVISION INSPECTION REPORT		
	AFIN: 26-00022		PERMIT #: AR0033880
	DATE: 8/8/2017		
	COUNTY: 26 Garland	PDS #: 098934	MEDIA: WN
GPS LAT: 34.493081 LONG: -93.057212 LOCATION: General Area			
FACILITY INFORMATION		INSPECTION INFORMATION	
NAME: Triumph Precision Components Fabrications LOCATION: 1923 Central Ave CITY: Hot Springs, AR 71901		FACILITY TYPE: 2 - Industrial INSPECTOR ID#: 34689 S - State FACILITY EVALUATION RATING: N INSPECTION TYPE: Industrial User DATE(S): 8/8/2017 ENTRY TIME: 12:30 EXIT TIME: 13:00 PERMIT EFFECTIVE DATE: 2/1/2013 PERMIT EXPIRATION DATE: 1/31/18	
RESPONSIBLE OFFICIAL			
NAME / TITLE: Jason Atkins / General Manager COMPANY: Triumph Precision Components Fabrications MAILING ADDRESS: 1923 Central Ave CITY, STATE, ZIP: Hot Springs AR 71901 PHONE & EXT: / FAX: 501-622-4267 / 501-624-5194 EMAIL: mcorballis@triumphgroup.com CONTACTED DURING INSPECTION: No		FAYETTEVILLE SHALE RELATED: N FAYETTEVILLE SHALE VIOLATIONS: N INSPECTION PARTICIPANTS NAME/TITLE/PHONE/FAX/EMAIL/ETC.: Michael Corballis/ Environmental Manager/ 501-622-4267 Dennis Brunson/ Pretreatment Coordinator/501-262-1881 x 15

POTW Pretreatmen

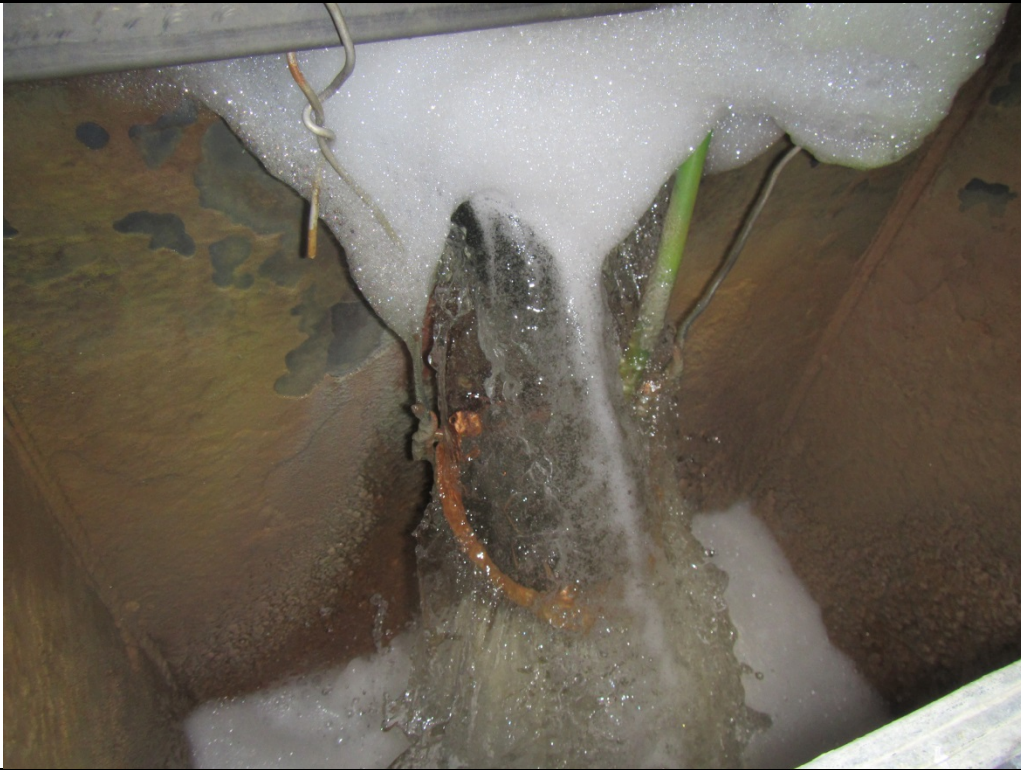
Location:	Triumph Precision Components Fabr		
Photographer:	Travis Harmon	Date:	8/8/17
Witness:	Michael Corballis, Dennis Brunson	Time:	1247
		Photo #:	1
Description:	Sample collection location.

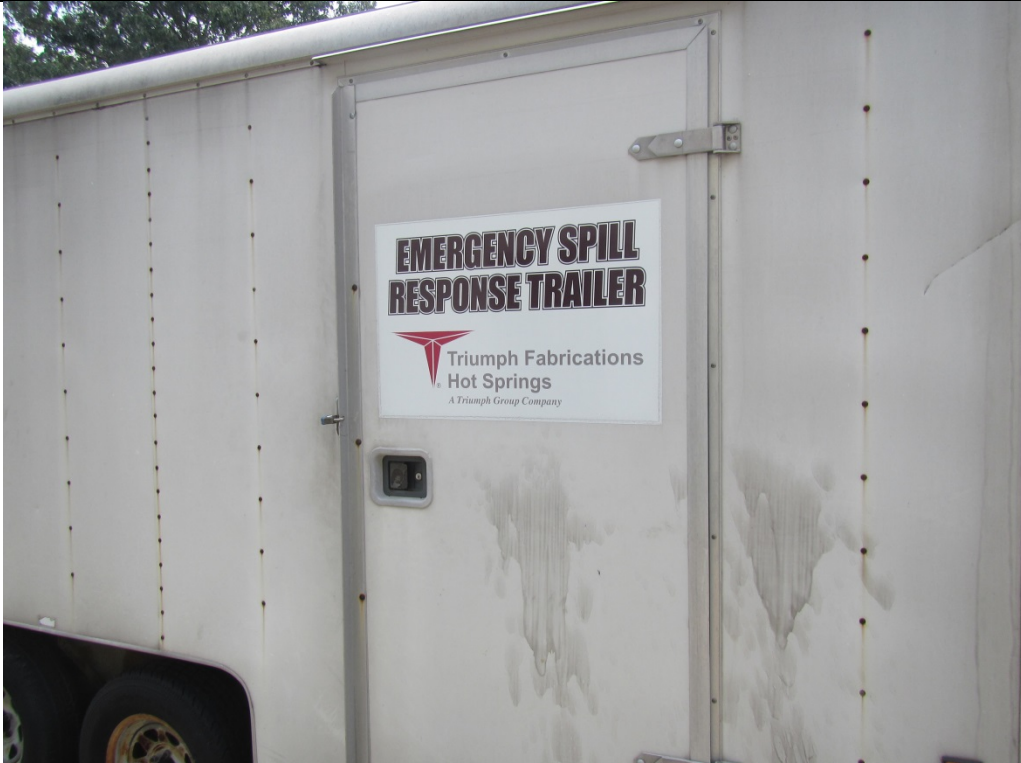
Photographer:	Travis Harmon	Date:	8/8/17
Witness:	Michael Corballis, Dennis Brunson	Time:	1250
		Photo #:	2
Description:	Spill equipment onsite. Also has catch basin.
