RE: City of Clinton - East Plant Inspections (Van Buren Co)

AFIN: 71-00018 Permit No.: AR0048836

Inspection Report: City of Clinton - East Plant, AFIN: 71-00018, Permit #: AR0048836

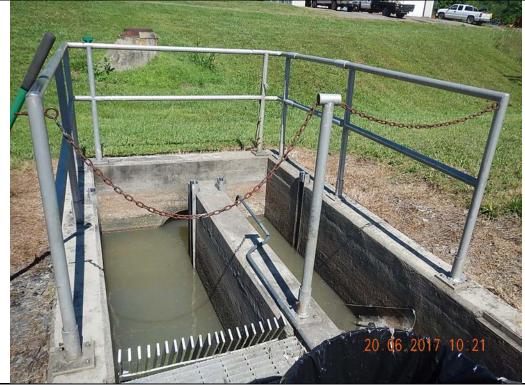
## Water Division Photographic Evidence Sheet Location: City of Clinton - East Plant Photographer: Kerri McCabe Date: June 20, 2017 Time: 1021 Witness: LeeVi Haas, Skyler Schlick Photo #: 1

Description: Preliminary at headworks (bar screen and auger).

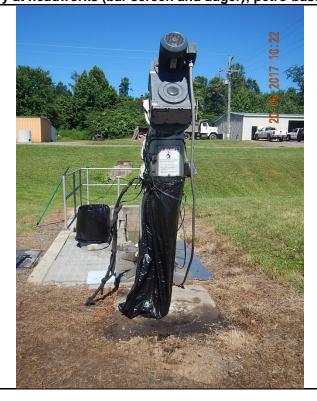
Photographer:Kerri McCabeDate:June 20, 2017Time:1022Witness:LeeVi Haas, Skyler SchlickPhoto #:2

Description: | Preliminary at headworks (bar screen and auger); petro-based leak noted.

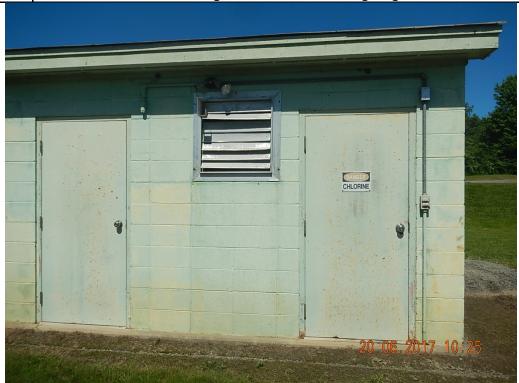
Photographer:	Kerri McCabe	Date:	June 20, 2017	Time:	1025
Witness: LeeV	'i Haas, Skyler Schlick			Photo #:	8

Description: Chlorine disinfection for irrigation water from storage lagoon.

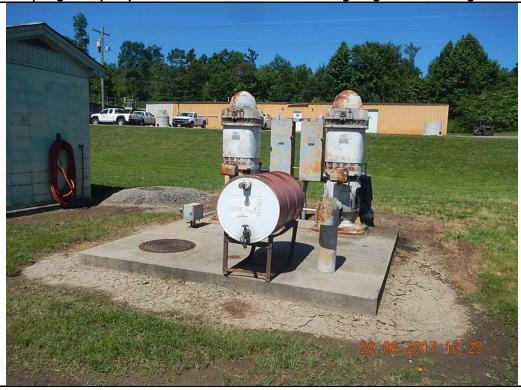
Water Division Photographic Evidence Sheet									
Location:	City	of Clinton - East Plant							
Photograph	Photographer: Kerri McCabe Date: June 20, 2017 Time:					1025			
Witness: L	Witness: LeeVi Haas, Skyler Schlick Photo #: 9								
Description	Description: Urrigation number to route affluent from the storage lagoon to the irrigation fields

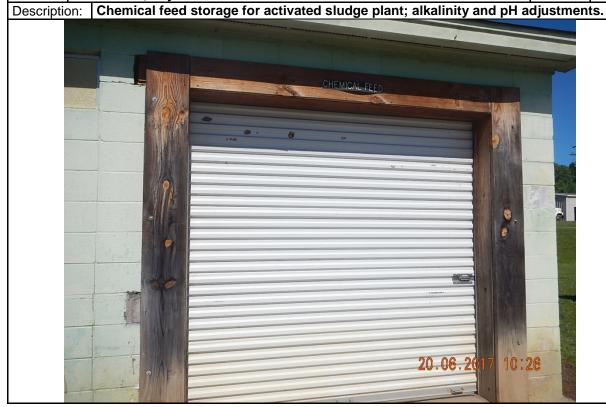
Photographe	r: Kerri McCabe	Date:	June 20, 2017	Time:	1026
Witness: Le	eVi Haas, Skyler Schlick			Photo #:	12

# Water Division Photographic Evidence Sheet Location: City of Clinton - East Plant Photographer: Kerri McCabe Date: June 20, 2017 Time: 1041 Witness: LeeVi Haas, Skyler Schlick Description: Secondary clarifier with skimmer arm; effluent routed back to storage lagoon.

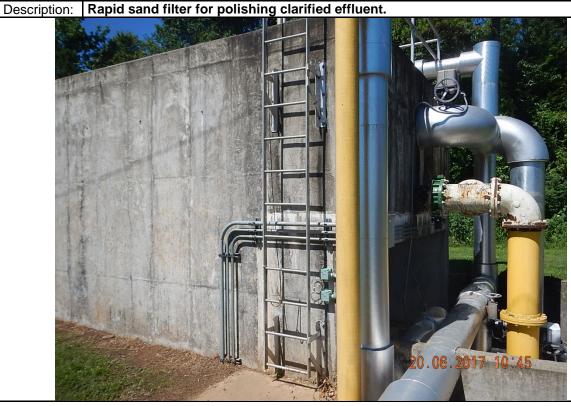
## Water Division Photographic Evidence Sheet Location: City of Clinton - East Plant Photographer: Kerri McCabe Date: June 20, 2017 Time: 1045 Witness: LeeVi Haas, Skyler Schlick Photo #: 17

Description: Rapid sand filter for polishing clarified effluent.

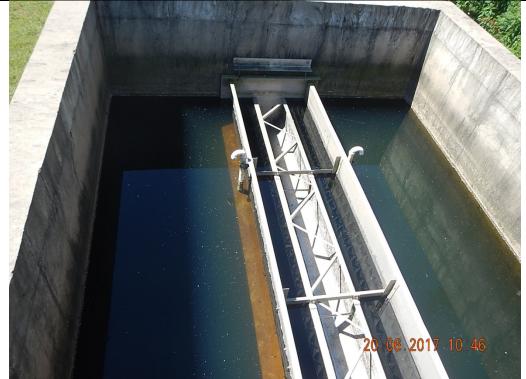
Photographer:Skyler SchlickDate:June 20, 2017Time:1046Witness:LeeVi Haas, Kerri McCabePhoto #:18

2. TREATMENT UNITS PROPERLY MAINTAINED: Waste valve for rapid sand filter had been ordered prior to the inspection, but	□s ☑m □u □na □ne
has not been received/installed.  3. STANDBY POWER OR OTHER EQUIVALENT PROVIDED: Mechanical plant only discharges 3 months/year; permit renewal	☑s ☐m ☐u ☐na ☐ne
<ul> <li>application is reporting two 200kw generators.</li> <li>ADEQUATE ALARM SYSTEM FOR POWER OR EQUIPMENT FAILURES AVAILABLE: Starts in lagoon system; manually route</li> </ul>	<u>ــــــــــــــــــــــــــــــــــــ</u>
to mechanical plant.

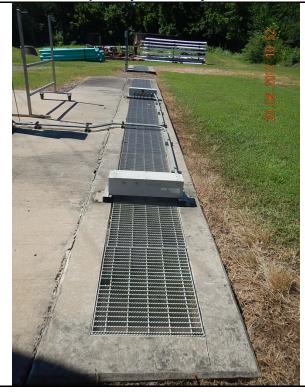
Photographer: Kerri McCabe Date: June 20, 2017 Time: 1052
Witness: LeeVi Haas, Skyler Schlick Photo #: 20

2.) The secondary flowmeter has not been calibrated since Jan 2014 and is reporting over compared to the primary device. Additionally, the staff gauge should be cleaned periodically in order to conduct an accurate instantaneous reading from the Parshall flume. This is a violation of Part III, Section C, 2 of the permit.

Description: UV disinfection unit and primary/secondary flowmeters.

After receiving your findings for our flow meter calibration, we contacted an engineering service to calibrate our flow meter. After two months of non-service; we contacted a second engineering service to perform the calibration. Due to conflicts in their schedule, they have scheduled this service to be completed this week of November 27, 2017.
