**RE:** City of Mountain View Inspections (Stone Co)

AFIN: 69-00011 NPDES Permit No.: AR0020117

On November 21, 2017, I performed a Compliance Evaluation Inspection, an SSO/Collection System Inspection, and a State WWTP Construction Inspection of the above-referenced facility in accordance with the provisions of the Federal Clean Water Act, the Arkansas Water and Air Pollution Control Act, and the regulations promulgated thereunder. Copies of the inspection reports are enclosed for your records.

VDEO		WATER	DIVISION I	NS	PECTIC	N REPORT	
ADLQ	IN: <b>69-00011</b> PI	ERMIT #: <b>AR0020117</b>			DATE: <b>11/21/2017</b>		
ARKANSAS		PDS	#: <b>100614</b>	MEDIA: WN			
Department of Environmental Quality	GP	S LAT: <b>35.86701</b>	4 LONG: -92.147	231	LOCATION:	General Area	
FACILITY INFORMAT	ΓΙΟΝ		IN	SPE	CTION INFO	RMATION	
City of Mountain View			FACILITY TYPE:  1 - Municipal	117	ector id#: 7208 S - Stat		
340 Westwood Ave			facility evaluation ratin  2 - Marginal	G:		CTION TYPE: mpliance Evaluation	
сту: Mountain View			DATE(S): EN	ITRY TIME	E: EXIT TIME:	PERMIT EFFECTIVE DATE:	
RESPONSIBLE OFFIC	CIAL		11/21/2017 0	9:15	14:20	8/31/2013 PERMIT EXPIRATION DATE:	
NAME: / TITLE	<u> </u>

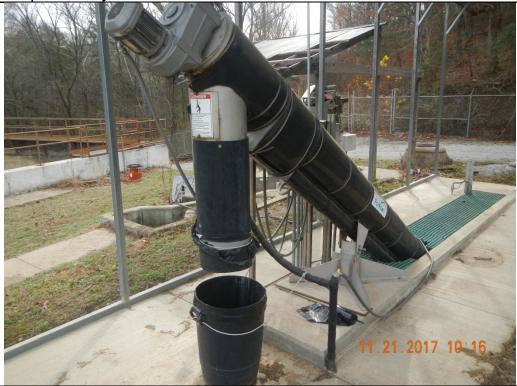
Water Division Photographic Evidence Sheet								
Location:	City	of Mountain View							
Photograp	her:	Skyler Schlick	Date:	11/21/2017	Time:	1016			
Witness:	Witness: Kerri McCabe Photo #: 1								
Description	n:   P	Preliminary.

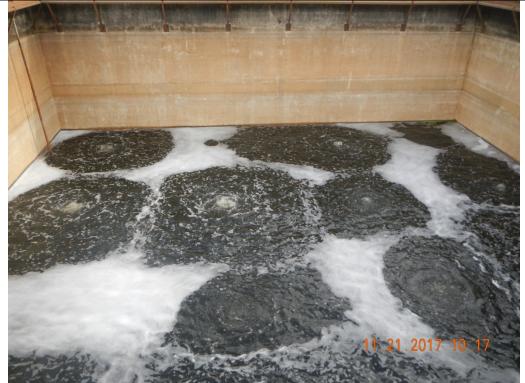
Photographer: Skyler Schlick
Witness: Kerri McCabe
Description: Aerated equalization (EQ) basin. Date: 11/21/2017 Time: 1017 Photo #:

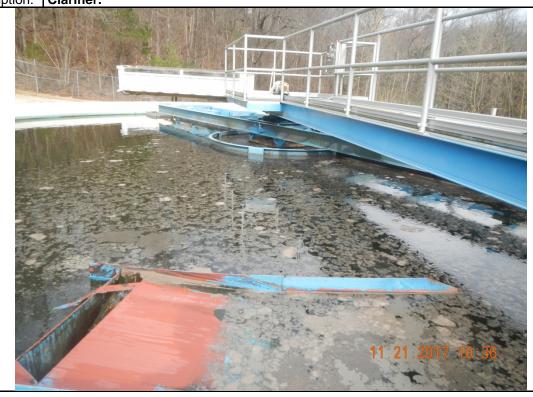
# Water Division Photographic Evidence Sheet Location: City of Mountain View Photographer: Skyler Schlick Date: 11/21/2017 Time: 1036 Witness: Kerri McCabe Photo #: 5 Description: Clarifier.

- 4.) The operator is using chlorine to clean the clarifier of algae. Since the city does not sample for Total Residual Chlorine (TRC) and has not demonstrated that chlorine is not discharged at toxic levels, the city must obtain approval from the Permits Branch to continue to use chlorine for cleaning purposes. This is a violation of Part III, Section A, 4 of the permit.

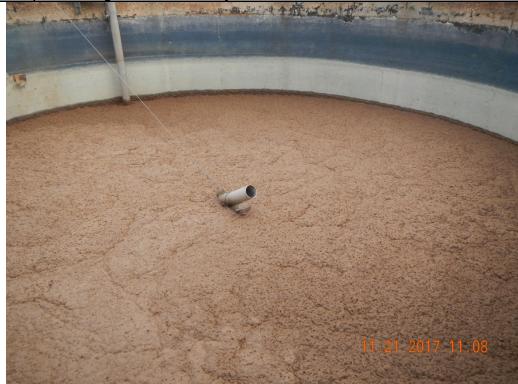
# Water Division Photographic Evidence Sheet Location: City of Mountain View Photographer: Skyler Schlick Date: 11/21/2017 Time: 1108 Witness: Kerri McCabe Photo #: 7

Description: Aerobic digester with foam layer.

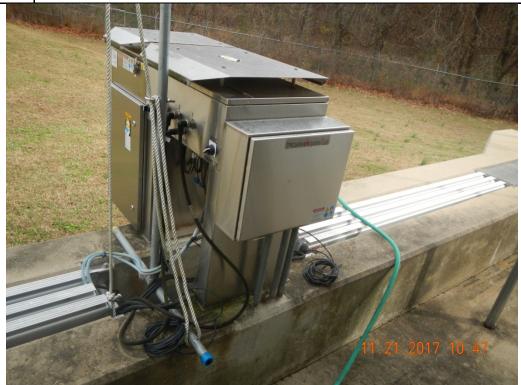
Photographer: Skyler Schlick	Date: 11/21/2017	Time:	1047
Witness: Kerri McCabe		Photo #:	8

Description: UV disinfection.

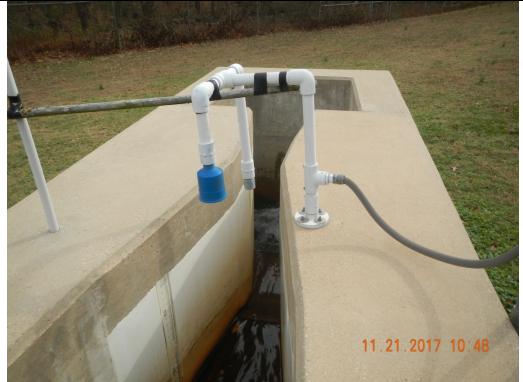
# Water Division Photographic Evidence Sheet Location: City of Mountain View Photographer: Skyler Schlick Date: 11/21/2017 Time: 1048 Witness: Kerri McCabe Photo #: 9

пореспол те	FLOW	CALCUI				ι π. Αιν	0020117	
Date: No	v 21, 2017	Time: 1	0:51						
Head in Inc	ches: 4 1/3"	Fee	t: <b>0.36</b>	,					
Type & Siz	e of Primary F	low Measur	ement D	evice	: 9" Paı	rshall	l flum	е	
Name & Mo	odel of Secon	dary Flow M	easuren	nent D	evice:		mens alizer)	Milltronics (	OCM III
Date of last	t Calibration o	f Secondary	Flow D	evice:					
Recorded F	Flow at Date 8	Time Listed	d Above	0.2	59 MG	D		(Facility Flow Me	eter)
	Flow at Date ted using flow chart				.4156 N asurement		ook-5 <sup>th</sup> E	Edition)	
% Error =	Recorded V	alue - Calculated V	alculate alue	d Valu	<u>e</u> x 1	100			
% Error =	0.259	0.4156	0.41	56	X 1	100			
% Error =	-0.1566 0.4156	X 100							
% Error =	-0.3768	X 100	)						
% Error =	-37.68	%							
Comments	Not within	+/- 10% rar	ige tota	lizer;	totalize	er is r	eport	ing under.

Description: 9" Parshall flume with totalizer.

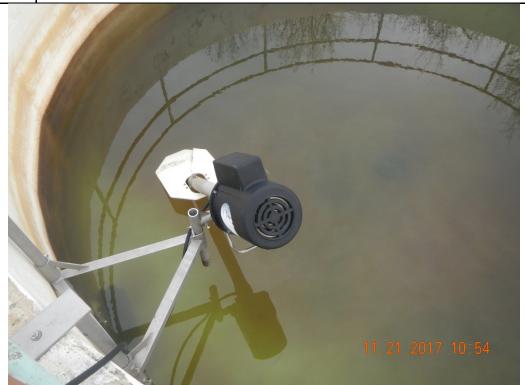
Photographer: Skyler Schlick	Date: 11/21/2017	Time:	1054
Witness: Kerri McCabe			10

Description: Post-aeration.

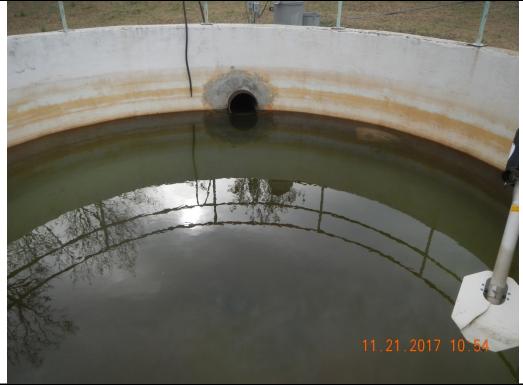
Water Division Photographic Evidence Sheet							
Location:	City	of Mountain View					
Photograp	her:	Skyler Schlick	Da	ate:	11/21/2017	Time:	1054
Witness: Kerri McCabe					Photo #:	: 11

Description: Post-aeration basin; effluent piped to outfall structure.

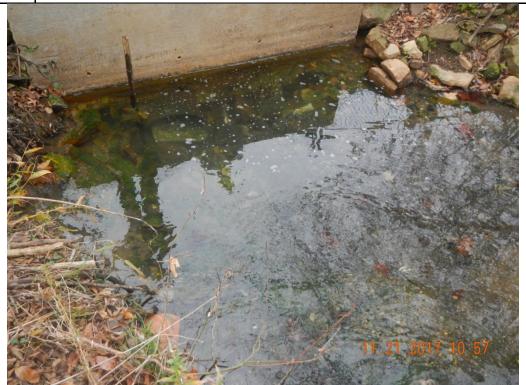
Photographer: Skyler Schlick	Date: 11/21/2017	Time:	1057
Witness: Kerri McCabe			12

The outfall location provided is not accurate. The actual outfall location is 35.867094, -92.146393. This location should be updated during permit renewal.

Description: Outfall 001.

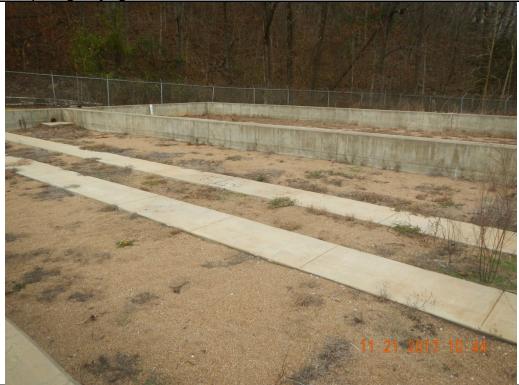
Water Division Photographic Evidence Sheet						
Location: Cit	y of Mountain View					
Photographer:	Skyler Schlick	Date:	11/21/2017	Time:	1044	
Witness: Kerri McCabe					13

Description: Sludge drying beds.

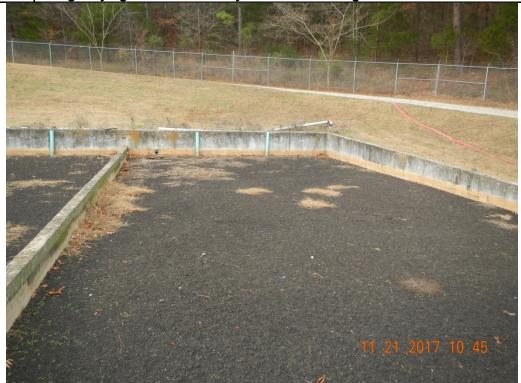
Photographer:Skyler SchlickDate:11/21/2017Time:1045Witness:Kerri McCabePhoto #:14

- 3.) There are excessive I&I issues within the collection system that are causing hydraulic overloading at the POTW. Evidence of an overflow of sludge was observed during the inspection. This is a violation of Part III, Section B, 1.A. of the permit. The release of sludge needs to be properly cleaned up and disposed of. Additionally, this excessive I&I is not allowing the operators to maintain an adequate sludge blanket in the clarifier. The excessive I&I within the collection system needs to be addressed to eliminate the issues occurring at the plant.

Description: Sludge drying beds with thin layer of wasted sludge.

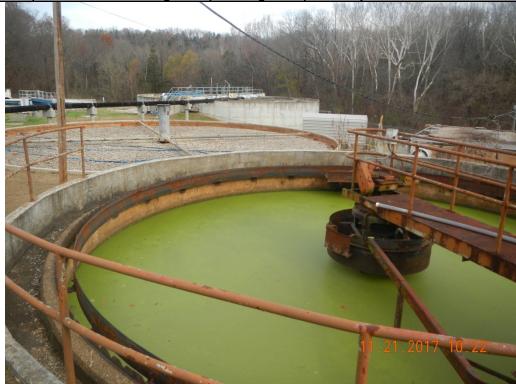
Water Division Photographic Evidence Sheet							
Location:	City	of Mountain View					
Photograp	her:	Skyler Schlick		Date:	11/21/2017	Time:	1022
Witness: Kerri McCabe F					Photo #	: 15

There are many treatment components that are not in use or maintained at the plant including: two (2) clarifiers, two (2) trickling filters, and a chlorine contact chamber.

Description: Clarifier and trickling filter (in background) not in operation.

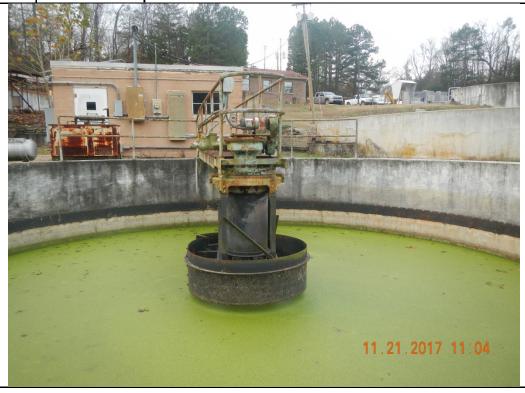
Photographer: Skyler Schlick	Date: 11/21/2017	Time:	1104
Witness: Kerri McCabe			16

Description: Clarifier not in operation.

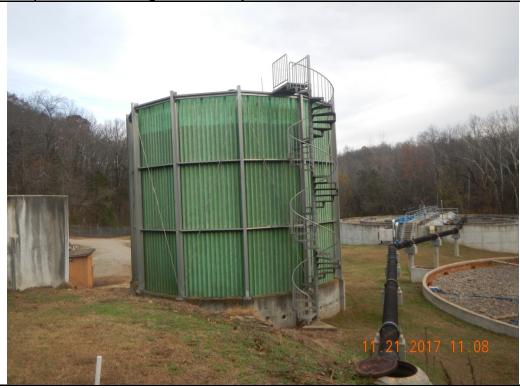
Water Division Photographic Evidence Sheet						
Location: C	City of Mountain View					
Photographe	er: Skyler Schlick	Date: 11/21/2017	Time:	1108		
Witness: Kerri McCabe Photo #: 17						
Description: Bio-tower trickling filter not in operation.

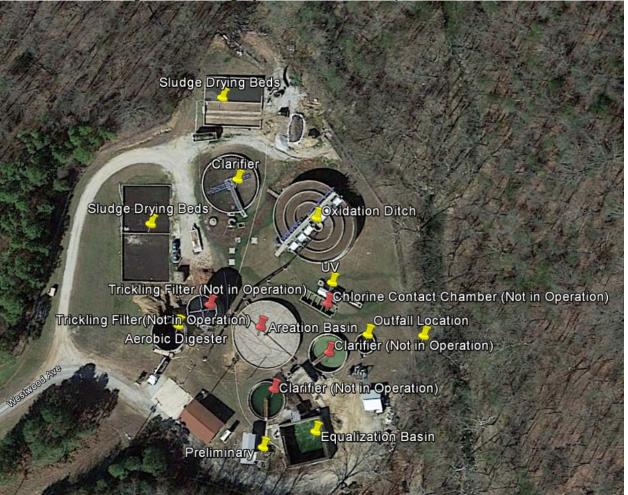
Figure 1. General overview of the site with major components labeled and components not in operation

labeled in red (Google Earth: imagery date March 4, 2016).

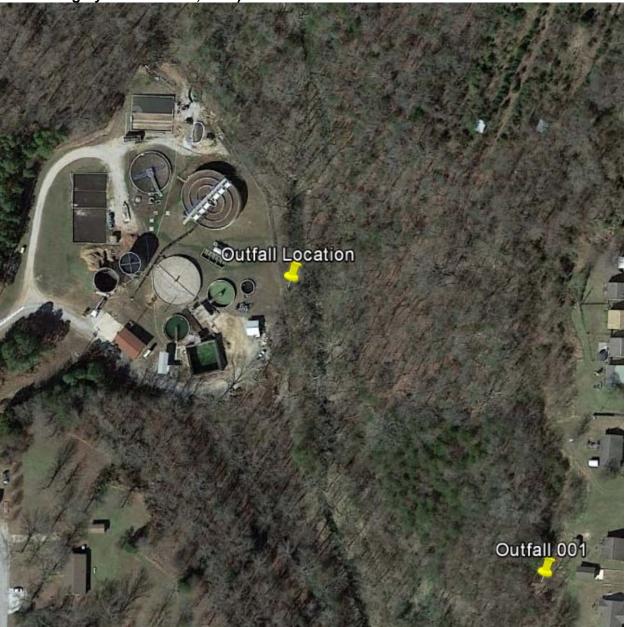
Figure 1. General overview of the site with outfall location and actual coordinates labeled (Google

Earth: imagery date March 4, 2016).
