WATER DIVISION INSPECTION REPORT							N REPORT
ADLQ	AF	IN: 18-00879 F	PERMIT #: AR002	ERMIT #: AR0022039			DATE: 8/22/2017
A R K A N S A S	CO	UNTY: 18 Critte	enden	PDS	#: 1007	73	MEDIA: WN
Department of Environmental Quality	GP	GPS LAT: 35.124212 LONG: -90.179016 LOCATION: Entrance					ntrance
FACILITY INFORMAT	ION		IN	ISPEC	TION IN	IFORI	MATION
NAME: West Memphis WWTP LOCATION:			FACILITY TYPE: 1 - Municipal	112	347 S -		
502 South Loop Rd.	FACILITY EVALUATION RATIN				Collection System		
West Memphis			1-7	NTRY TIME: 19:28	EXIT TI		PERMIT EFFECTIVE DATE: 8/1/2013
RESPONSIBLE OFFIC]				PERMIT EXPIRATION DATE:		
NAME: / TITLE William Johnson / Mayor					7/31/2018		
COMPANY:	FAYETTEVILLE SHALE RELATED: N						
West Memphis Utilities			FAYETTEVILLE SHALE VIOLATIONS: N				
205 South Redding			INSPECTION PARTICIPANTS				
CITY, STATE, ZIP:			NAME/TITLE/PHONE/FAX/EM/		stant G	onora	l Manager
West Memphis AR 72301 PHONE & EXT: / FAX:			Todd Pedersen/ Assistant General Manager Amanda Hicks/ City Engineer Robert Hatchett/ Senior Pump Mechanic

Inspection Report: West Memphis WWTP, AFIN: 18-00879, Permit #: AR0022039

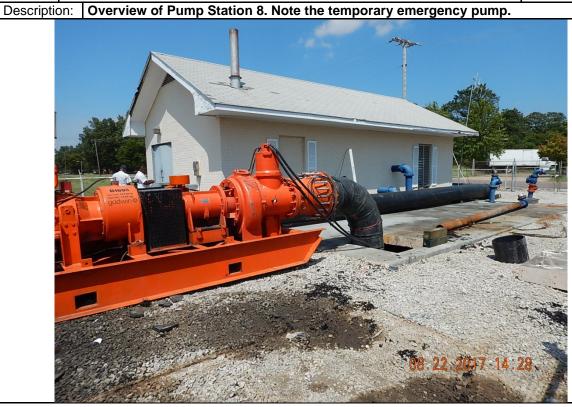
Water Division Photographic Evidence Sheet							
Location:	Wes	t Memphis WWTP					
Photograp	her:	Sarah Frasher	Date:	8/22/2017	Time:	14:29	
Witness:	Bren	t Walker			Photo #:	1

The Pump Station 8 was experiencing a malfunction with their pump and a temporary emergency pump had to be used (Photos 1-4). The emergency pump appeared adequate to meet the needs of the collection system. The city is experiencing problems with some of their pumps and is looking at installing bypass pumps for the larger pump stations.

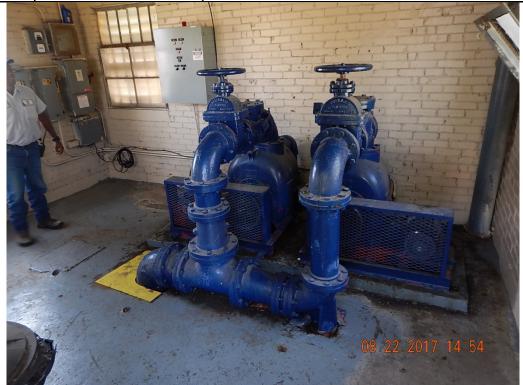
Photographer: Sarah Frasher	Date: 8/22/2017	Time:	14:54
Witness: Brent Walker		Photo #:	: 6

Description: View of the inside of Pump Station 1.

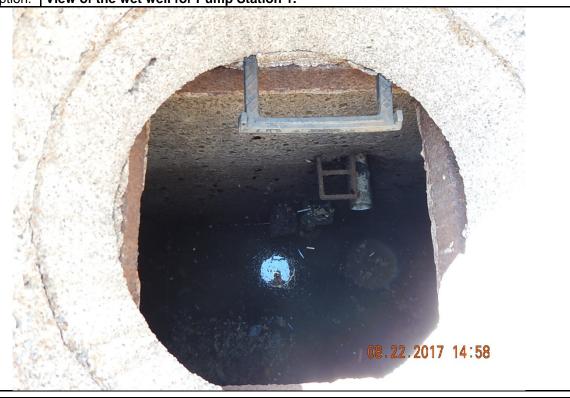
Water Division Photographic Evidence Sheet Location: West Memphis WWTP Photographer: Sarah Frasher Date: 8/22/2017 Time: 14:58 Witness: Brent Walker Photo #: 7

Description: View of the wet well for Pump Station 1.

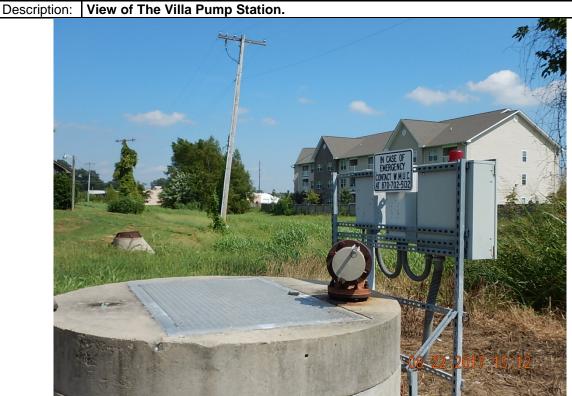
Water Division Photographic Evidence Sheet Location: West Memphis WWTP Photographer: Sarah Frasher Witness: Brent Walker Description: View of The Villa Pump Station wet well. Note the high accumulation of solids/grease but clean wet well wall.

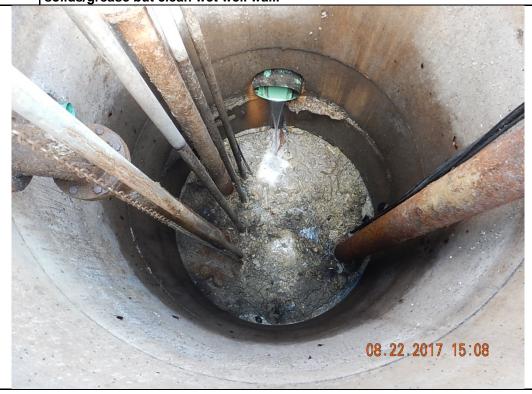
- 1. High accumulation of grease/solids was observed in wet well (Photo 9)
- 2. Electrical box was unlocked (Photo 10). This is also in violation of Item 41.2 for 10 States Standards.

Solids/grease accumulation is still a major problem for parts of the city especially at the Bill's Grill Pump Station and The Villa Pump Station. The city has observed that the Bill's Grill Pump Station does not have enough flow that causes the constant buildup of solids. The Villa Pump Station services an apartment complex that frequently experiences accumulation of solids/grease (see attached individual pump station checklist). The city needs to find a better solution to combat this reoccurring problem.

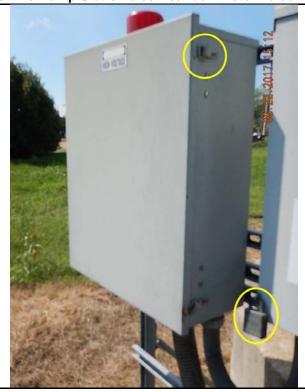
Photogra	apher: Sarah Frasher	Date:	8/22/2017	Time:	15:12
Witness:	Brent Walker			Photo #:	10

Description: View of The Villa Pump Station electrical box. Note the box was left unlocked.
