**RE: Quarterly Inspection conducted on March 7, 2018**  
**AFIN 15-00001**  
**Permit Number 0284-S3N**

### Class 3 Landfill Inspection

<b>Site Name</b>	Green Bay Packaging, Inc.	<b>County</b>	Conway	<b>AFIN</b>	15-00001
<b>Facility Address</b>	338 Highway 113, Morrilton, AR 72110	<b>Phone Number</b>	501-354-9289	<b>Permit Number</b>	0284-S3N
<b>Permittee Address</b>	338 Highway 113, Morrilton, AR 72110	<b>E-Mail Address</b>	hvae@gbp.com	<b>PDS #</b>	101993
<b>Date</b>	3/7/2018	<b>Entry Time</b>	1322	<b>Exit Time</b>	1417

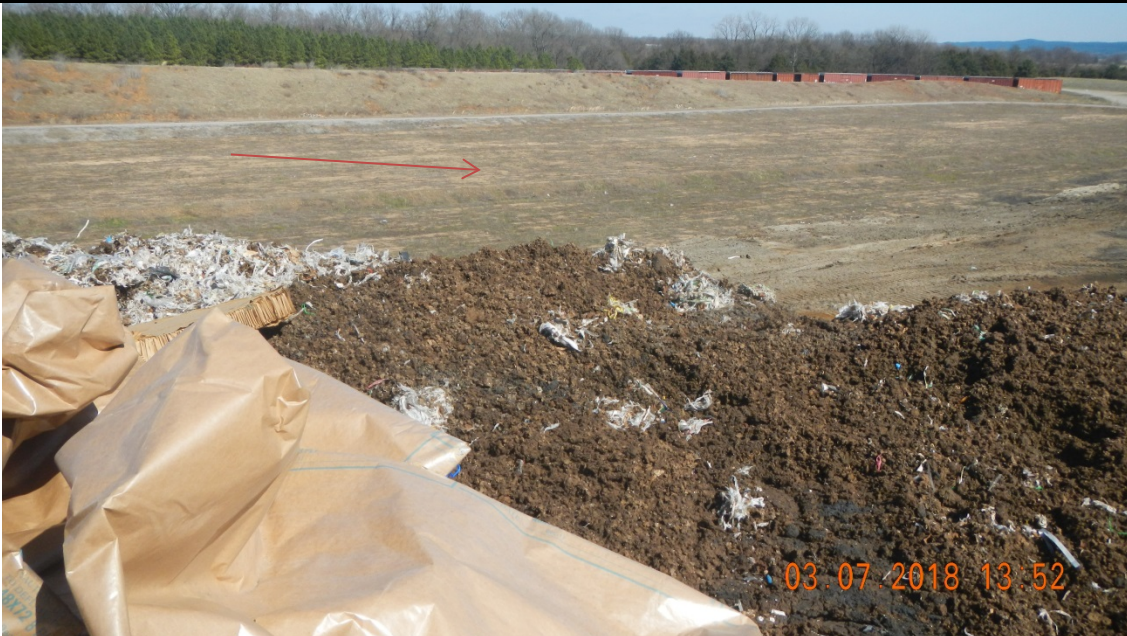
<b>Witness</b>	N/A		
<b>Photo #</b>	1	<b>Of</b>	3	<b>Date</b>	3/7/2018	<b>Time</b>	1352
<b>Description</b>	An eastern view from the working face to observe waste and cover material, with the mid cell berm (noted with a red arrow) in the background.

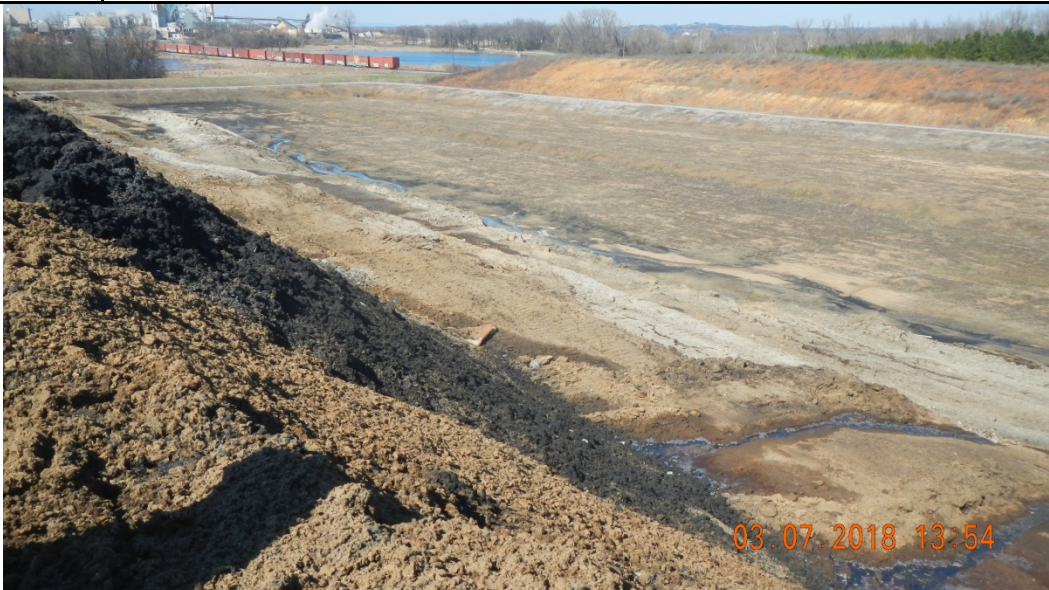
Regulation	Item Description	Comments
	518	Surface water controls	
	510(h)(l)	Contouring prevents surface water flowing into or through waste	
	517(a)(b)	Run-on/off control system present and adequate	
	510(h)(2)	Surface water control prevents off-site sediment accumulation	
X	510(h)(i)	Adequate maintenance of intermediate/final cover vegetation	Woody vegetation was present on the west slope of the active cell. (Refer to Photo #3.)
	514	Gas monitoring program	
	510(n)	Leachate leaks or evidence of leachate seepage	Leachate was observed on the east slope of the active cell; however, this is addressed in the facility's NPDES permit. (Refer to Photo #2.)
	526	Survey controls	
	529	Leachate collection system	
	519	Liquid restrictions

<b>Witness</b>	N/A		
<b>Photo #</b>	2	<b>Of</b>	3	<b>Date</b>	3/7/2018	<b>Time</b>	1354
<b>Description</b>	After the most recent heavy rain event, leachate was observed leaving the landfill and diverting to the on-site treatment pond operated by GBP. This process is addressed in the facility's NPDES permit and operating plan.

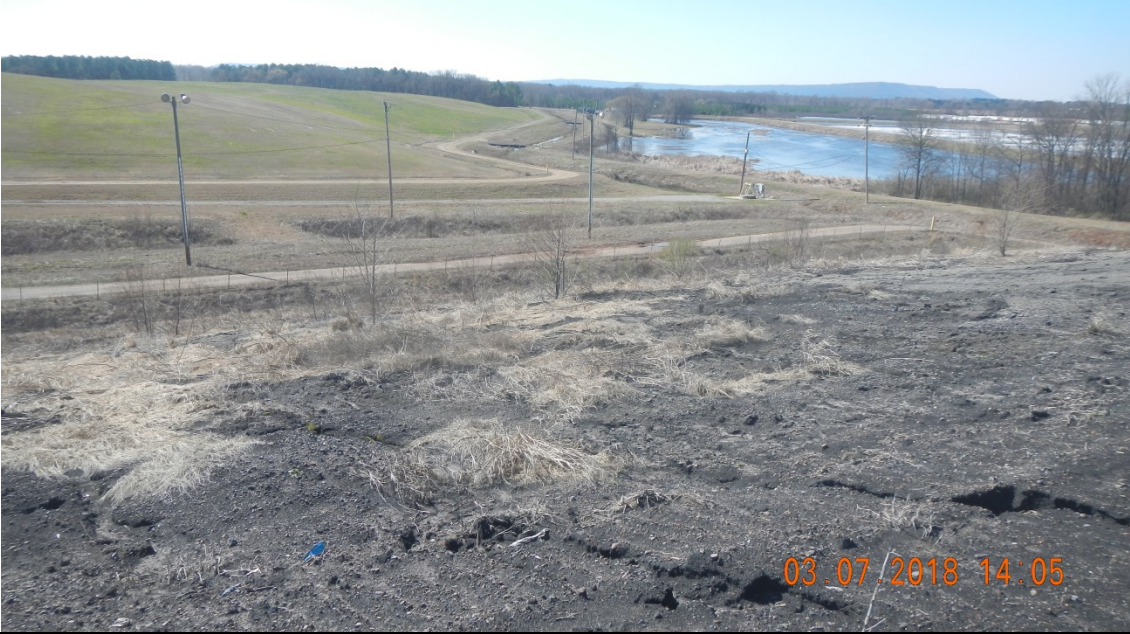
<b>Witness</b>	N/A		
<b>Photo #</b>	3	<b>Of</b>	3		<b>Date</b>	3/7/2018	<b>Time</b>	1405
<b>Description</b>	Woody vegetation was present on the western slope of the active landfill unit.
