RE: Huntsville WWTF Inspection

AFIN: 44-00018 Permit No.: AR0022004

OFFICE OF WATER QUALITY INSPECTION REPORT

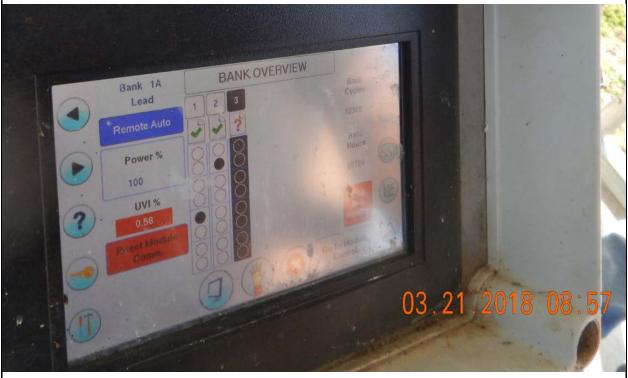
Photographer:	Garrett Grimes, District 1 Inspector	Date: 03/21/2018	Time:	09:54
Witness:			Photo #:	2

During the inspection some algae was observed growing in the clarifiers (Photo #2). Also, the sludge dryer appeared to be leaking tar from the insulation (Photo #3). The algae growing in the clarifier did not appear to be interfering with treatment, and Mr. Garrett and Mr. Eoff stated that the clarifiers are scrubbed. Mr. Eoff stated that the tar leaking from the sludge dryer was from insulation placed around the machine and would not contaminate the sludge. Even though the above concerns were not directly affecting treatment at the time of the inspection, the City of Huntsville should monitor and address these to avoid possible future operation and maintenance violations.

Under the general Comments section (photo #2) algae growth in clarifiers. We had cleaned the weirs very recently. It is a never ending fight to keep the algae controlled considering it is the perfect environment for algae growth. We will continue to do our best to keep this situation under control.

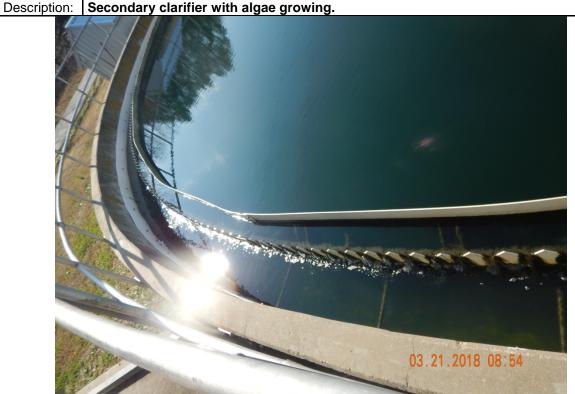
Office of Water Quality Photographic Evidence Sheet		
Location: Hu	Intsville WWTF		
Photographer	Garrett Grimes, District 1 Inspector Date: 03/21/2018	Time:	10:15
Witness:		Photo #	
Description:	Sludge dryer with tar dripping from the insulation onto the floor of the	e buildi	ng.

(photo #3) tar leaking from ducts on sludge dryer. We have scraped it up as best as possible and will continue to do so in the future as it leaks out.

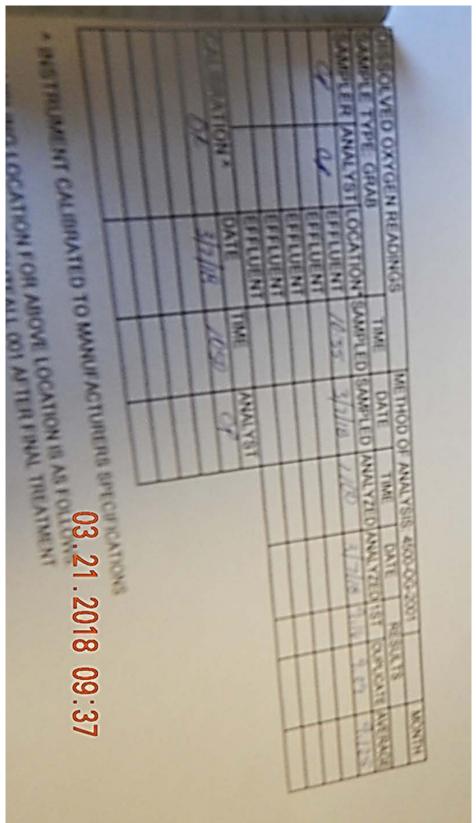
- 1.) Records viewed during the inspection indicated that Dissolved Oxygen (DO) was not measured during the week of March 11-17, 2018 (Attachment 1). This is a violation of Part I, Section A. of the permit.

- 4.) The calibration records for dissolved oxygen does not state the pre and post calibration measurements and does not state the difference of the calibrated measure from the expected measure of dissolved oxygen at 100% saturation at a given temperature (Attachment 1). Records from the calibrations must be maintained by the facility. This is a violation of Part III, Section C.7. of the permit. Please maintain all calibration records and verify that the above information is included.

Attachment 1: Dissolved Oxygen sheet with calibration. Records only state that the calibration was "OK" and does not show the actual calibration recordings. No Dissolved Oxygen measures are present from the week of March 11 - 17, 2018.

Response: The D.O. analysis had been completed during that time period, however the operator had failed to transfer the readings from the scrap sheet he used in the field onto the bench sheet in the lab. I had already noticed this and addressed it before reporting on the monthly DMR. I have instructed my operators to be sure and transfer the information to the lab bench sheet as soon as possible each day.

Response: We have changed our bench sheet to include these items and will continue to do so in the future.

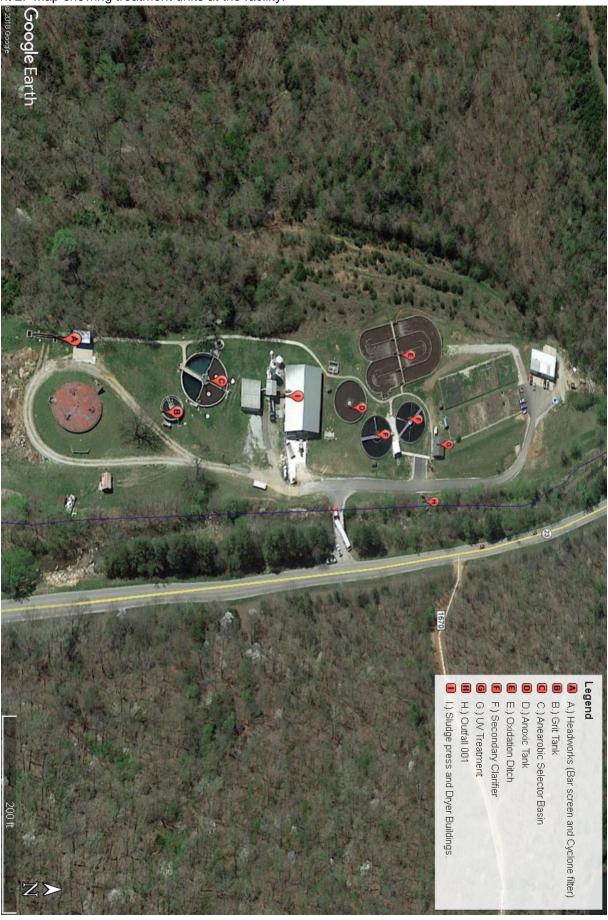
Attachment 2: Map showing treatment units at the facility.

A map of the facility and treatment units are displayed in Attachment 2.
