RE: City of Wynne Inspection

AFIN: 19-00071 Permit No.: AR0021903

On May 23, 2018, I performed a Compliance Evaluation Inspection, Collection System/SSO Inspection, and Industrial Stormwater Inspection of the above referenced facility in accordance with the provisions of the Federal Clean Water Act, the Arkansas Water and Air Pollution Control Act, and the regulations promulgated thereunder. A copy of the inspection reports are enclosed for your records.

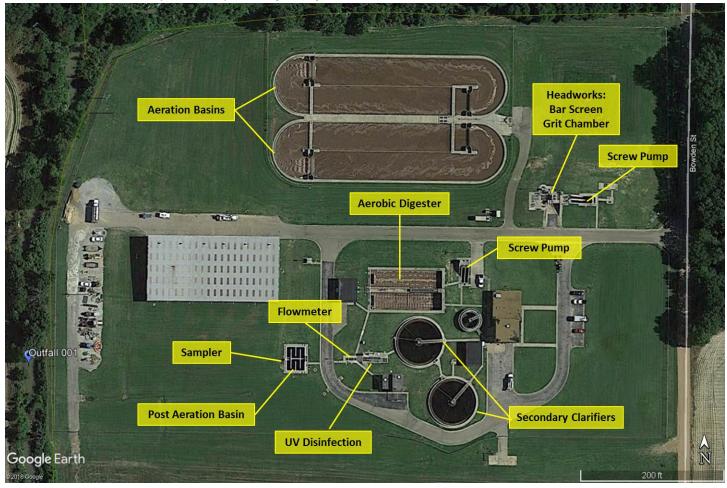
Figure 1. Google Earth image with labels of the City of Wynne Wastewater Treatment Plant.

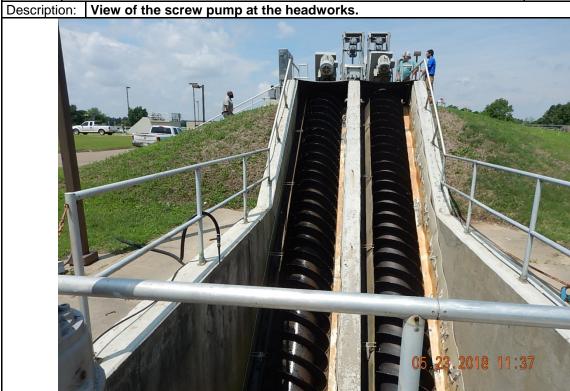
Photographer:Sarah FrasherDate:5/23/2018Time:11:39Witness:NonePhoto #:2

Description: Overview of the headworks.

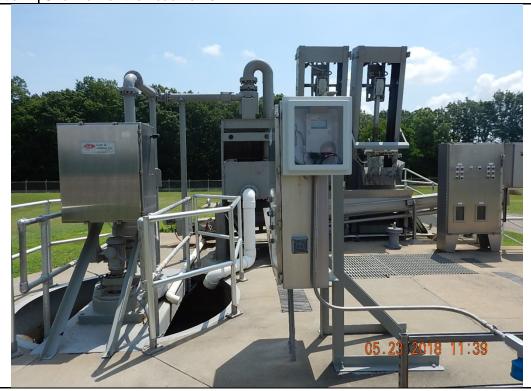
### **Water Division Photographic Evidence Sheet** Location: City of Wynne Photographer: Sarah Frasher Date: 5/23/2018 11:38 Time: Witness: None Photo #: Description: Close-up view of the bar screen.

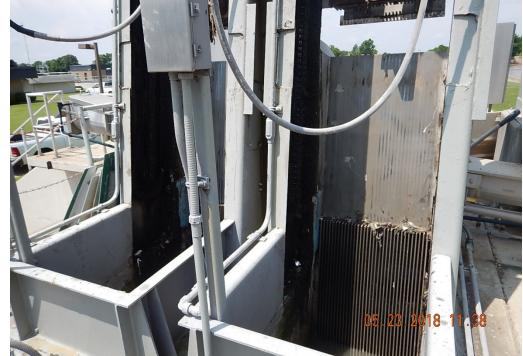
Photographer: Sarah Frasher 11:38 Date: 5/23/2018 Time: Witness: None Photo #:

Description: View of the grit chamber.

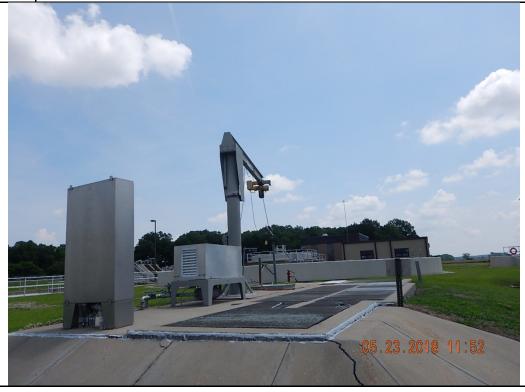
# Water Division Photographic Evidence Sheet Location: City of Wynne Photographer: Sarah Frasher Witness: None Date: 5/23/2018 Time: 11:51 Photo #: 9 Description: View of the 9 inch Parshall flume.

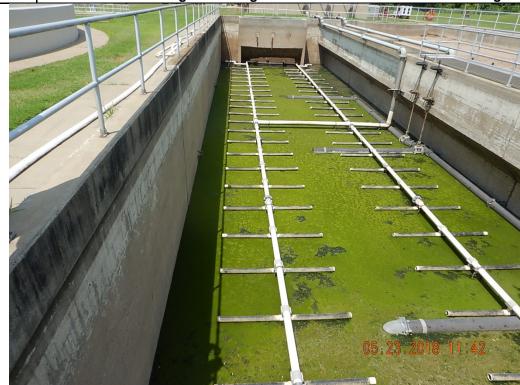
Description: View of a sludge containment area no longer in use.
