A R K A N S A S
Department of Environmental Quality

RE: Clarksville Light and Water Inspections (Johnson Co)
AFIN: 36-00038 **NPDES Permit No.: AR0022187**
ARR00C447

A R K A N S A S Department of Environmental Quality	WATER DIVISION INSPECTION REPORT		
	AFIN: 36-00038	PERMIT #: AR0022187	DATE: 8/9/2018
	COUNTY: 36 Johnson	PDS #: 104534	MEDIA: WN
	GPS LAT: 35.446591 LONG: -93.486566 LOCATION: Entrance		
FACILITY INFORMATION		INSPECTION INFORMATION	
NAME: Clarksville Light and Water LOCATION: 1305 South Crawford St CITY: Clarksville		FACILITY TYPE: 1 - Municipal INSPECTOR ID#: 71330 S - State FACILITY EVALUATION RATING: 4 - Satisfactory INSPECTION TYPE: Compliance Evaluation DATE(S): 8/9/2018 ENTRY TIME: 08:00 EXIT TIME: 12:00 PERMIT EFFECTIVE DATE: 10/1/2014 PERMIT EXPIRATION DATE: 9/30/2019	
RESPONSIBLE OFFICIAL		FAYETTEVILLE SHALE RELATED: N	
NAME / TITLE: Gregg Rainey / Pollution Control Superintendent COMPANY: Clarksville Light and Water MAILING ADDRESS: P.O. Box 1807 CITY, STATE, ZIP: Clarksville AR 72830 PHONE & EXT. / FAX: 479-754-7929 / EMAIL: gregg.rainey@clarksvillelightwater.com CONTACTED DURING INSPECTION: Yes		FAYETTEVILLE SHALE VIOLATIONS: N

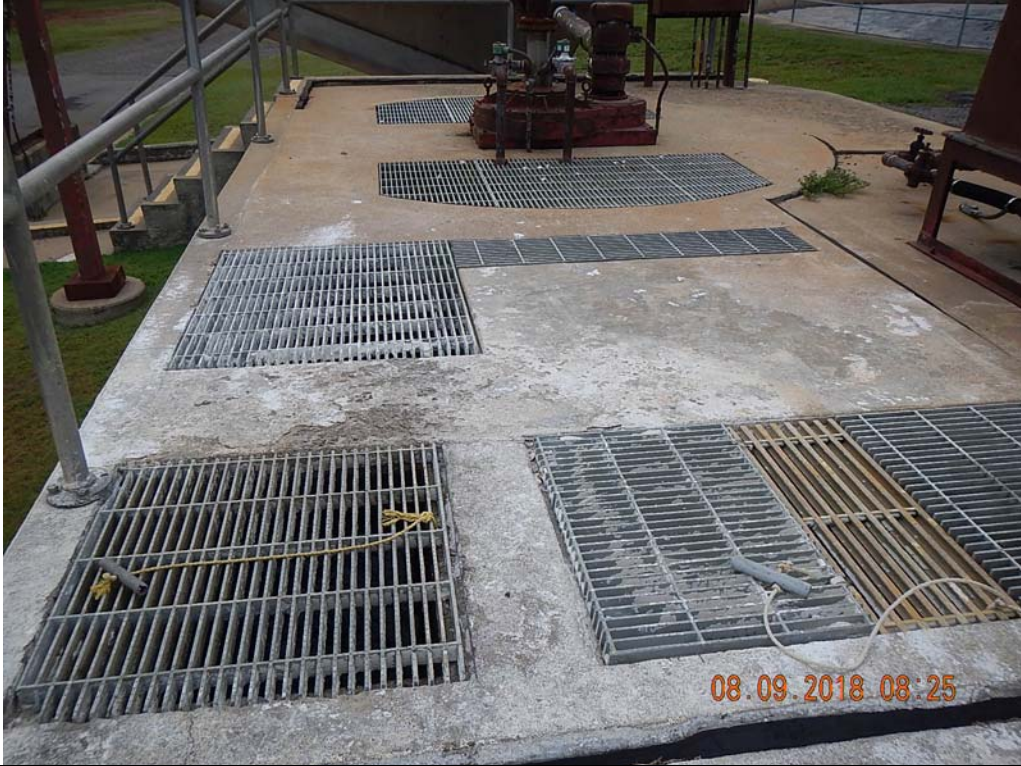
Location:	Clarksville Light and Water		
Photographer:	Dannielle Gray	Date:	8/9/2018
Witness:	None	Time:	0825
Description:	Influent tank	Photo #:	1

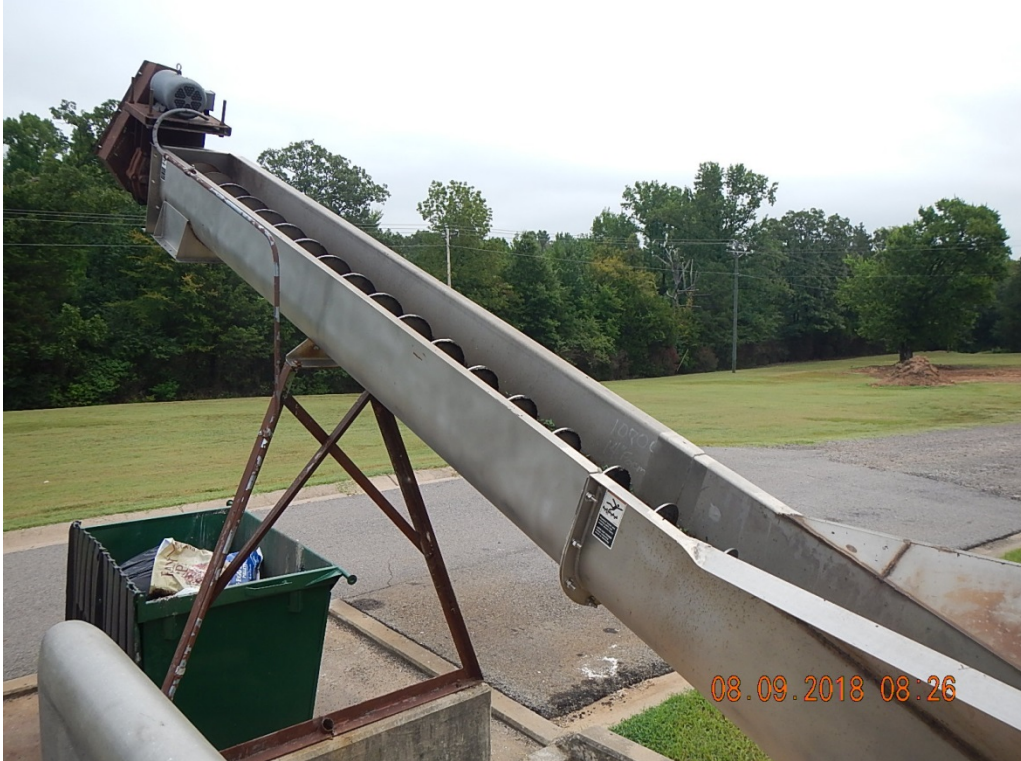
Photographer:	Dannielle Gray	Date:	8/9/2018
Witness:	None	Time:	0826
Description:	Grit chamber and waste bin	Photo #:	2

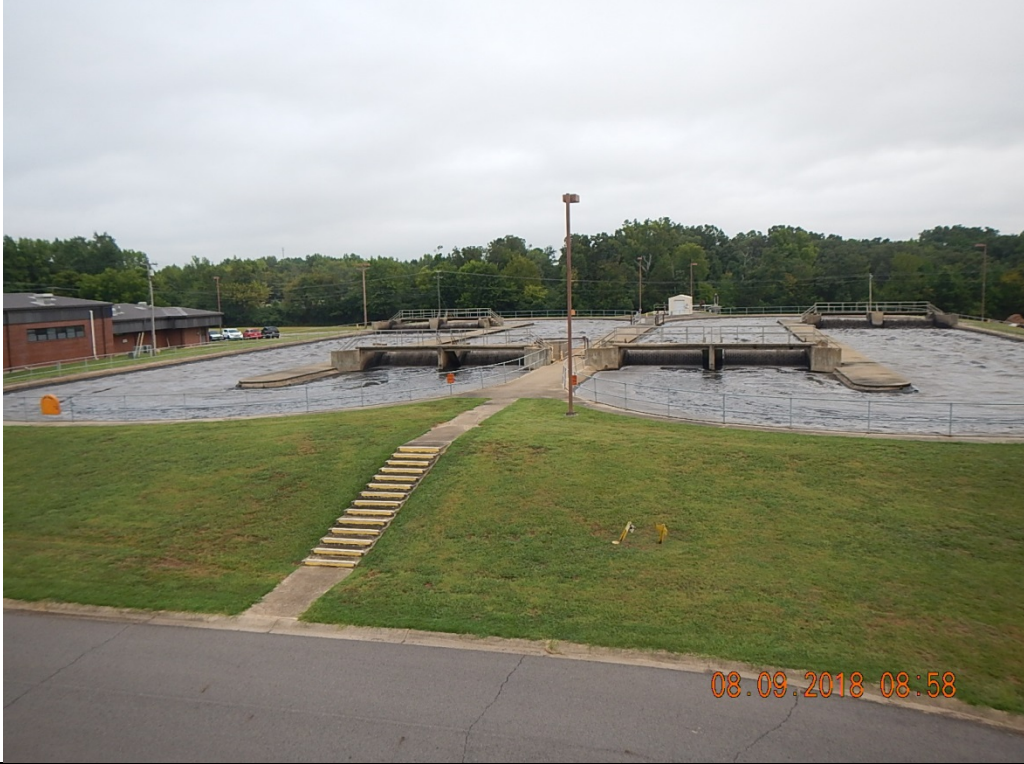
Location:	Clarksville Light and Water		
Photographer:	Dannielle Gray	Date:	8/9/2018
Witness:	None	Time:	0858
		Photo #:	3
Description:	Activated sludge tracks

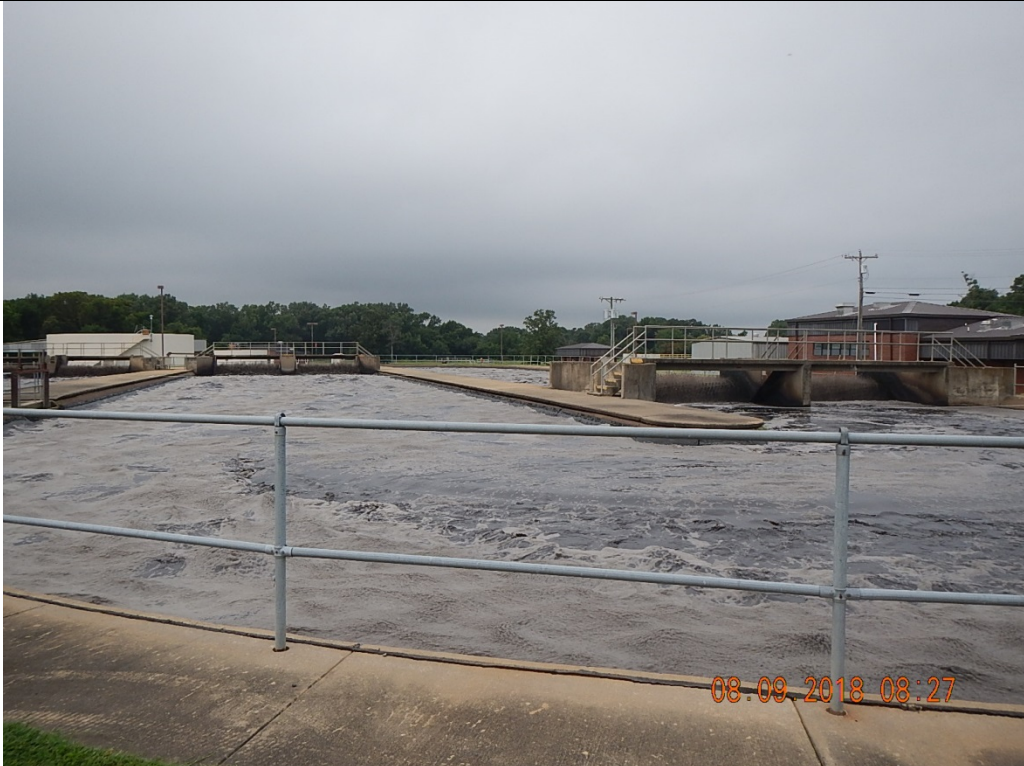
Photographer:	Dannielle Gray	Date:	8/9/2018
Witness:	None	Time:	0827
		Photo #:	4
Description:	Close-up of activated sludge treatment track

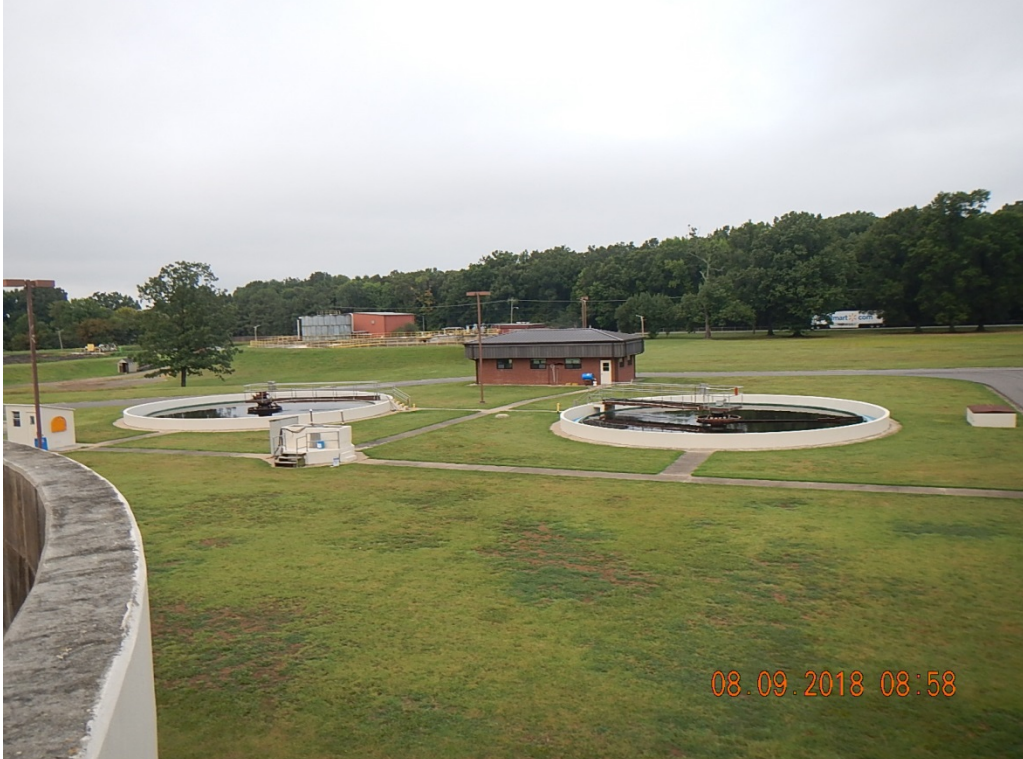
Location:	Clarksville Light and Water		
Photographer:	Dannielle Gray	Date:	8/9/2018
Witness:	None	Time:	0858
		Photo #:	5
Description:	Secondary Clarifiers

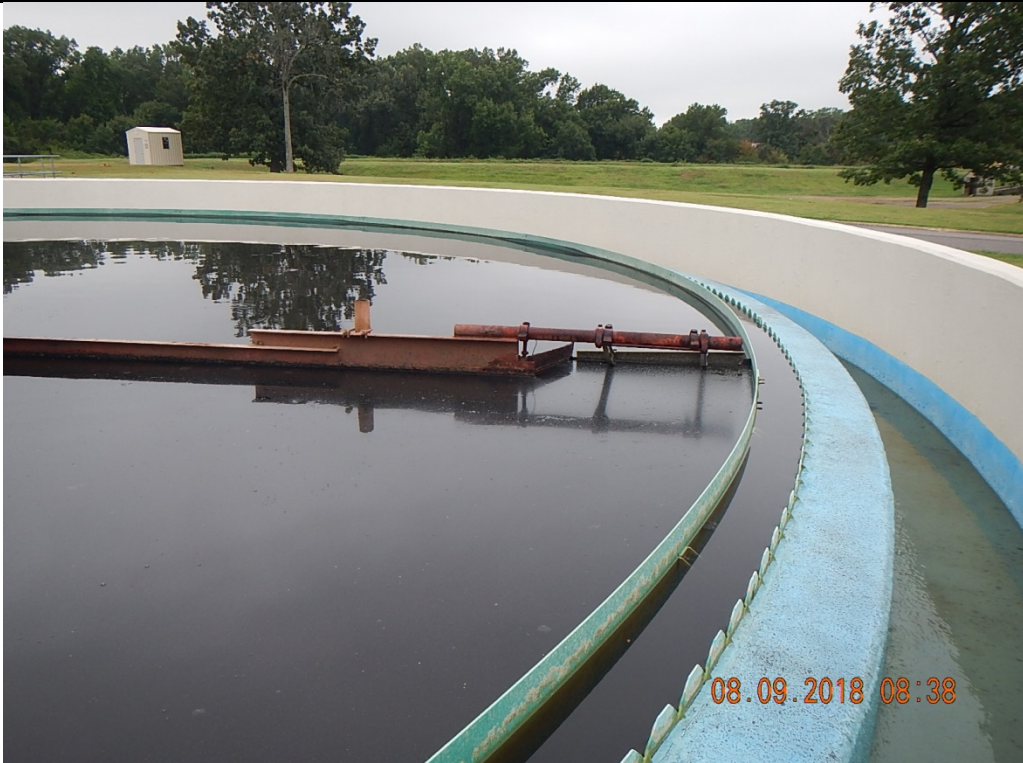
Photographer:	Dannielle Gray	Date:	8/9/2018
Witness:	None	Time:	0838
		Photo #:	6
Description:	Close-up of clarifier skimmer and weir plate

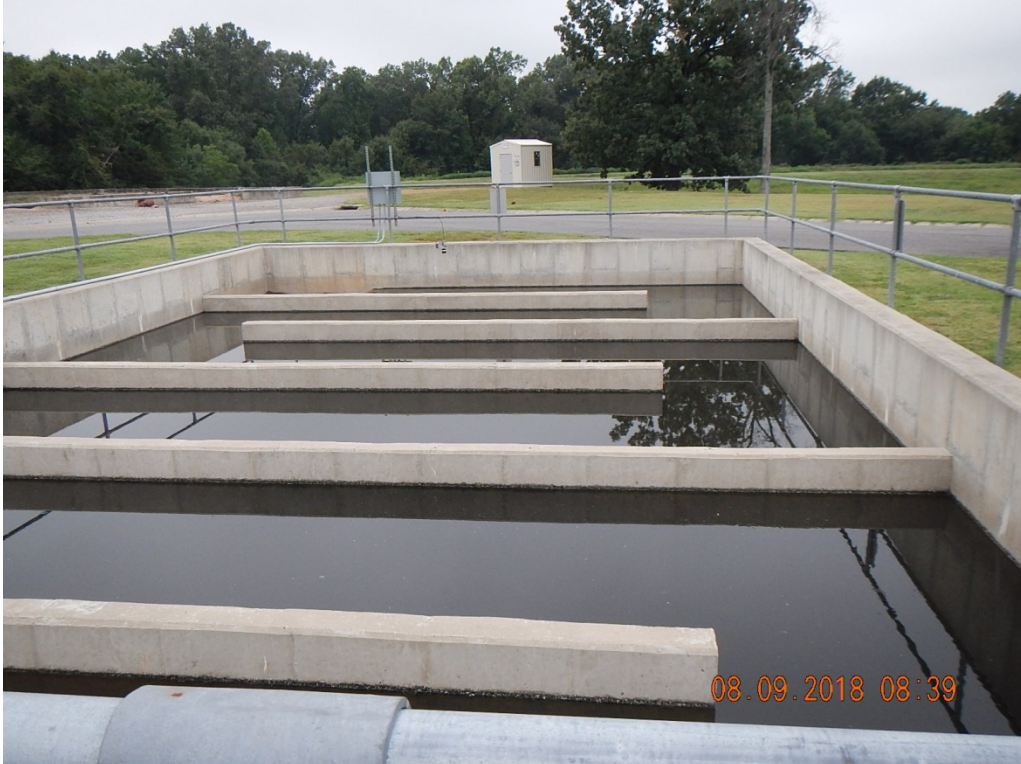
Location:	Clarksville Light and Water		
Photographer:	Dannielle Gray	Date:	8/9/2018
Witness:	None	Time:	0839
		Photo #:	7
Description:	Chlorine contact chamber

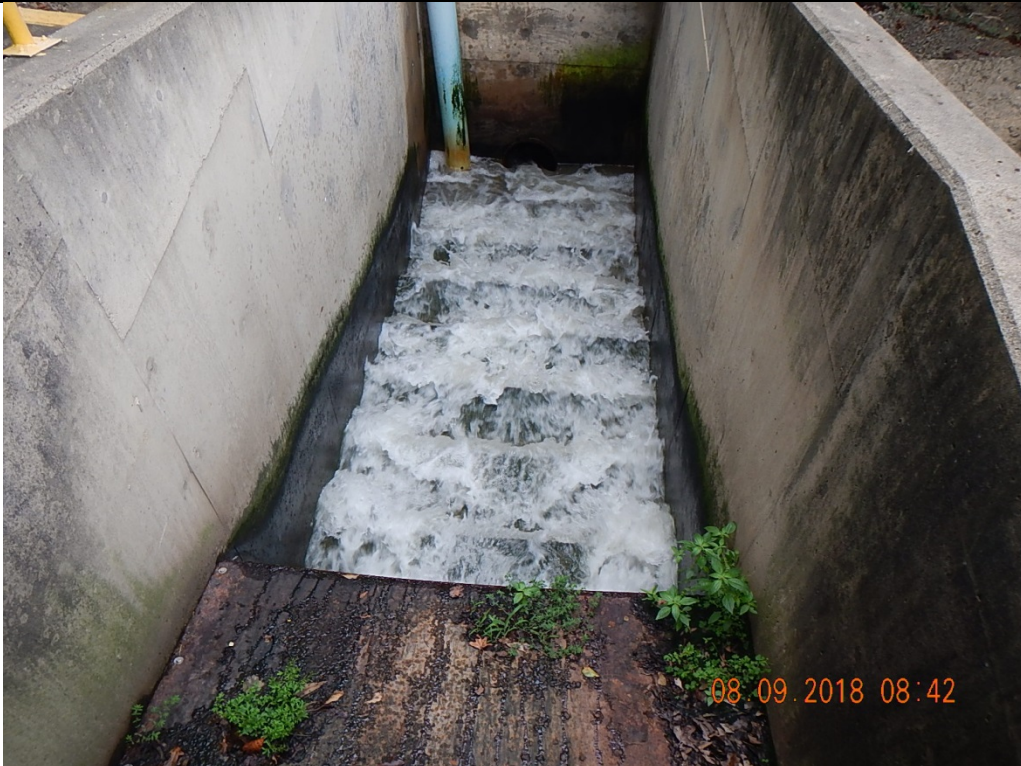
Photographer:	Dannielle Gray	Date:	8/9/2018
Witness:	None	Time:	0842
		Photo #:	8
Description:	Aeration steps at effluent

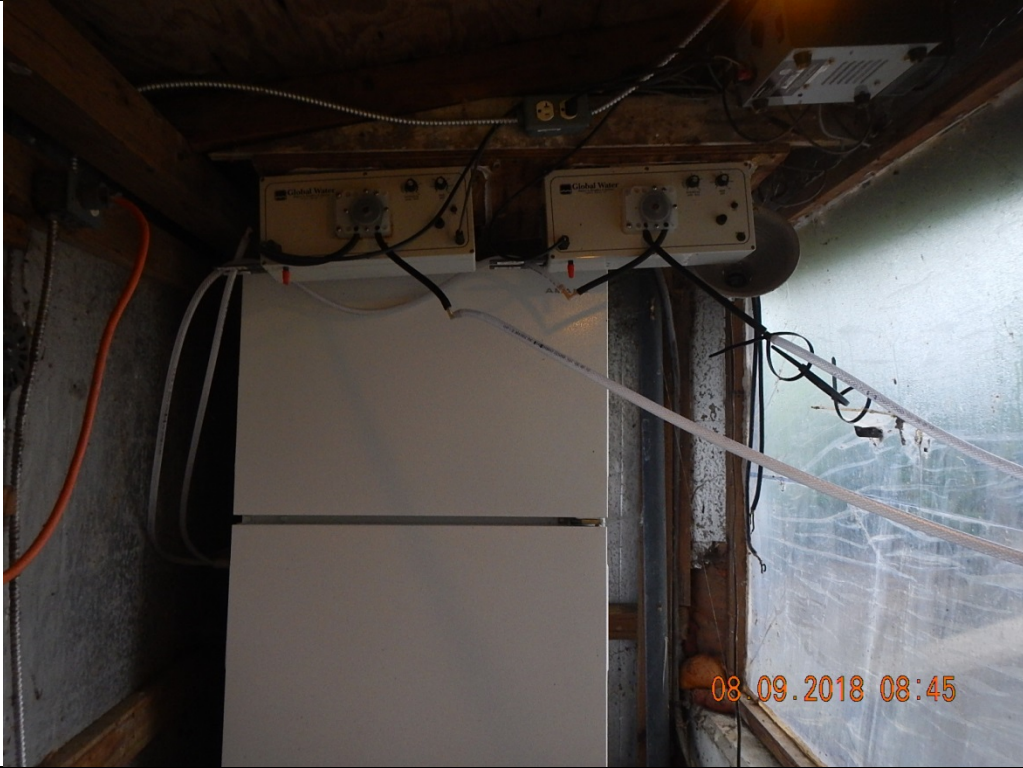
Location:	Clarksville Light and Water		
Photographer:	Dannielle Gray	Date:	8/9/2018
Witness:	None	Time:	0845
		Photo #:	9
Description:	Fixed composite sampler and refrigerator for temperature-controlled storage during collection.

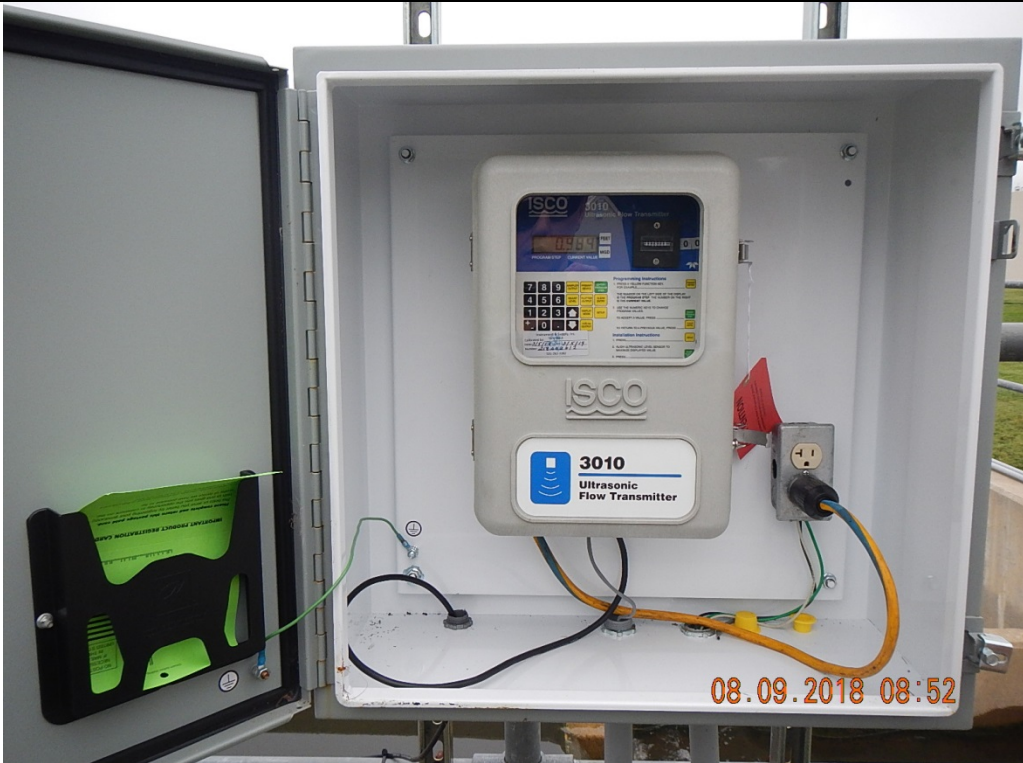
3. SECONDARY INSTRUMENTS (TOTALIZERS, RECORDERS, ETC.) PROPERLY OPERATED AND MAINTAINED: 3010 Ultrasonic flow transmitter installed this year at chlorine contact chamber for Outfall 001 (in pipe).	<input checked="" type="checkbox"/> Y <input type="checkbox"/> N <input type="checkbox"/> NA <input type="checkbox"/> NE

Photographer:	Dannielle Gray	Date:	8/9/2018
Witness:	None	Time:	0852
		Photo #:	10
Description:	Newly installed ultrasonic flow meter; installed at end of chlorine contact chamber (in pipe).

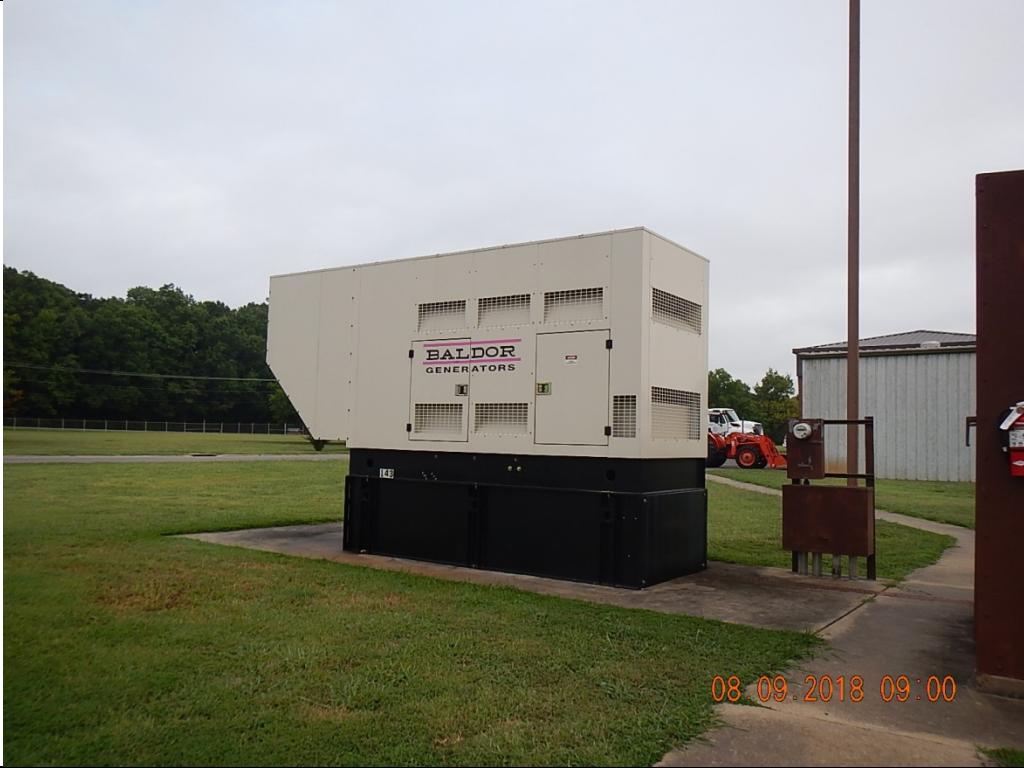
Location:	Clarksville Light and Water		
Photographer:	Dannielle Gray	Date:	8/9/2018
Witness:	None	Time:	0900
		Photo #:	11
Description:	Fixed generator onsite

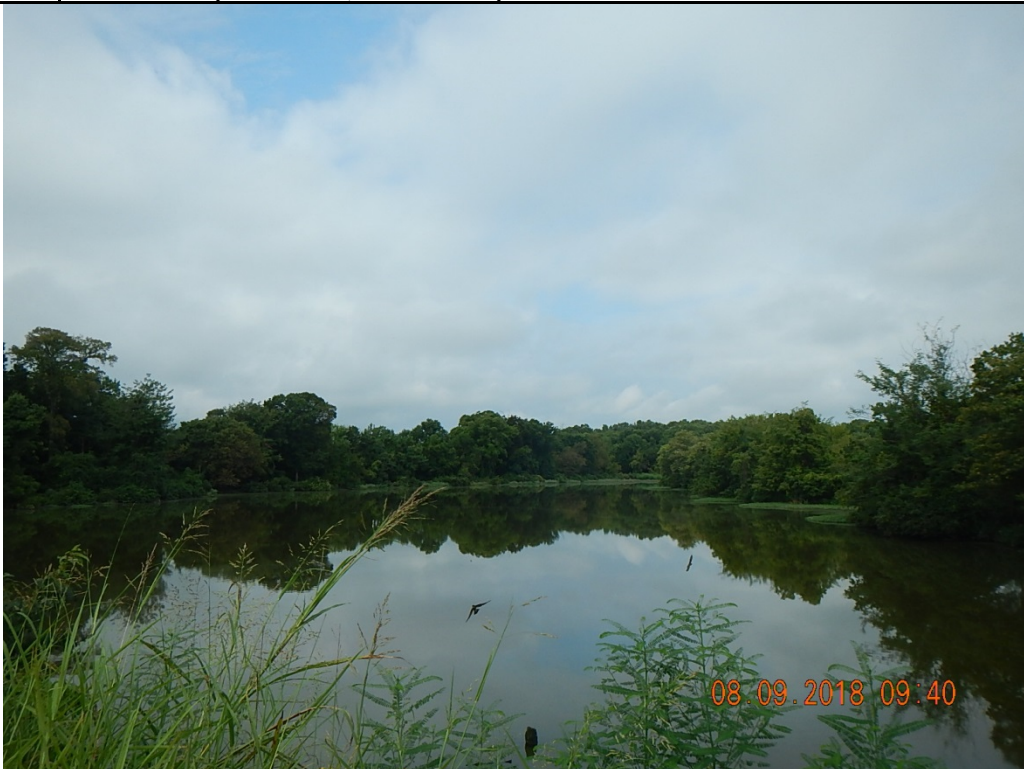
Photographer:	Dannielle Gray	Date:	8/9/2018
Witness:	None	Time:	0940
		Photo #:	12
Description:	Outfall 001 (35.440667, -93.484722)

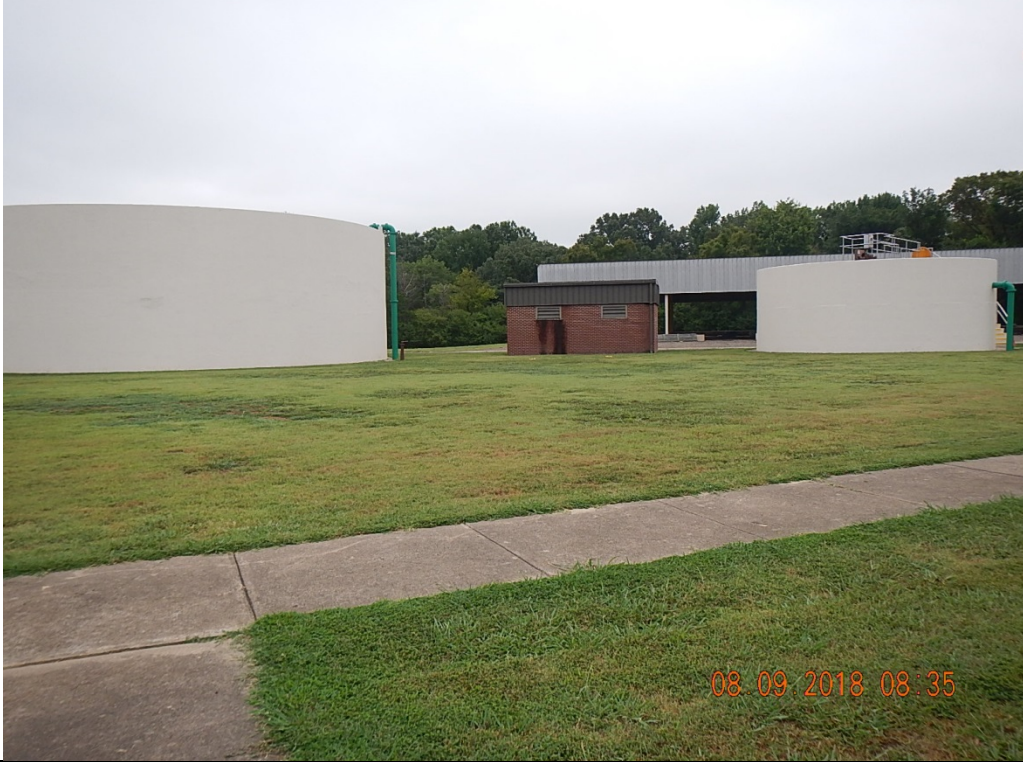
Location:	Clarksville Light and Water		
Photographer:	Dannielle Gray	Date:	8/9/2018
Witness:	None	Time:	0835
		Photo #:	13
Description:	Sludge handling components: thickener (photo right) and digester (photo left)

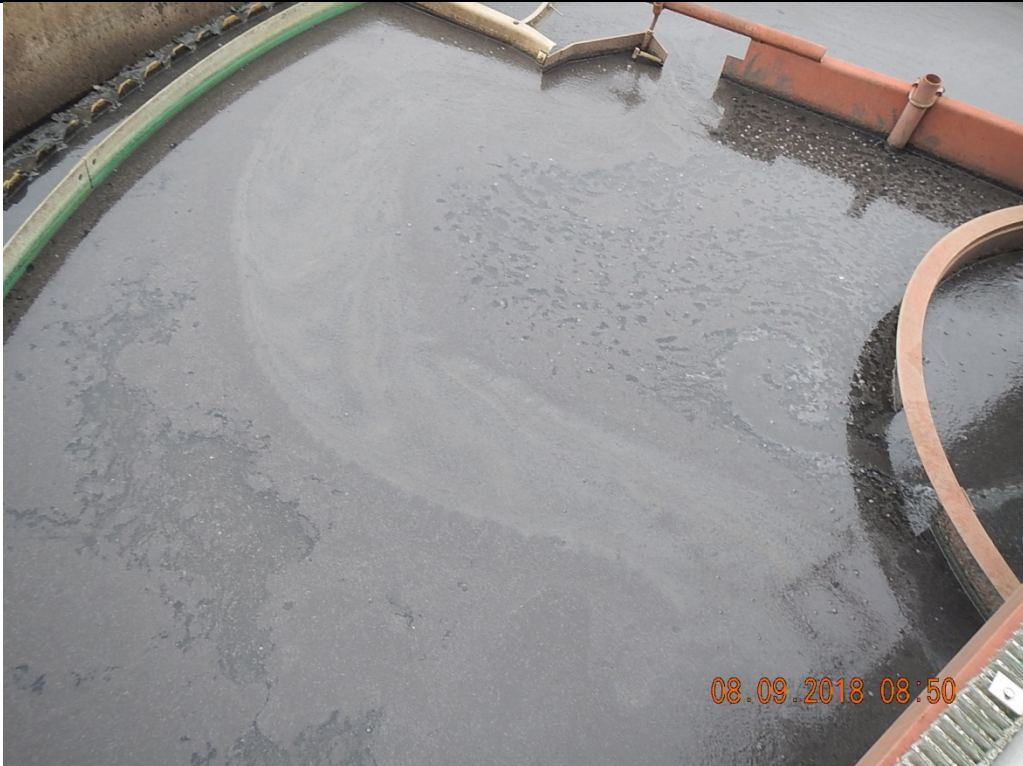
Photographer:	Dannielle Gray	Date:	8/9/2018
Witness:	None	Time:	0850
		Photo #:	14
Description:	Skimmer and WAS in thickener

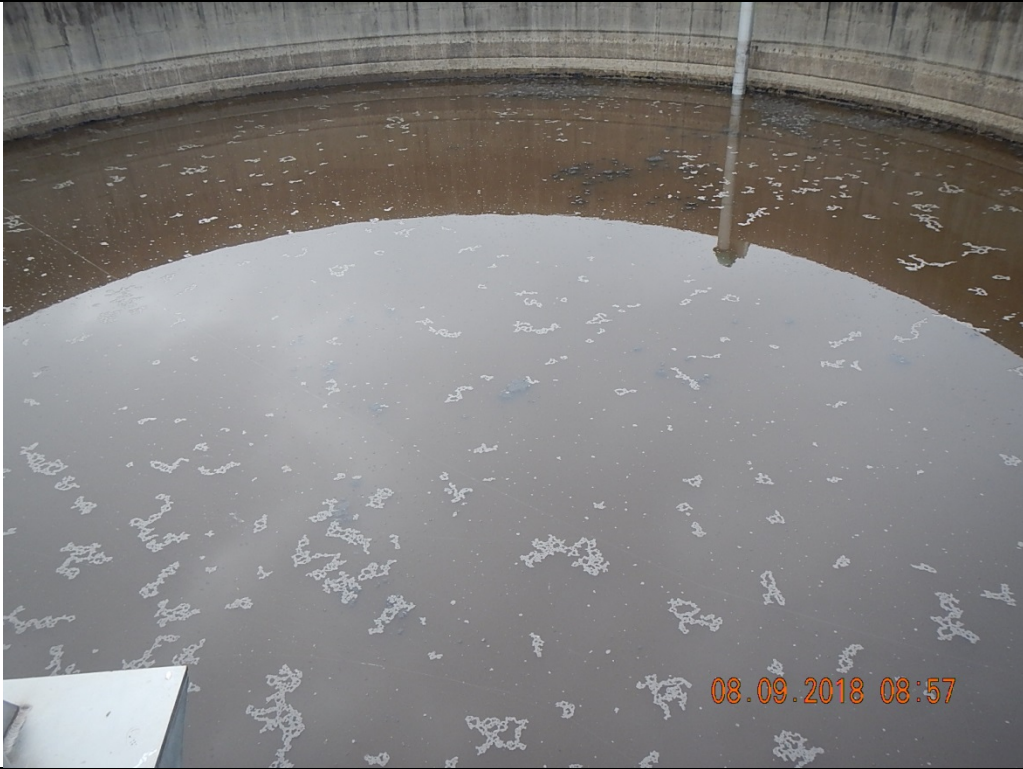
Waste sludge is dewatered and land applied under ADEQ State No-Discharge permit 5205-W. During inspection, sludge in the digester was being decanted in preparation for an upcoming land application.

Location:	Clarksville Light and Water		
Photographer:	Dannielle Gray	Date:	8/9/2018
Witness:	None	Time:	0857
		Photo #:	15
Description:	Digester decanting during inspection

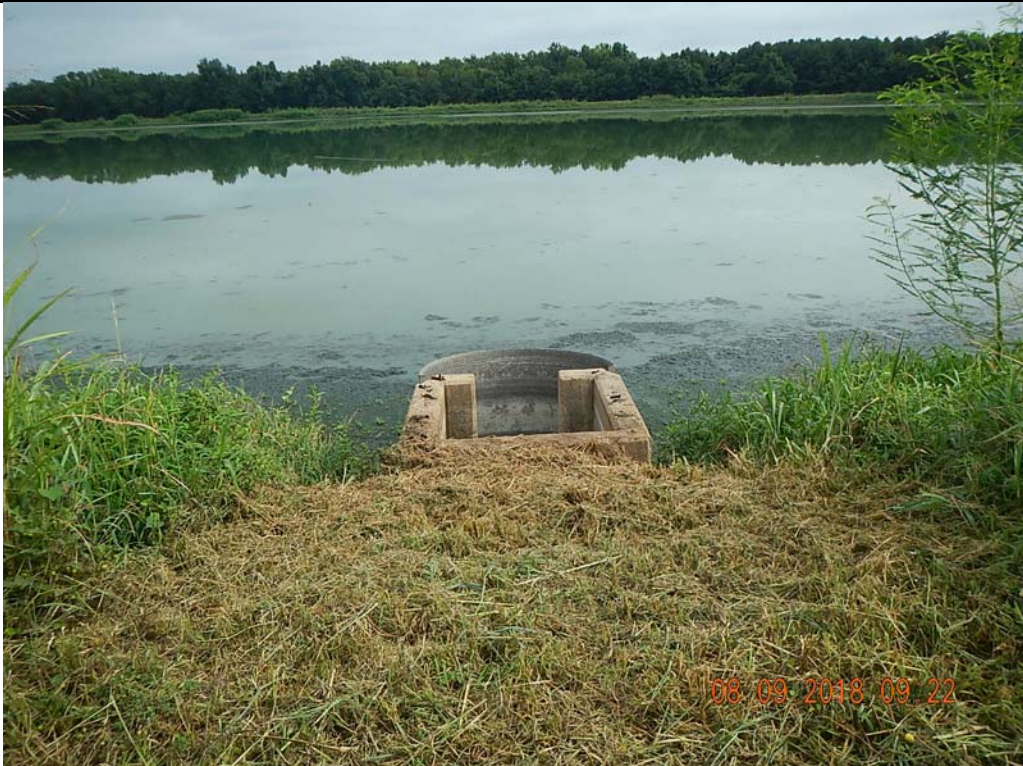
Photographer:	Dannielle Gray	Date:	8/9/2018
Witness:	None	Time:	0922
		Photo #:	16
Description:	Facing north, Pond #1

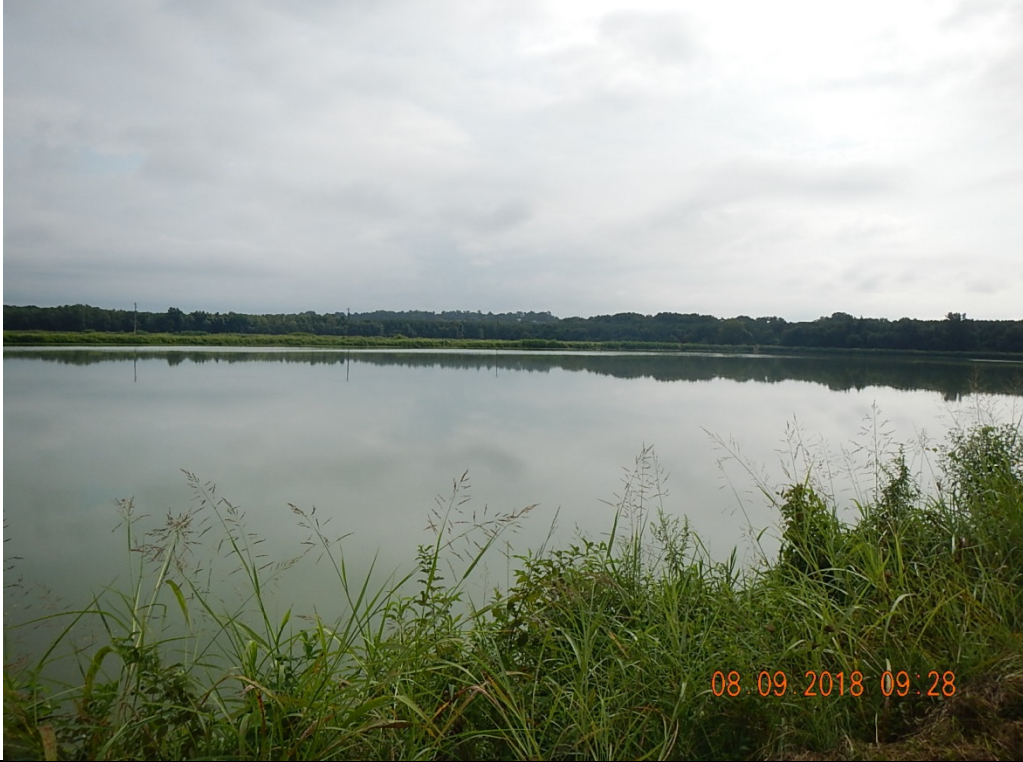
Location:	Clarksville Light and Water		
Photographer:	Dannielle Gray	Date:	8/9/2018
Witness:	None	Time:	0928
		Photo #:	17
Description:	Facing southeast, Pond #2

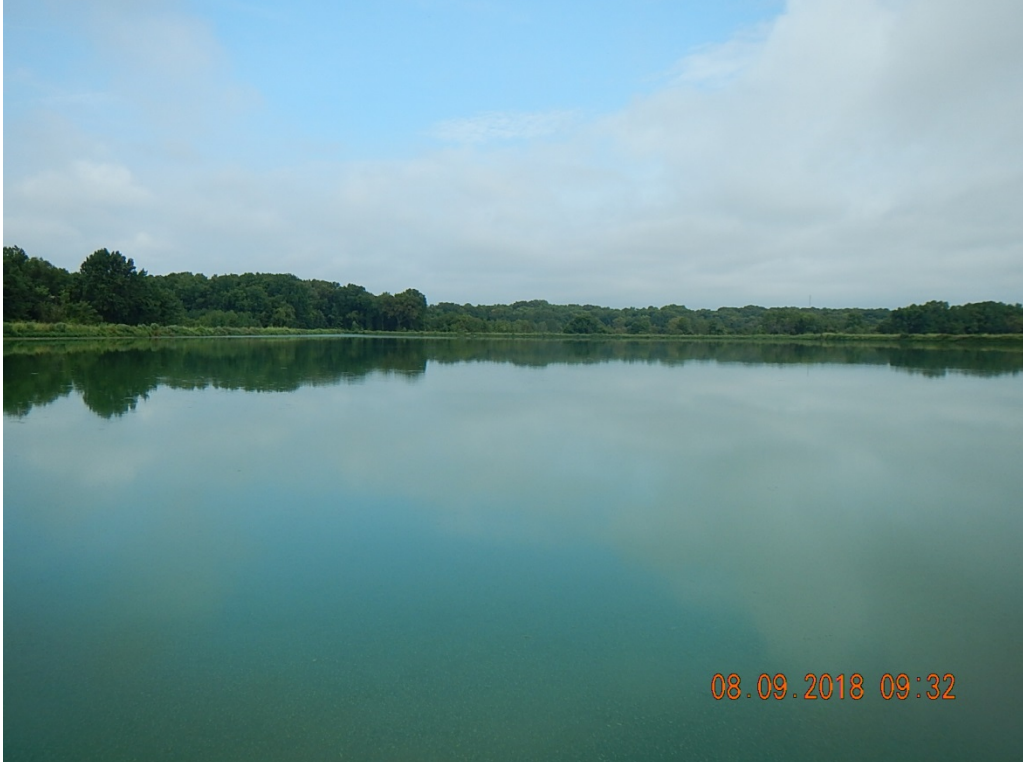
Photographer:	Dannielle Gray	Date:	8/9/2018
Witness:	None	Time:	0932
		Photo #:	18
Description:	Facing south, Pond #3

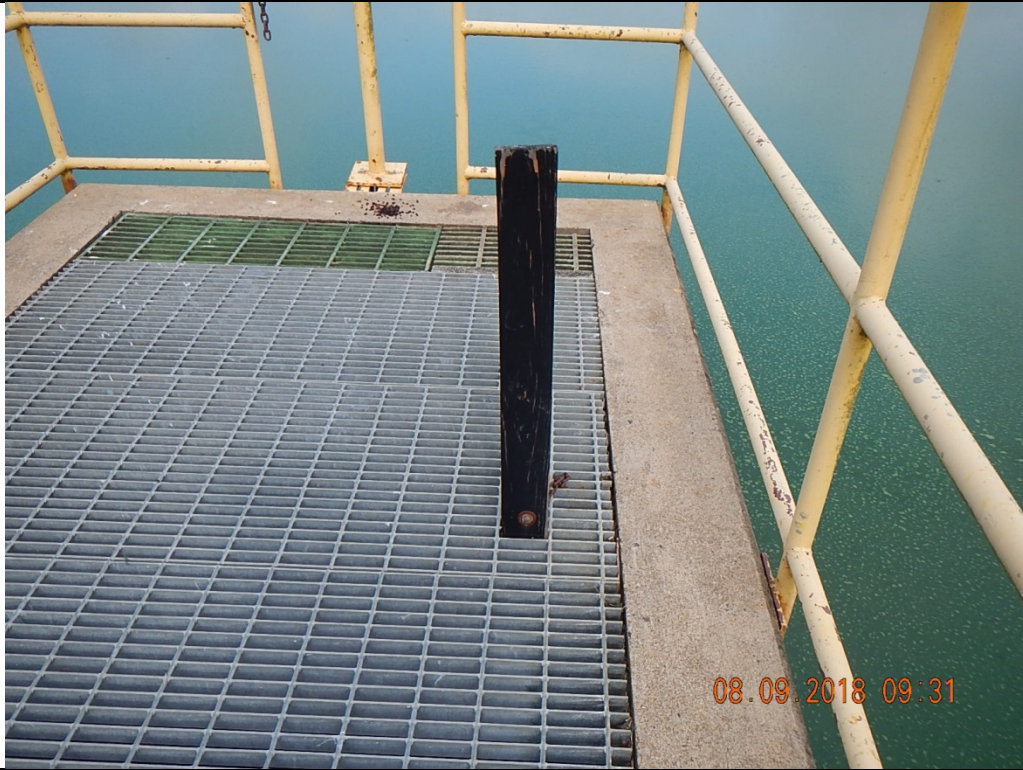
Location:	Clarksville Light and Water		
Photographer:	Dannielle Gray	Date:	8/9/2018
Witness:	None	Time:	0931
		Photo #:	19
Description:	Effluent box in south east corner of Pond #3 includes sampling location, staff gage, and weir.

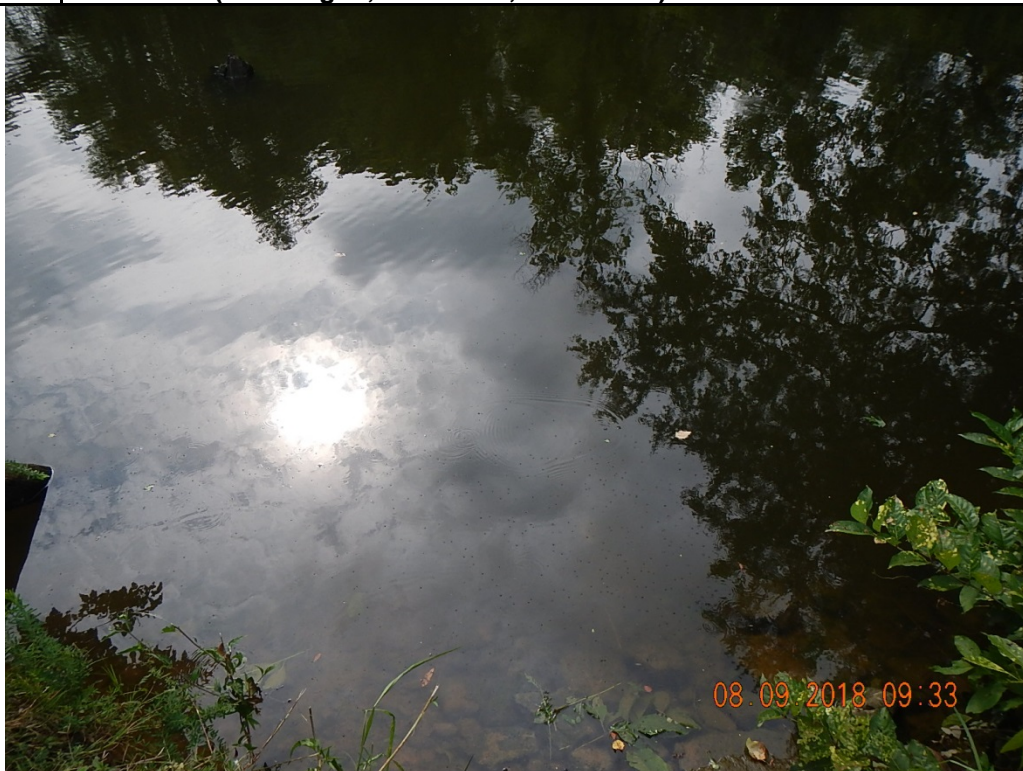
Photographer:	Dannielle Gray	Date:	8/9/2018
Witness:	none	Time:	0933
		Photo #:	20
Description:	Outfall 002 (submerged; 35.445556, -93.473472)

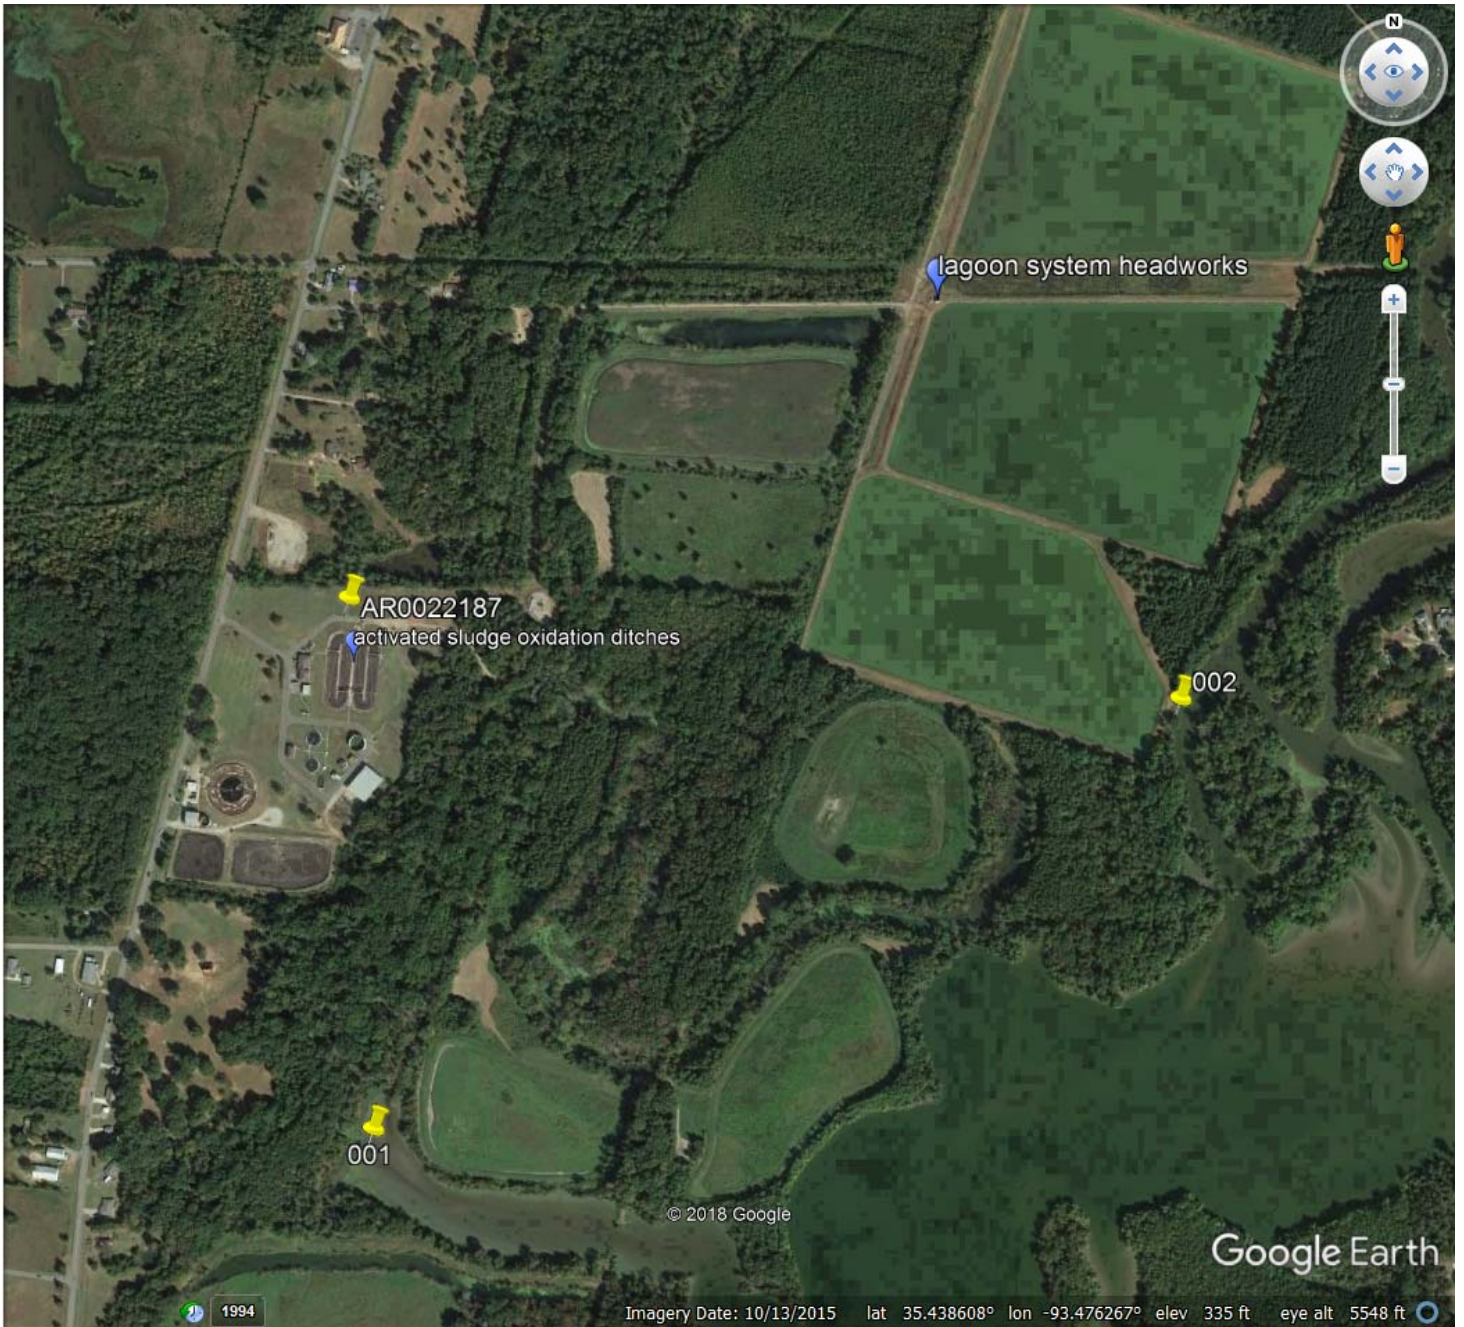
Both outfalls were inspected. As shown in Figure 1, the outfalls are not immediately accessible near the main treatment components. The operator informed that both outfalls are inspected regularly. Biomonitoring samples are collected at the outfall locations and not at the effluent chamber at the main plant. All other samples are collected as the wastewater exits final treatment for both the lagoon system and the activated sludge system.

Figure 1. Google Earth image dated Oct 13, 2015 showing treatment plant overview and outfall locations. Note: round oxidation ditch and two drying beds shown in photo below are part of another facilities treatment plant and not AR0022187.

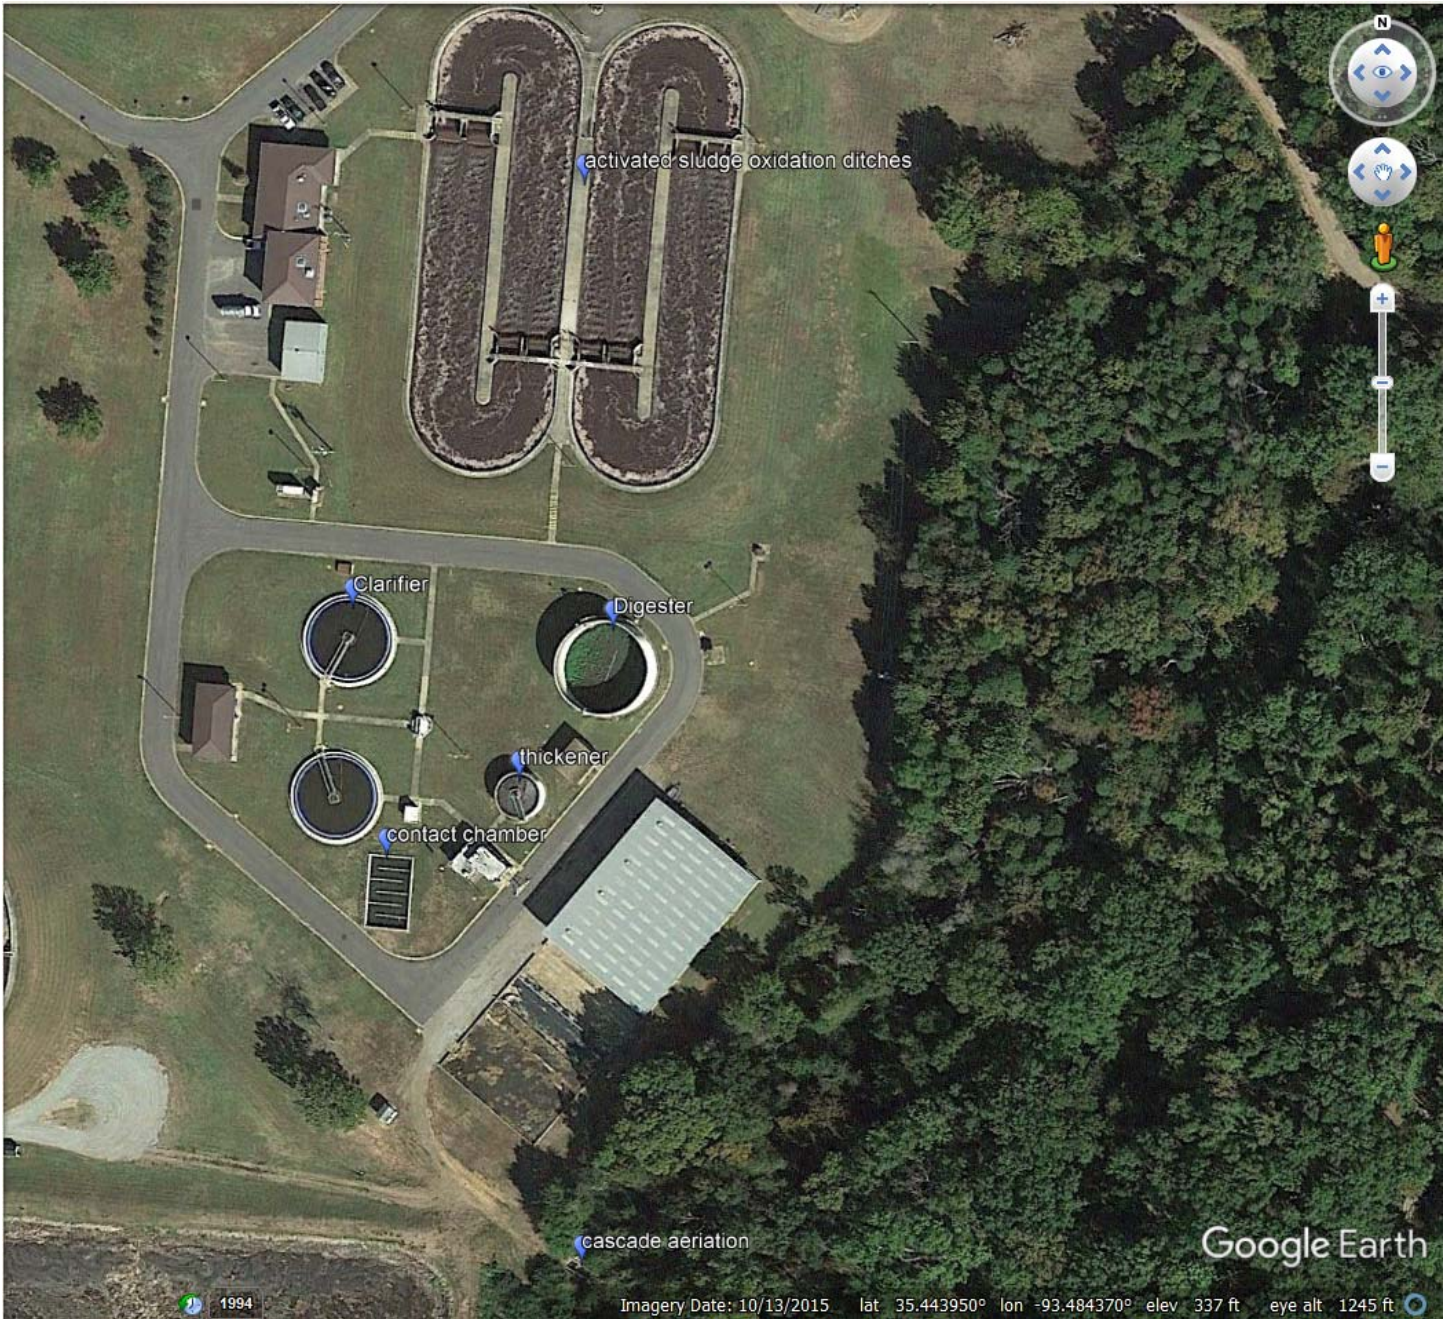
Figure 2. Google Earth image dated Oct 13, 2015 showing activated sludge (main) treatment plant and components.

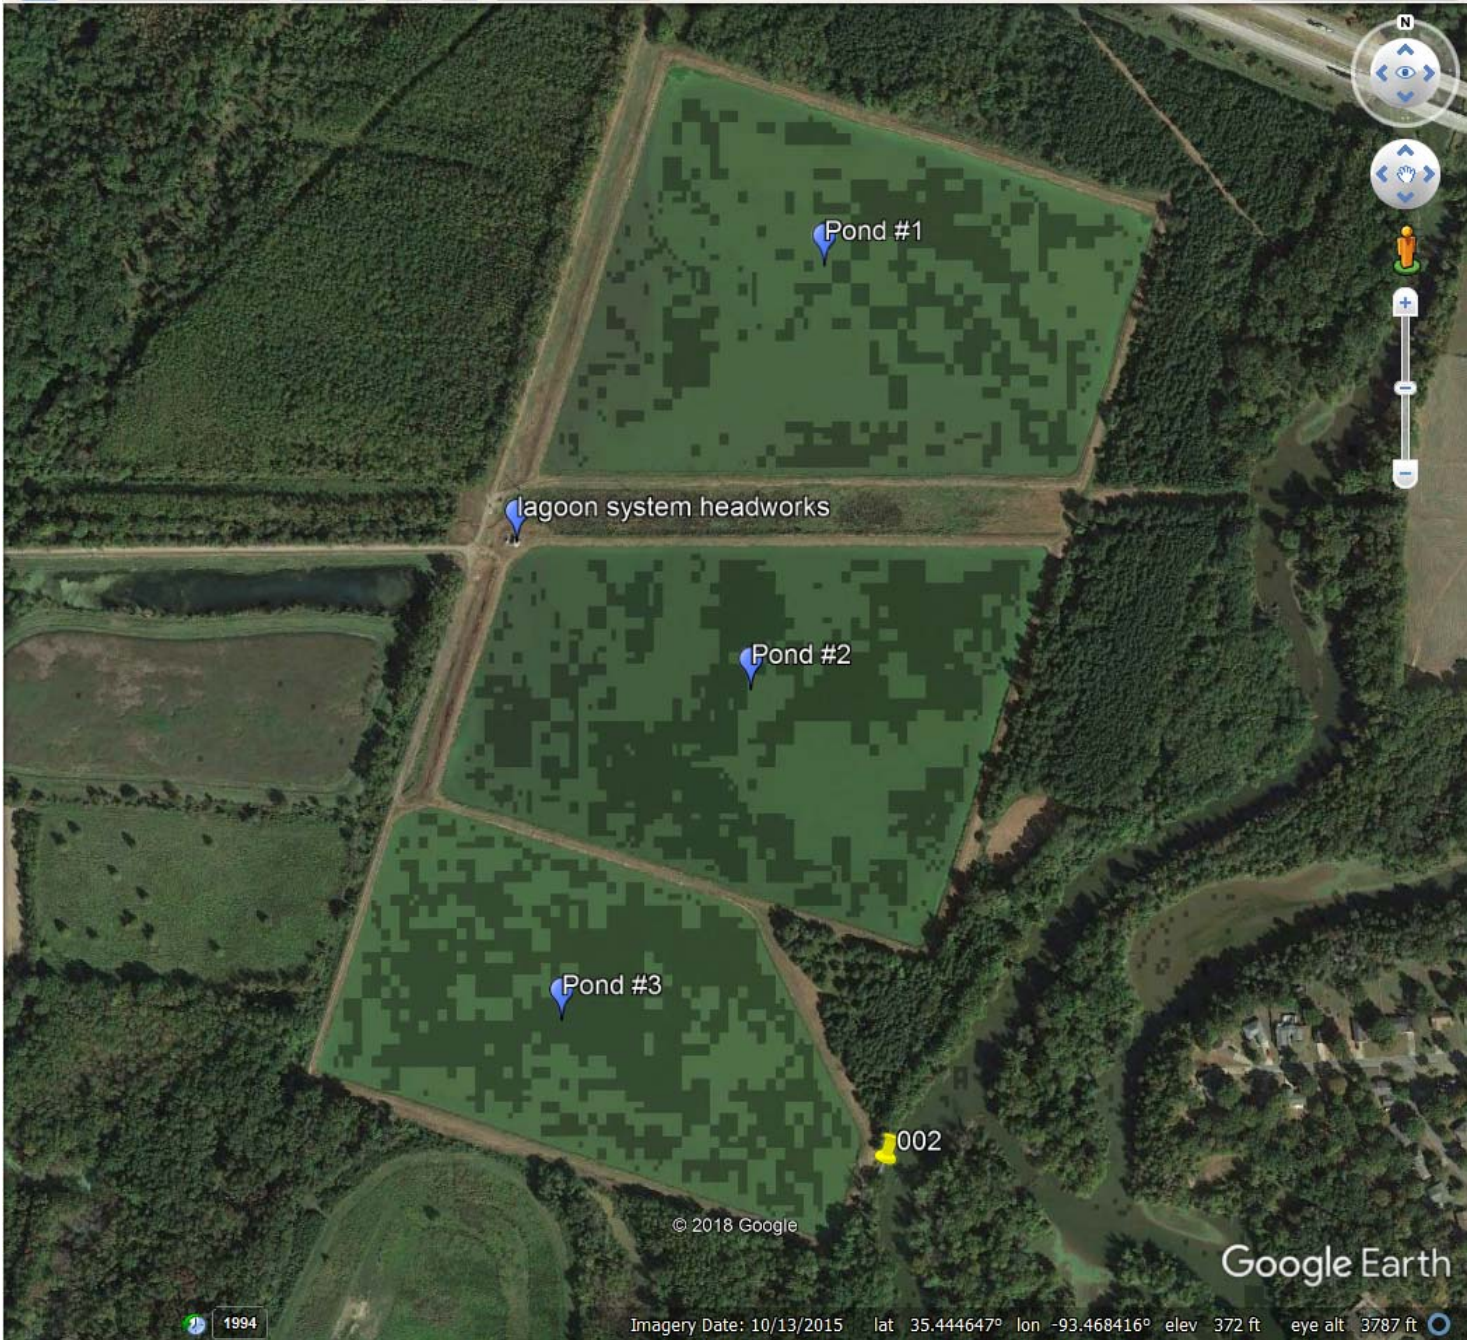
Figure 3. Google Earth image dated Oct 13, 2015 showing three-cell oxidation pond system.
