RE: Georgia-Pacific Consumer Opera Inspections (Ashley Co)

AFIN: 02-00013 NPDES Permit No.: AR0001210

VDEO		WATER	DIVISION I	NSI	PECT	101	REPORT
ADLU	AF	IN: 02-00013 P	PERMIT #: AR0001210				DATE: 8/24/2018
	CC	DUNTY: 02 Ashle	y	PDS #: 104794			MEDIA: WN
A R K A N S A S Department of Environmental Quality			3 LONG: -91.96 7	7238	LOCATION	ON: E	ntrance
FACILITY INFORMAT							MATION
NAME:			FACILITY TYPE:	INSPE	CTOR ID#:		
Georgia-Pacific Consumer Operation	ns L	LC – Crossett	2 - Industrial		531 S - 3		
Paper Operations			FACILITY EVALUATION RATIN	IG:		INSPECTIO	
100 Mill Supply Road			2 - Marginal			Comp	oliance Evaluation
CITY:				NTRY TIME	EXIT TII		PERMIT EFFECTIVE DATE:
Crossett, AR			8/24/2018 1	0:12	17:1	IU	11/1/2010
RESPONSIBLE OFFI	RESPONSIBLE OFFICIAL						PERMIT EXPIRATION DATE: 10/31/2015
NAME: / TITLE	: N/a	nufacturing					10/01/2010
Michael L. Hohnadel / Vice Pres. of Manufacturing			FAYETTEVILLE SHALE RELATED: N				
Georgia-Pacific Consumer Operations LLC - Crossett			FAYETTEVILLE SHALE VIOLATIONS: N

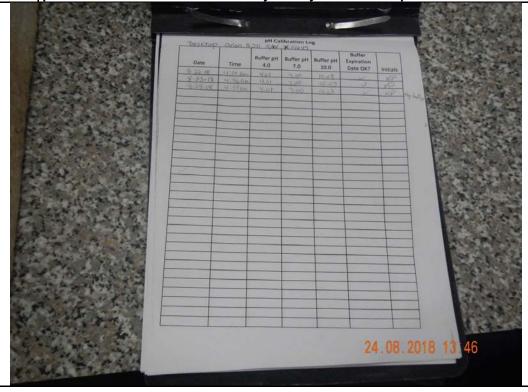
Photographer:Michael YoungDate:8/24/2018Time:13:46Witness:Photo #:2

Description: pH meter used by facility.

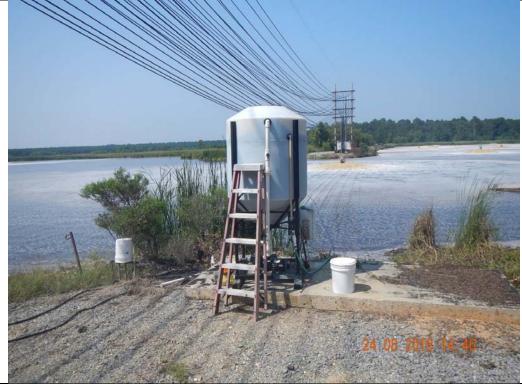
Water Division Photographic Evidence Sheet							
Location: Georgia-Pacific Consumer Opera							
Photograp	her:	Michael Young	Date:	8/24/2018	Time:	14:46	
Witness:					Photo #:	15

Description: Aerators were in operation during inspection.

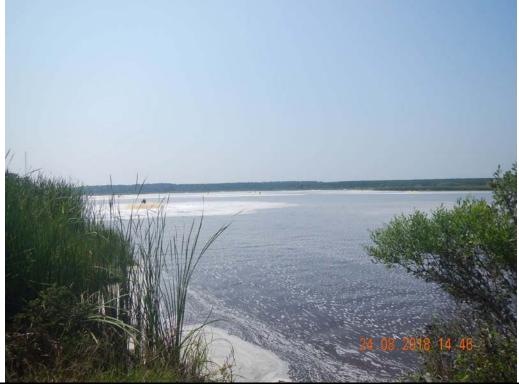
Photographer: Michael Young Date: 8/24/2018 Time: 14:47
Witness: Photo #: 16

Description: Wastewater bioagumentation supplement.

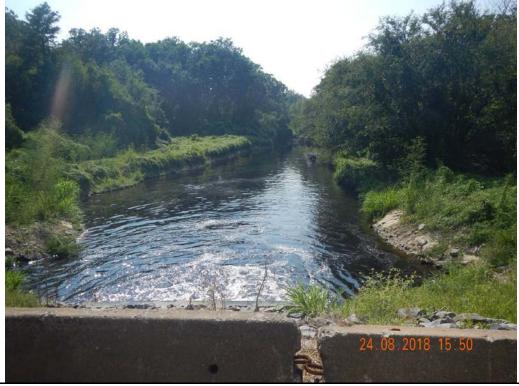
Witness: Photo #: 21

Description: Discharge from SMS 002 Outfall.

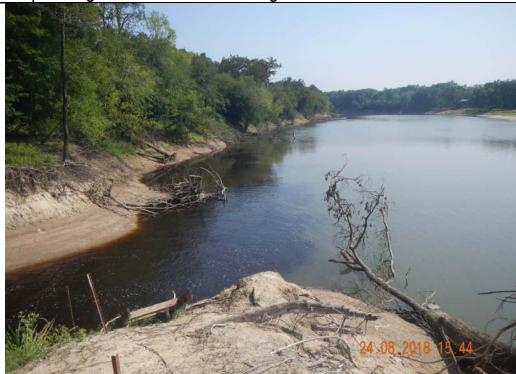
Photographer:Michael YoungDate:8/24/2018Time:15:44Witness:Photo #:22

On August 24, 2018, I performed an inspection with the above participants. Georgia-Pacific Consumer Operations LLC - Crossett Paper Operations manufactures paper products and has a discharge of ~40 MGD at Outfall 001. Permitted outfalls at this facility are three internal outfalls (Outfalls 101-103), Outfall 001, and a Stream Monitoring Station (SMS) 002. The treatment design for this facility is influent enters the WWTP (see Photo 3) and there is a chemical addition of Hydrogen Peroxide (see Photo 5) followed by a bar screen for fiber removal (see Photo 4). Primary treatment is in the clarifier (see Photo 6). Sludge is removed from the clarifier and passed through a belt press to be hauled by trucks to a permitted landfill site (see Photo 7-8). A temporary variance has been granted to abandon the use of the ash settling basins (see Photo 11) and an additional temporary variance has permitted for the use of oxygen diffusion into the wastewater stream after the clarifier (see Photo 12). Nutrient addition is used when needed (see Photo 13), and wastewater then enters the aeration stabilization basin (ASB) (see Photo 15) where there are feeds of additional wastewater bioagumentation supplements (see Photos 14; 16). Monitoring is performed at Outfall 001 (see Photo 18) and flow is monitored using a totalizer (see Photo 17). Chemical addition of defoamer takes place at Outfall 001 (see Photo 19). Wastewater then enters the polishing pond (~640 acre Mossy Lake) and is monitored at SMS 002 (see Photo 20). The discharged water enters Coffee Creek and is discharged at the Ouachita River (see Photos 21-22). A records review and facility inspection were performed during this CEI.
