ARKANSAS  
Department of Environmental Quality

RE: Blytheville Wastewater Treatment Plant Inspections  
West AFIN: 47-00544 Permit No.: AR0022560 & ARR00C337  
North AFIN: 47-00929 Permit No.: AR0022586 & ARR000249  
South AFIN: 47-00926 Permit No.: AR0022578 & ARR00C338

<b>WATER DIVISION INSPECTION REPORT</b>		
AFIN: <b>47-00544</b>	PERMIT #: <b>AR0022560</b>	DATE: <b>5/31/2018</b>
COUNTY: <b>47 Mississippi</b>	PDS #: <b>105937</b>	MEDIA: <b>WN</b>
GPS LAT: <b>35.934850</b> LONG: <b>-89.942647</b> LOCATION: <b>Entrance</b>

**Water Division Photographic Evidence Sheet**

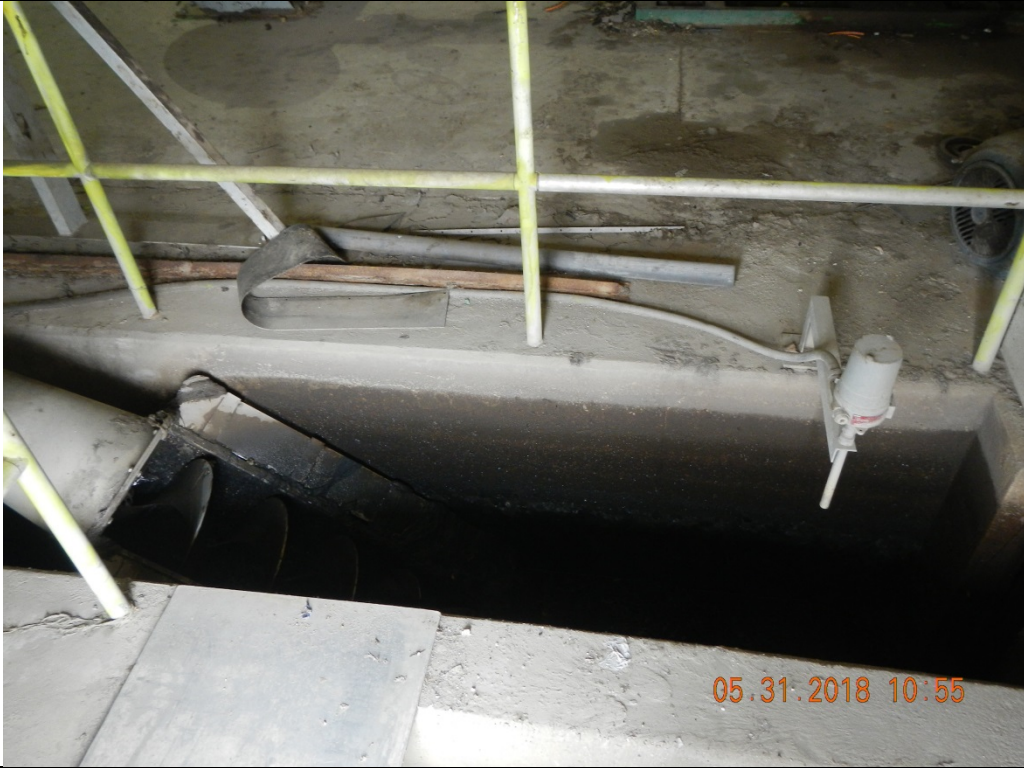
Location:	<b>Blytheville – West WWTP</b>		
Photographer:	<b>Brent Walker</b>	Date:	<b>5/31/2018</b>
Witness:	<b>None</b>	Time:	<b>1055</b>
Description:	<b>Bar screen in influent channel.</b>

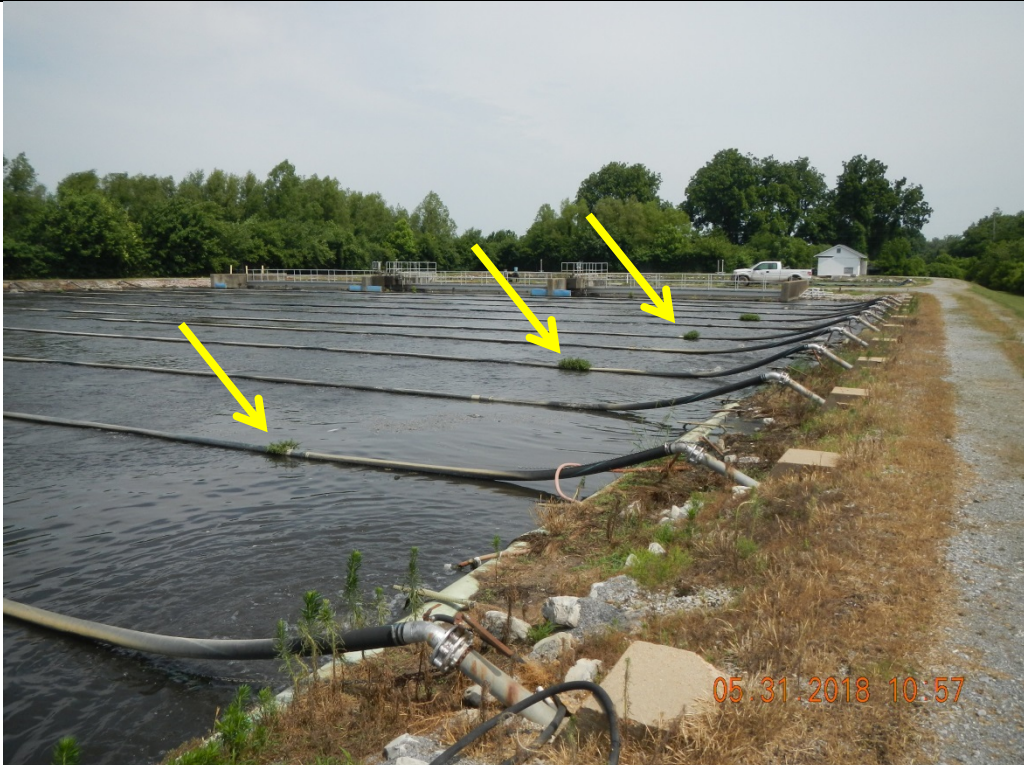
1. There were multiple locations where vegetation was growing on the air lines and clarifier curtains. This can result in cracking and rapid deterioration of components as roots continue to grow and spread.

Photographer:	<b>Brent Walker</b>	Date:	<b>5/31/2018</b>
Witness:	<b>None</b>	Time:	<b>1057</b>
Description:	<b>Overview of aeration basin. Note vegetation growing on air lines.</b>

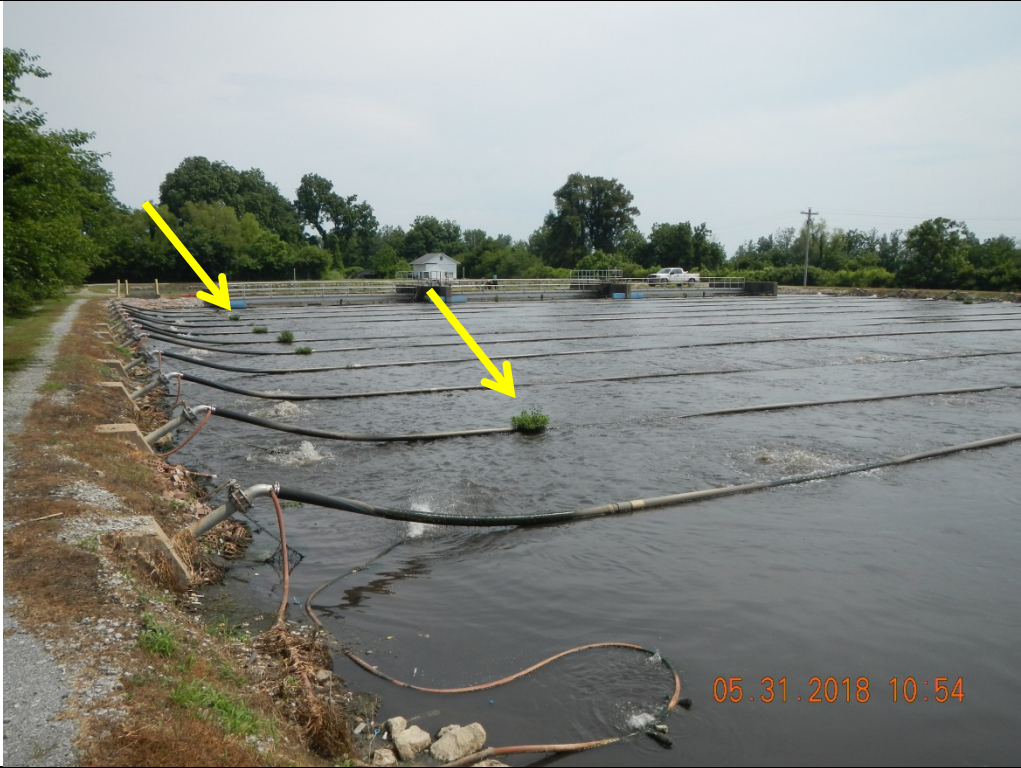
Location:	<b>Blytheville – West WWTP</b>		
Photographer:	<b>Brent Walker</b>	Date:	<b>5/31/2018</b>
Witness:	<b>None</b>	Time:	<b>1054</b>
		Photo #:	<b>3</b>
Description:	<b>Overview of aeration basin. Note vegetation growing on air lines.</b>

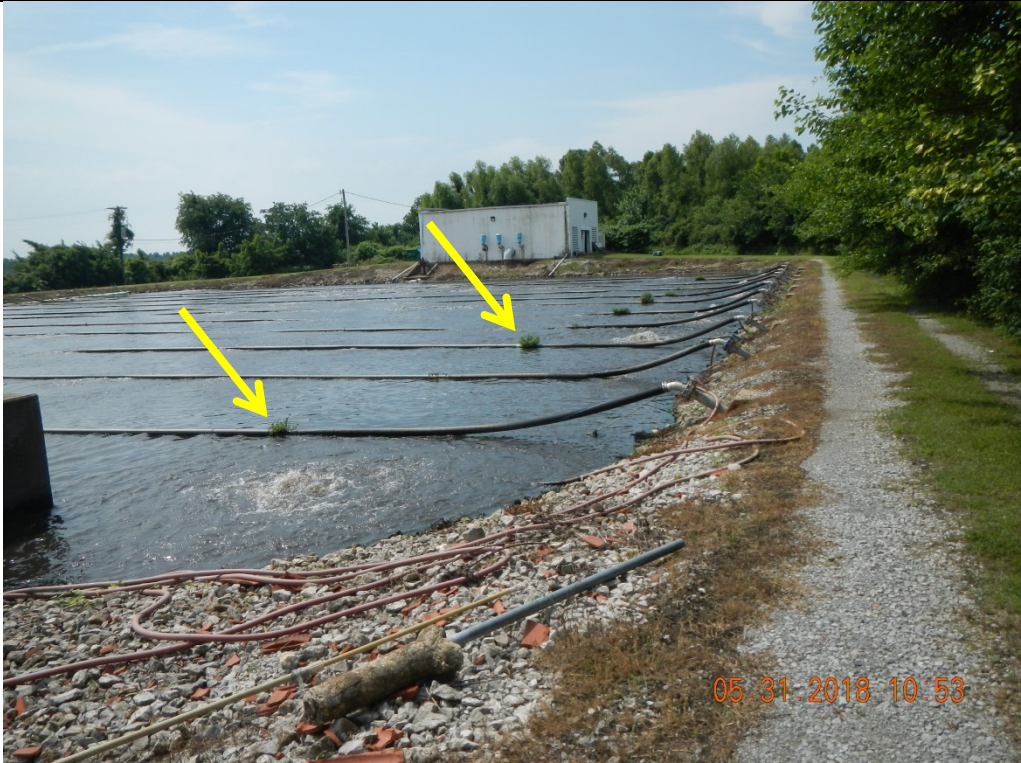
Photographer:	<b>Brent Walker</b>	Date:	<b>5/31/2018</b>
Witness:	<b>None</b>	Time:	<b>1053</b>
		Photo #:	<b>4</b>
Description:	<b>Overview of aeration basin. Note vegetation growing on air lines.</b>

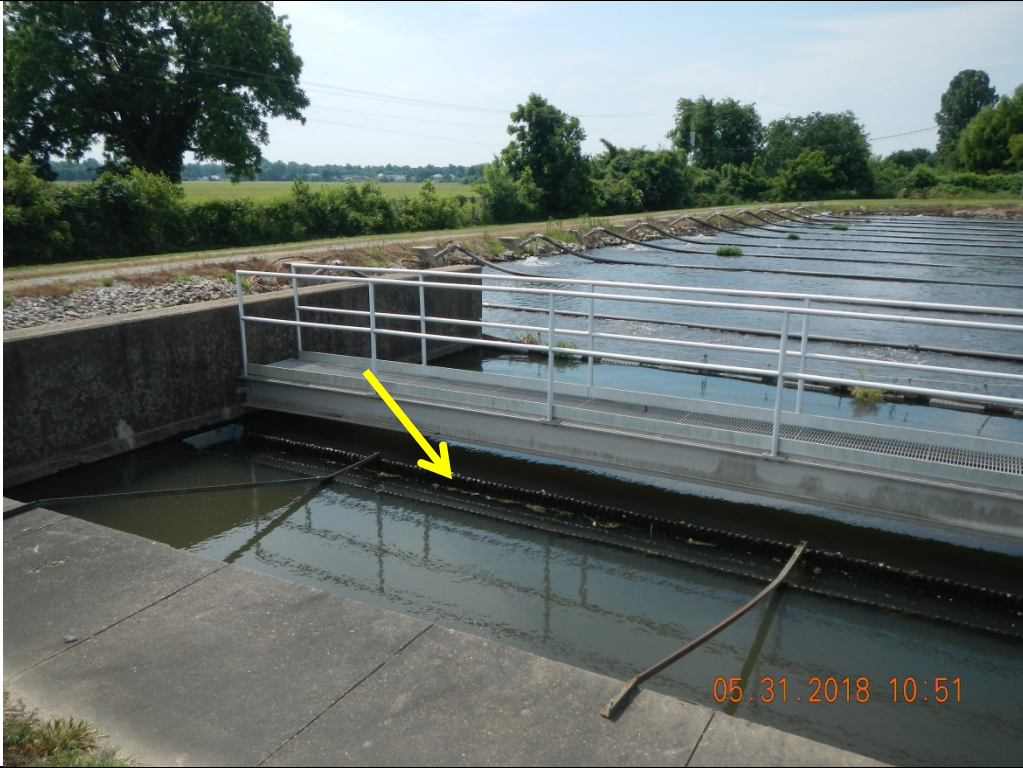
2. There were extensive accumulations of solids in the clarifier weirs.
3. The clarifier sludge return was partially clogged and overflowing.
4. There were air leaks due to broken air lines and/or damaged diffusers in the polishing pond. This reduces treatment efficiency and results in increased energy consumption.

Location:	<b>Blytheville – West WWTP</b>		
Photographer:	<b>Brent Walker</b>	Date:	<b>5/31/2018</b>
Witness:	<b>None</b>	Time:	<b>1051</b>
		Photo #:	<b>5</b>
Description:	<b>Clarifier with excess solids accumulated in weir trough.</b>

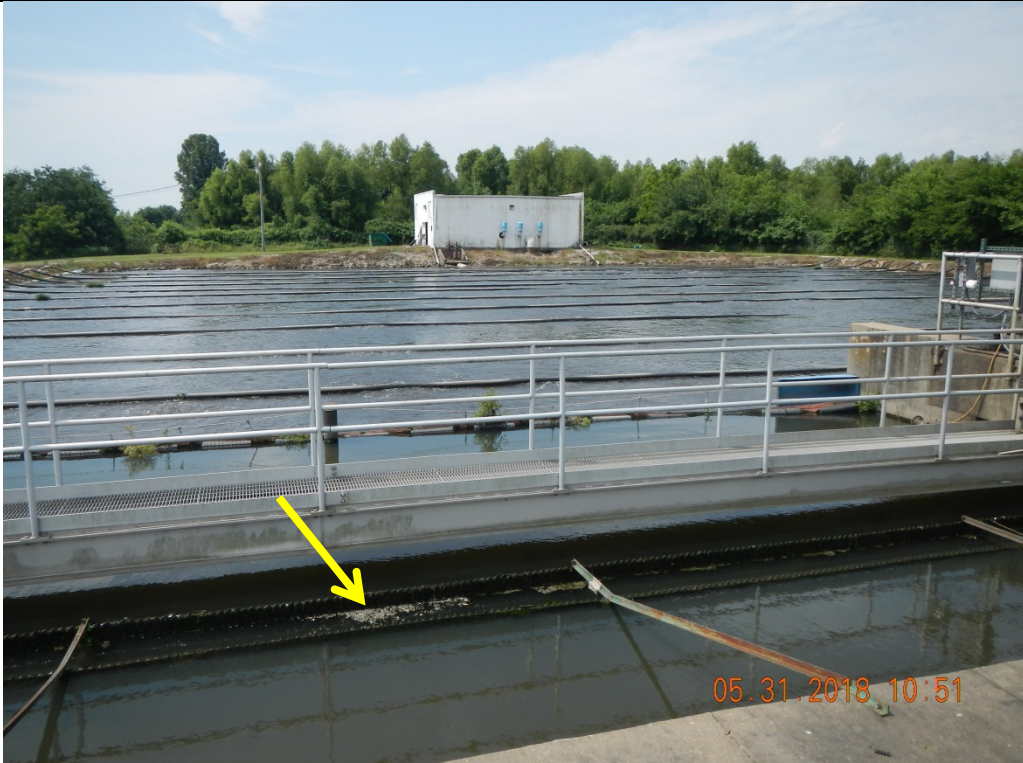
Photographer:	<b>Brent Walker</b>	Date:	<b>5/31/2018</b>
Witness:	<b>None</b>	Time:	<b>1051</b>
		Photo #:	<b>6</b>
Description:	<b>Clarifier with excess solids accumulated in weir trough.</b>

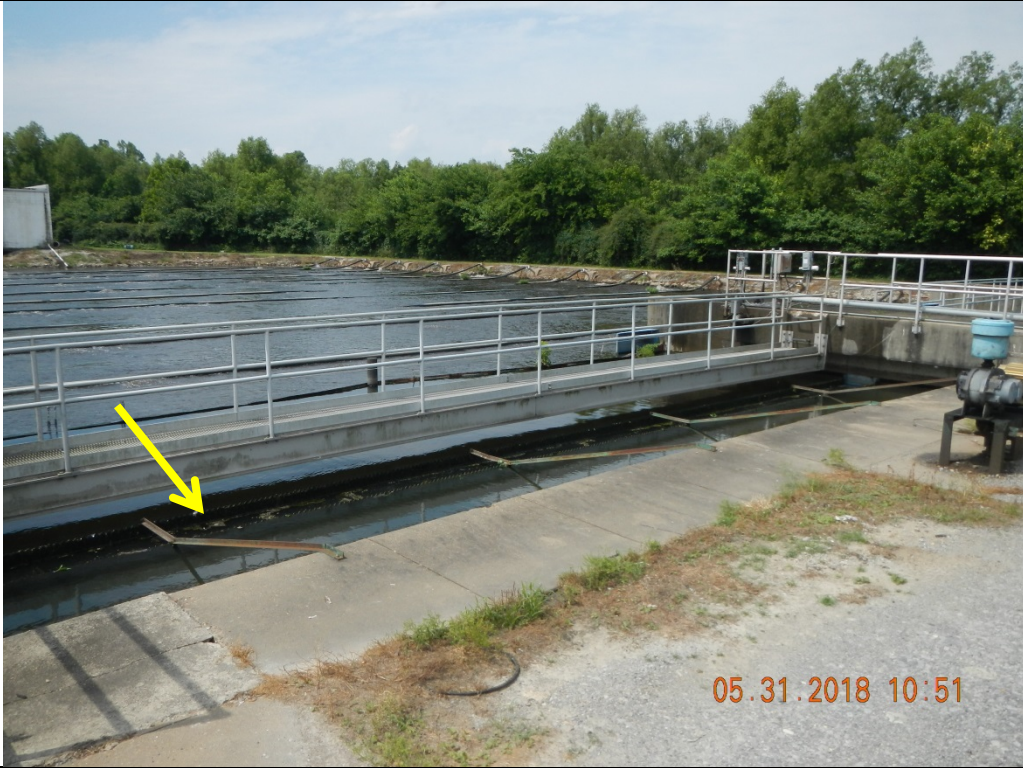
Location:	<b>Blytheville – West WWTP</b>		
Photographer:	<b>Brent Walker</b>	Date:	<b>5/31/2018</b>
Witness:	<b>None</b>	Time:	<b>1051</b>
Description:	<b>Clarifier with excess solids accumulated in weir trough.</b>

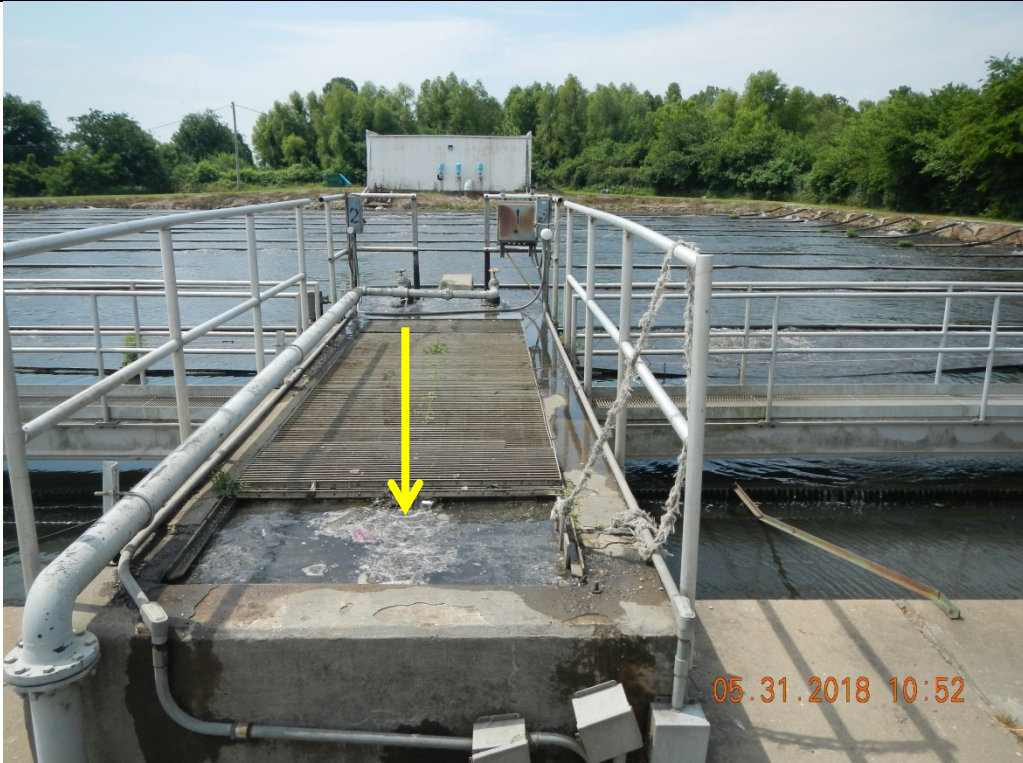
Photographer:	<b>Brent Walker</b>	Date:	<b>5/31/2018</b>
Witness:	<b>None</b>	Time:	<b>1052</b>
Description:	<b>Sludge return overflowing due to blockage.</b>

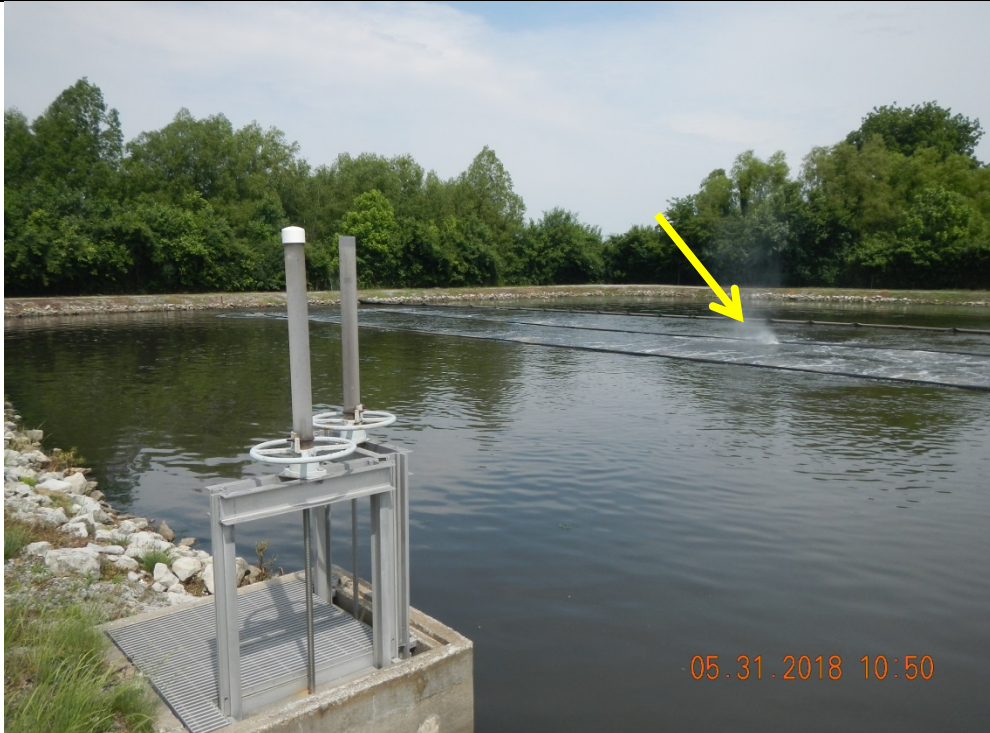
Location:	<b>Blytheville – West WWTP</b>		
Photographer:	<b>Brent Walker</b>	Date:	<b>5/31/2018</b>
Witness:	<b>None</b>	Time:	<b>1050</b>
		Photo #:	<b>9</b>
Description:	<b>Overview of polishing pond. Note wastewater spray due to air leaks and/or damaged diffusers.</b>

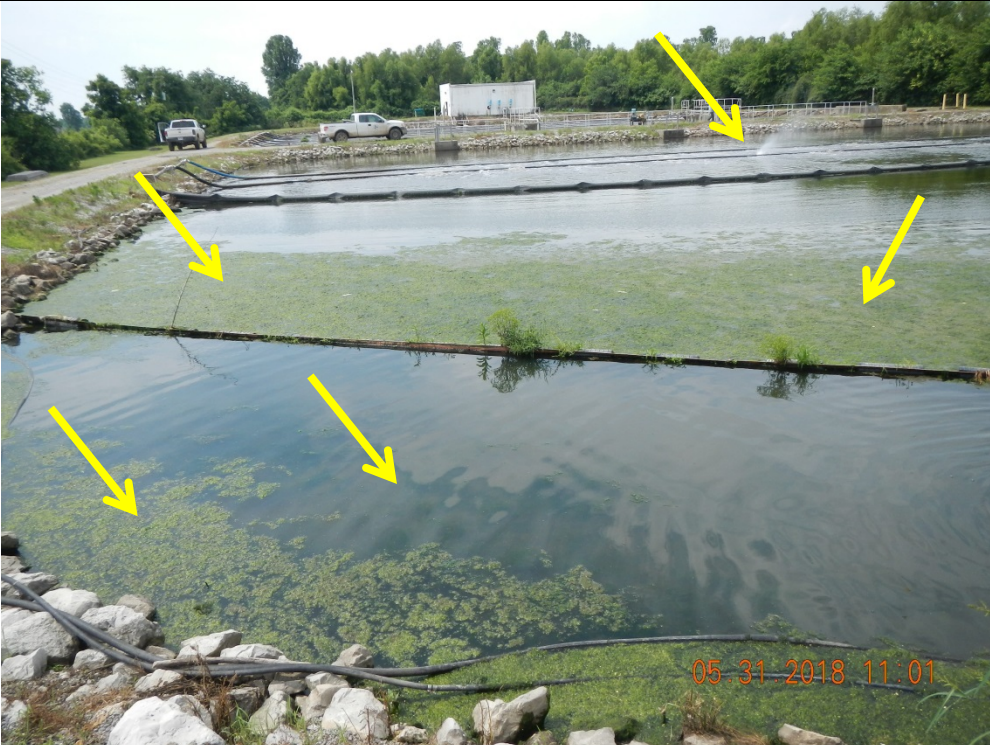
5. There was an extensive accumulation of sludge in the polishing pond. This can lead to short circuiting and decreased treatment efficiency. Furthermore, there was a large amount of floating solids/algae on the surface of the polishing pond near the outlet.

Photographer:	<b>Brent Walker</b>	Date:	<b>5/31/2018</b>
Witness:	<b>None</b>	Time:	<b>1101</b>
		Photo #:	<b>10</b>
Description:	<b>Overview of polishing pond. Note wastewater spray due to air leaks and/or damaged diffusers. Also note floating solids/algae and submerged accumulated solids/sludge.</b>

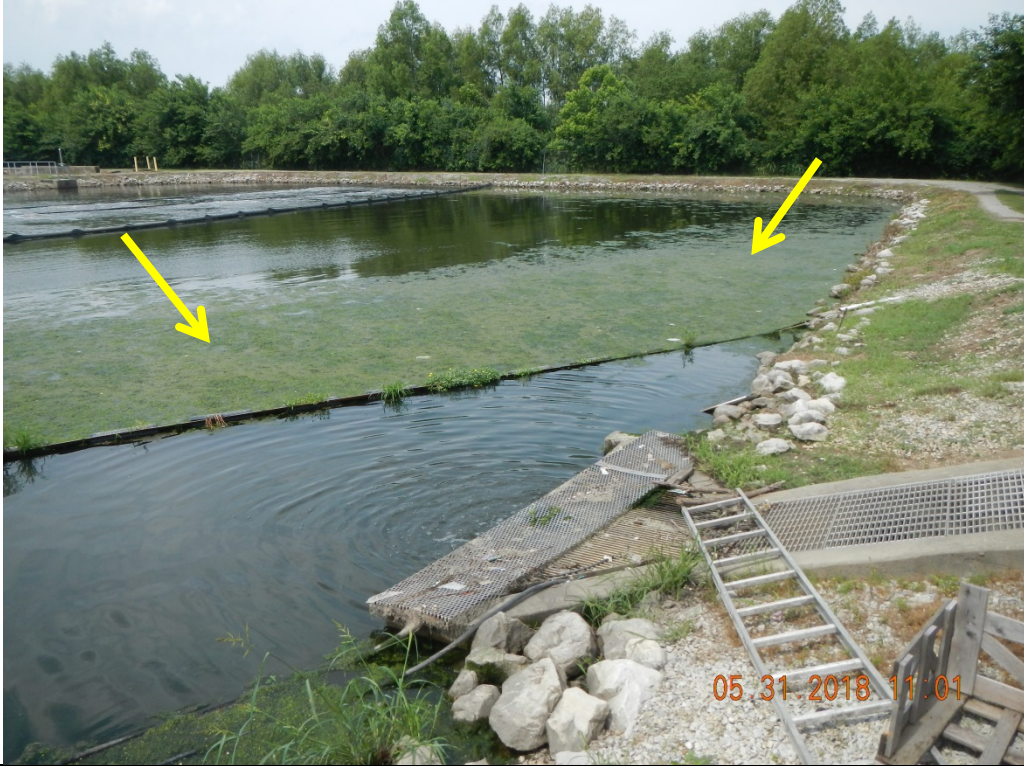
Location:	<b>Blytheville – West WWTP</b>		
Photographer:	<b>Brent Walker</b>	Date:	<b>5/31/2018</b>
Witness:	<b>None</b>	Time:	<b>1101</b>
		Photo #:	<b>11</b>
Description:	<b>Overview of polishing pond. Note floating solids/algae.</b>

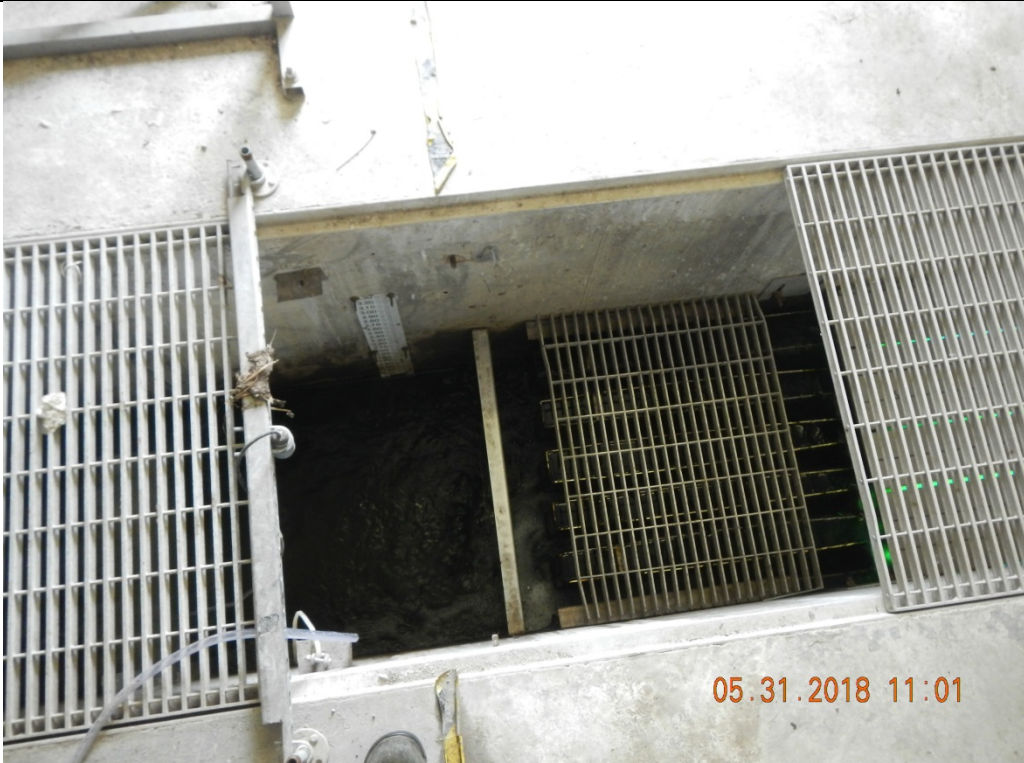
Photographer:	<b>Brent Walker</b>	Date:	<b>5/31/2018</b>
Witness:	<b>None</b>	Time:	<b>1101</b>
		Photo #:	<b>12</b>
Description:	<b>Effluent channel with UV disinfection equipment and flow transducer.</b>

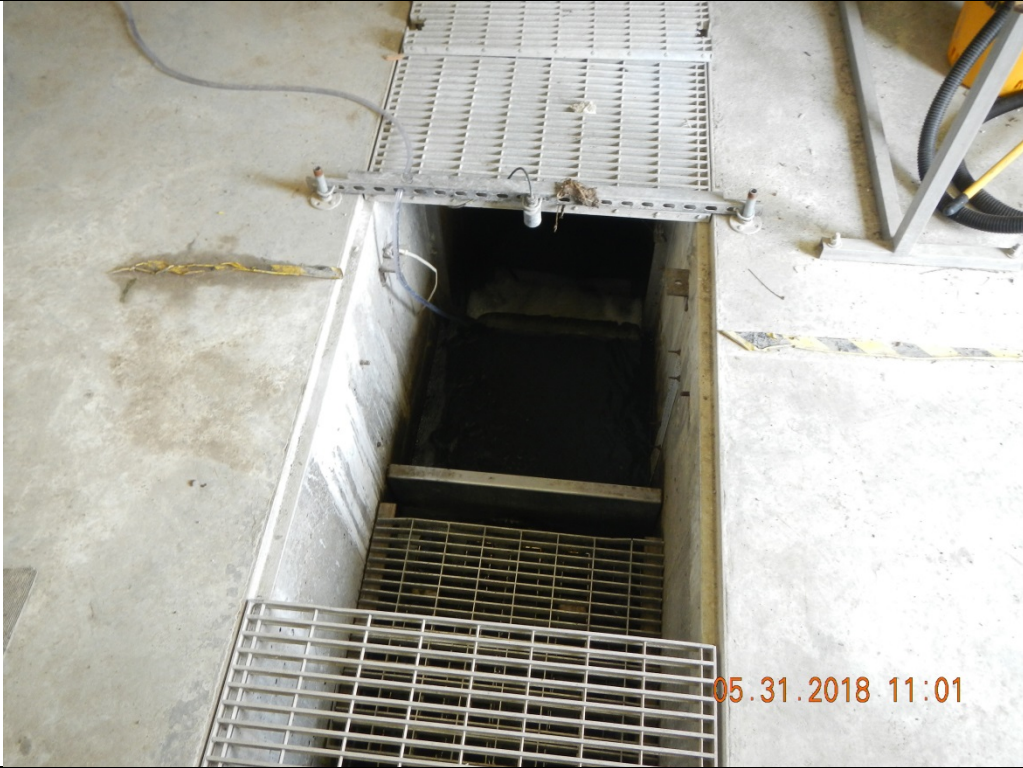
Location:	<b>Blytheville – West WWTP</b>		
Photographer:	<b>Brent Walker</b>	Date:	<b>5/31/2018</b>
Witness:	<b>None</b>	Time:	<b>1101</b>
		Photo #:	<b>13</b>
Description:	<b>Effluent channel with UV disinfection equipment, flow transducer and weir.</b>

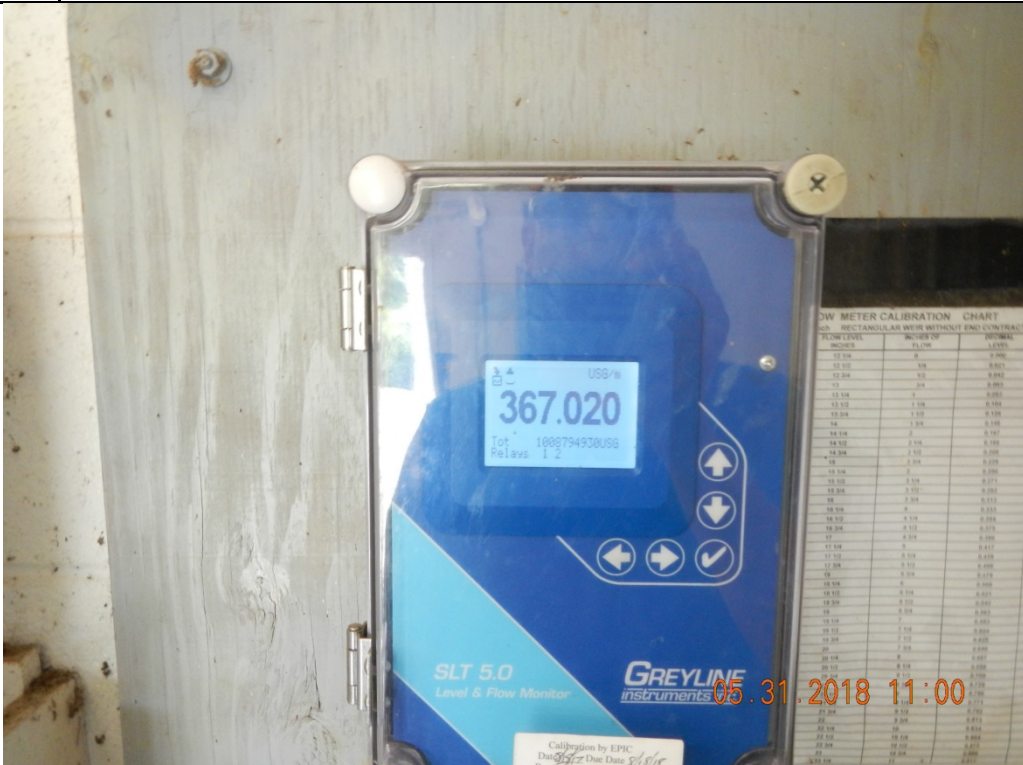
Photographer:	<b>Brent Walker</b>	Date:	<b>5/31/2018</b>
Witness:	<b>None</b>	Time:	<b>1100</b>
		Photo #:	<b>14</b>
Description:	<b>Effluent flowmeter. Effluent flow was 367 GPM or 0.528 MGD.</b>
