RE: Quarterly Inspection conducted on April 22, 2019
AFIN 18-00094
Permit Number 0245-S1-R2

Class 1 Landfill Inspection

Site Name	Crittenden County Class 1	County	Crittenden	AFIN	18-00094
Facility Address	1299 Khun Rd. West Memphis, AR 72301	Phone Number	LF: 870-732-4290 Off: 870-732-6580	Permit Number	0245-S1-R2
Permittee Address	Crittenden Co. Judge	E-Mail Address	arredllc@swb.net	PDS #	107595
Date	4/22/2019	Entry Time	1030	Exit Time	1240

Arkansas Department of Environmental Quality (ADEQ)
Official Photograph Sheet

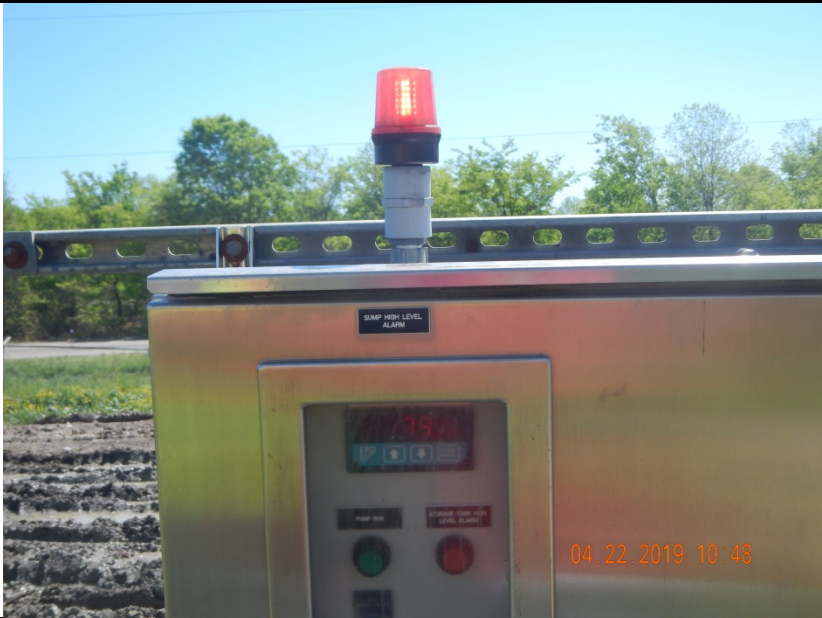
Category 2 (continued)													
Regulation	Item Description					Comments							
	427	Surface Water Controls											
	411(h)(1)	Contouring prevents surface water flowing into or through waste											
	418(a)(b)	Run-on/off control system present and adequate											
	411(h)(2)	Surface water control prevents off-site sediment accumulation											
	411(i);427(f)	Adequate maintenance of intermediate/final cover vegetation											
	415	Gas monitoring program											
X	411(o)	Leachate leaks or evidence of leachate seepage					Leachate leaks observed in Cell 1A. (Refer to Photo #4.)						
	426	Survey controls											
X	429	Leachate collection system					Hi level alarm light observed flashing at leachate pump control panel in Cell 2A which read 79.0" and at the leachate control panel in Cell 1A which read 85.0".(Refer to Photo #1, - #3.)						
	420	Liquid Restrictions											
Category 3

Location	Crittenden Co. Class 1 Landfill			Permit	0245-S1-R2	AFIN	18-00094
Photographer	Tobin Baker, ADEQ Solid Waste Inspector		<i>TB</i>	Witness	N/A		
Photo #	1	Of	4	Date	4/22/2019	Time	1048
Description	Hi level alarm light observed flashing at leachate pump control panel in Cell 2A, which read 79".

You should immediately initiate all actions necessary to resolve and correct the alleged violations cited in the attached report. Written notification of the corrective actions taken, or to be taken, for the alleged violations must be submitted within thirty (30) calendar days from the date of this letter to the attention of Tobin Baker. This written notification could include, but not be limited to, photographs, receipts, or analytical results, documenting correction of violations. If you have any questions, please do not hesitate to contact me at (870) 935-7221 or bakert@adeq.state.ar.us.

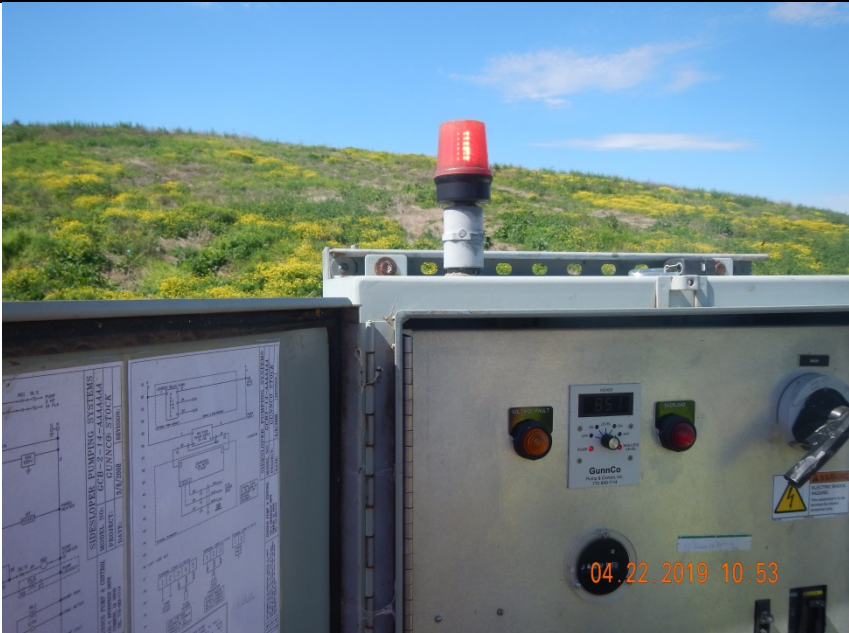
Location	Crittenden Co. Class 1 Landfill			Permit	0245-S1-R2	AFIN	18-00094
Photographer	Tobin Baker, ADEQ Solid Waste Inspector		<i>TB</i>	Witness	N/A		
Photo #	2	Of	4	Date	4/22/2019	Time	1053
Description	Hi level alarm light observed flashing at leachate pump control panel for Cell 1A.
