RE: City of Hot Springs POTW Inspections (Garland Co)

AFIN: 26-00145 NPDES Permit No.: AR0033880

inspection Report. Cit	y Oi	not oprings r	<u> </u>	1 VV, AFIN. 20-001	143, FE	:IIIIII #	. AKU	000000	
	<u>VDEO</u>		WATER	R	DIVISION I	NSP	EC.	TIO	N RE	PORT
	ADLY	AF	IN: 26-00145	Ы	ERMIT #: AR003 3	3880			DATE: 5	/15/2019
A	RKANSAS	CC	OUNTY: 26 Gar	laı	nd	PDS #	#: 108 :	323		MEDIA: WN
Dep	partment of Environmental Quality	GF	PS LAT: 34.450	31	6 LONG: -93.019	0033 L	OCAT	ION: (General .	Area
	FACILITY INFORMAT	TON			IN	SPECT	ΓΙΟΝ Ι	NFOF	RMATION	1
Cit	y of Hot Springs POTW				FACILITY TYPE: 1 - Municipal		OR ID#:	State		
	Davidson Drive				3 - Satisfactory			Con	npliance	Evaluation
Но	t Springs, AR 71901					O:10	13:		9/1/20	FECTIVE DATE:
NAME	RESPONSIBLE OFFICE: / TITLE	CIAL	<u> </u>						PERMIT EX 8/31/2	PIRATION DATE:
	nty Ledbetter / Utilities Director					01141		4		
COMP	y of Hot Springs POTW				FAYETTEVILLE	SHAL	E REL	AIEL): N	
	NG ADDRESS:				FAYETTEVILLE	SHAL	E VIO	LATIC	NS: N	
) Adams Street STATE, ZIP:				NAME/TITLE/PHONE/FAX/EMA		TON F	PARTI	CIPANT	<u>S</u>

Water Division Photographic Evidence Sheet Location: City of Hot Springs POTW Photographer: Travis Harmon Date: 5/15/20

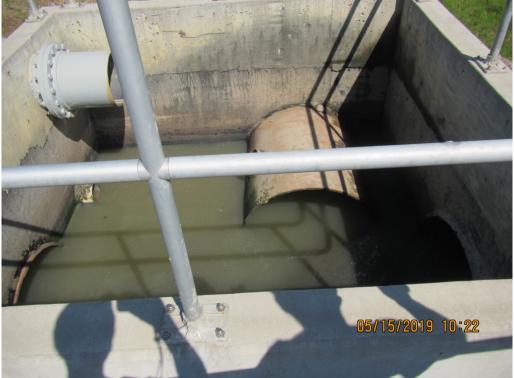
Description: Plant influent box.

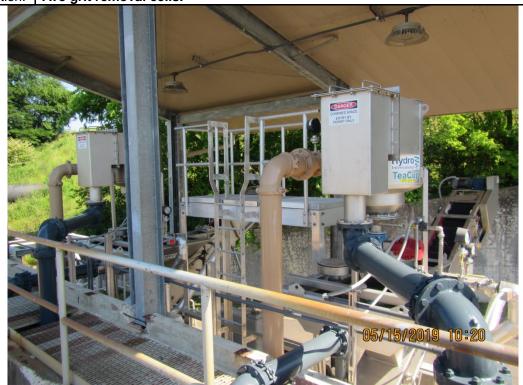
Witness:
 None
 Photo #:
 2

Description: Two grit removal cells.

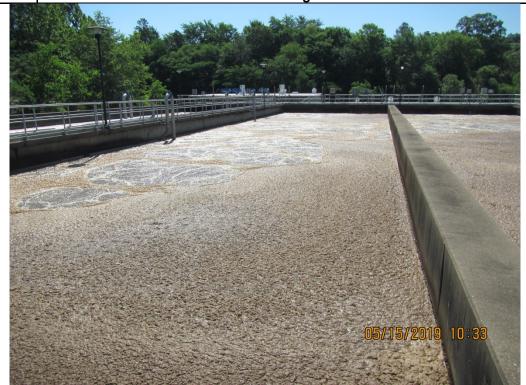
Photographer: Travis Harmon	Date:	5/15/2019	Time:	1033
Witness: None			Photo #	Ω

Description: Three aeration basins with activated sludge.

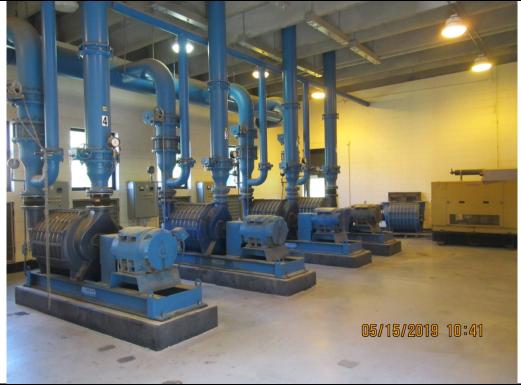
Water Division Photographic Evidence Sheet Location: City of Hot Springs POTW Photographer: Travis Harmon Date: 5/15/2019 Time: 1041 Witness: None Photo #: 11

Description: Blowers for aeration basins.

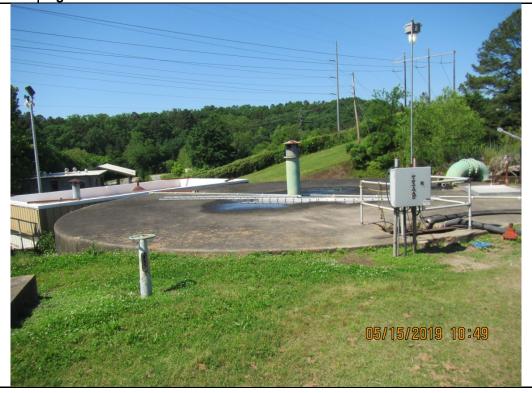
Photographer:	Travis Harmon	Date:	5/15/2019	Time:	1049
Witness: None	•			Photo #:	12

Description: Digester.

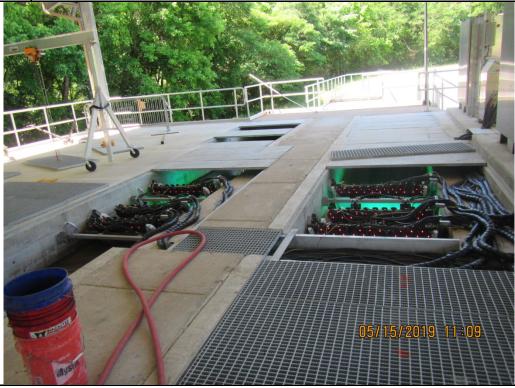
Water Division Photographic Evidence Sheet Location: City of Hot Springs POTW Photographer: Travis Harmon Date: 5/15/2019 Time: 1109 Witness: None Photo #: 15

Description: Two lines of UV disinfection.

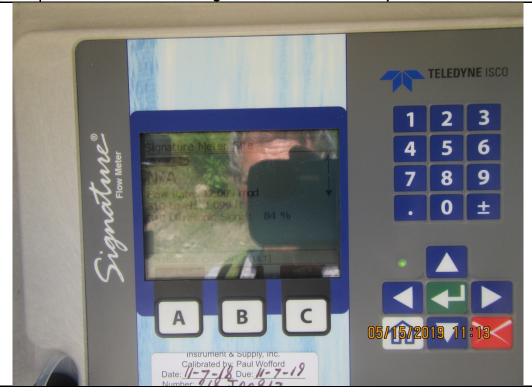
Witness:
 None
 Photo #:
 16

Description: Effluent flowmeter. Reading 12.009 MGD at time of inspection.

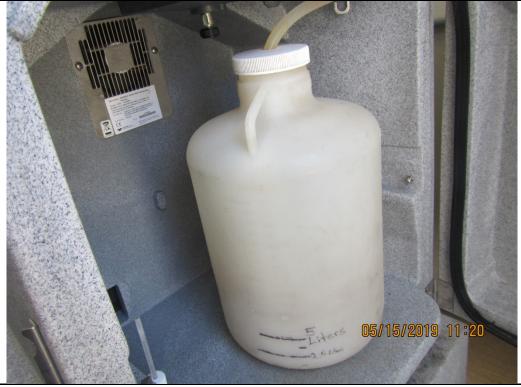
Water Division Photographic Evidence Sheet Location: City of Hot Springs POTW Photographer: Travis Harmon Date: 5/15/2019 Time: 1120 Witness: None Photo #: 17

Description: Composite sampler with thermometer.

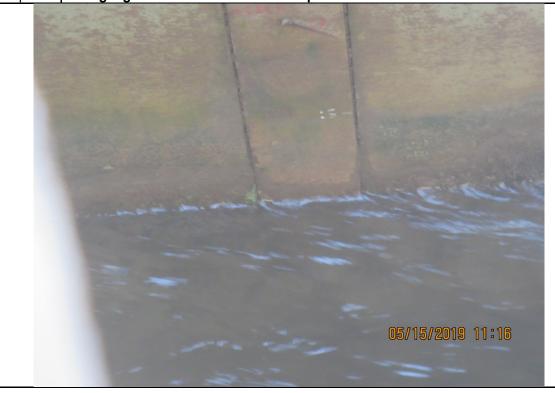
Photographer:	Travis Harmon	Date:	5/15/2019	Time:	1116
Witness: None				Photo #	18

- A diffuser line in the middle aeration basin needs repair (see Photo 9).
 - Excessive algae are present in secondary clarifiers (see Photo 10).
 - The staff gauge at the Parshall flume is not readable and should be cleaned or replaced (see Photo 18).

7.	IF MONITORING IS PERFORMED MORE OFTEN THAN REQUIRED ARE RESULTS REPORTED ON THE DMR:	□y □n ☑na □ne
SE	CTION E: FLOW MEASUREMENT	
PE	RMITTEE FLOW MEASUREMENT MEETS PERMIT REQUIREMENTS	□S ☑M □U □NA □NE
DE	TAILS: Flume staff gauge needs replaced.

1.	PRIMARY FLOW MEASUREMENT DEVICE PROPERLY INSTALLED AND MAINTAINED: TYPE OF DEVICE: 4 ft. Parshall F	lume □Y ☑N □NA □NE
2.	FLOW MEASURED AT EACH OUTFALL AS REQUIRED:	Øy □n □na □ne

Description: Staff gauge at Parshall flume needs replaced.

• Staff Gauge Cleaned/ in Effluent Flow

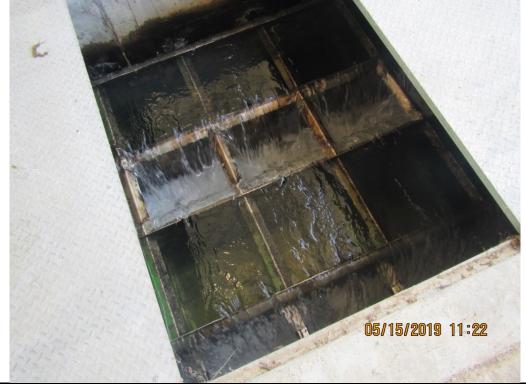
Water Division Photographic Evidence Sheet Location: City of Hot Springs POTW Photographer: Travis Harmon Date: 5/15/2019 Time: 1122 Witness: None Photo #: 19

Description: Final effluent appears sufficiently treated at the time of inspection.

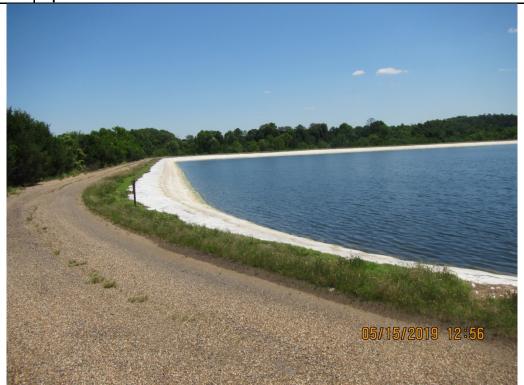
Photographer: Travis Harmon	Date: 5/15/2019	Time:	1256
Witness: None		Photo #	: 20

Description: **Equalization basin.**
