RE: NLR Faulkner Lake Plant Inspection

AFIN: 60-00274 Permit No.: AR0020303

WATER DIVISION INSPECTION REPORT

Inspection Report: NLR Faulkner Lake Plant, AFIN: 60-00274, Permit #: AR0020303

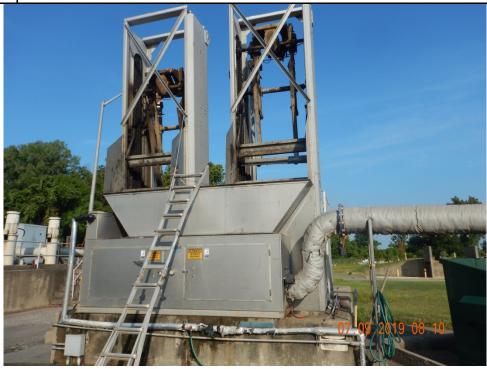
Water Division Photographic Evidence Sheet									
Location:	NLR	Faulkner Lake Plant								
Photograp	her:	Jason Bolenbaugh	Date:	7/9/2019	Time:	08:10				
Witness:					Photo #:	1

Description: Bar screen

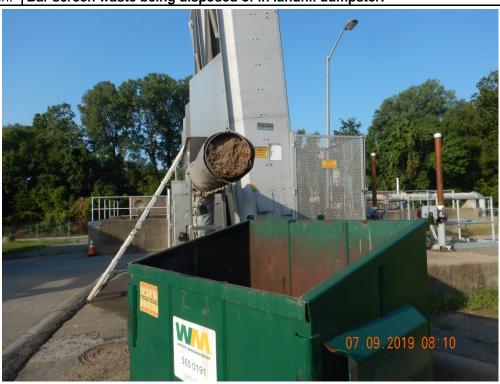
Photograph	er: Jason Bolenb	augh		Date:	7/9/2019	Time:	08:1
Witness:						Photo #	
	_

Description: Bar screen waste being disposed of in landfill dumpster.

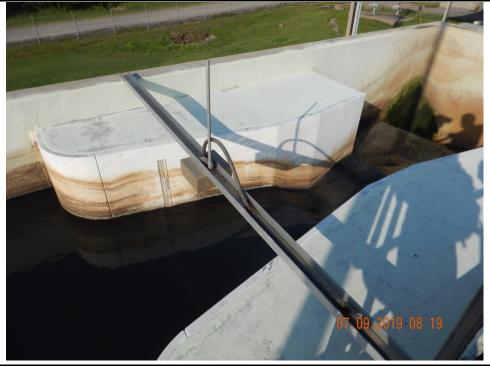
Water Division Photographic Evidence Sheet						
Location:	NLR	Faulkner Lake Plant				
Photograph	ner:	Jason Bolenbaugh	Date:	7/9/2019	Time:	08:19
Witness:					Photo #	# : 5

Description: Influent parshall flume.

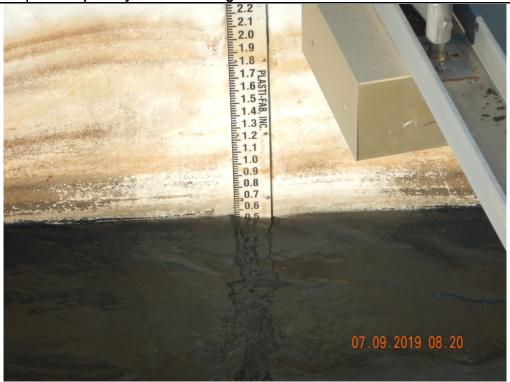
Photographer:	Jason Bolenbaugh	Date:	7/9/2019	Time:	08:20
Witness:				Photo #:	6

Description: Influent primary flow measuring device.

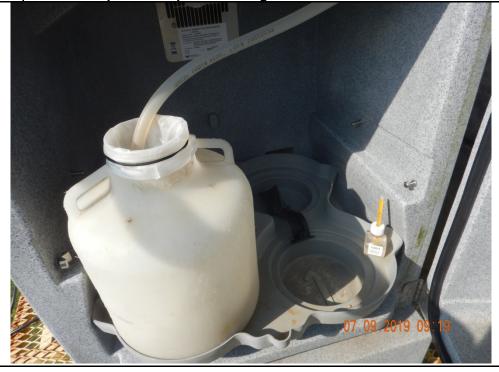
Water Division Photographic Evidence Sheet Location: NLR Faulkner Lake Plant Photographer: Jason Bolenbaugh Date: 7/9/2019 Time: 09:19 Witness: Photo #: 7

Description: Influent composite sampler was refrigerated at -1.7° C.

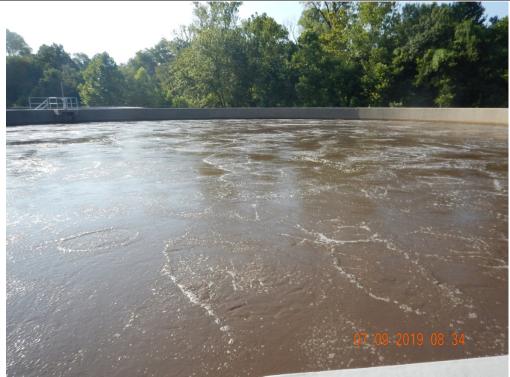
Photographer:	Jason Bolenbaugh	Date:	7/9/2019	Time:	08:34
Witness:				Photo #:	8

Description: Aeration Basin 1.

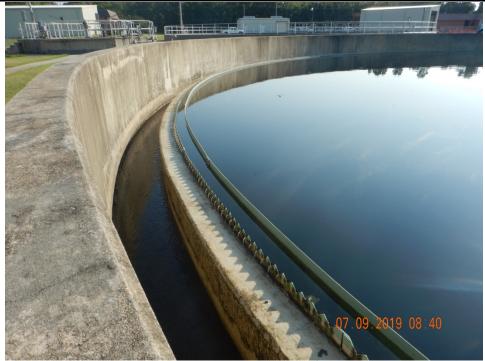
Water Division Photographic Evidence Sheet Location: NLR Faulkner Lake Plant Photographer: Jason Bolenbaugh Witness: Photo #: 11

Description: Clarifier 2 well maintained.

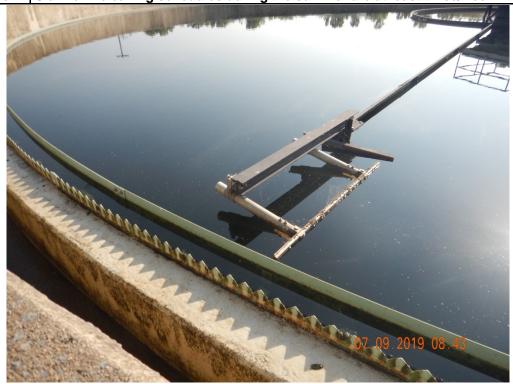
Photographer:Jason BolenbaughDate:7/9/2019Time:08:43Witness:Photo #:12

Description: Clarifier 2 cleaning schedules during the summer are at least twice/week.

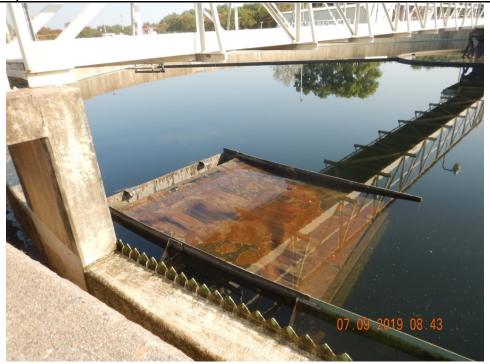
Water Division Photographic Evidence Sheet Location: NLR Faulkner Lake Plant Photographer: Jason Bolenbaugh Date: 7/9/2019 Time: 08:43 Witness: Photo #: 13

Description: Clarifier 2

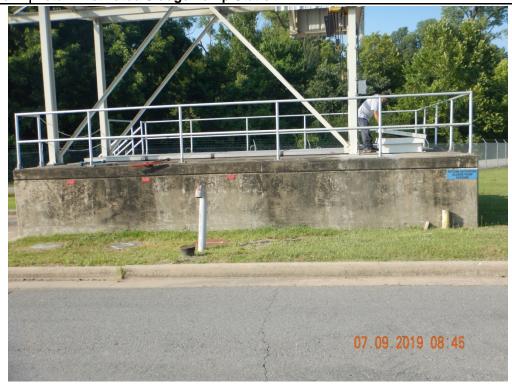
Photographer:Jason BolenbaughDate:7/9/2019Time:08:45Witness:Photo #:14

Description: Return Activated Sludge Pump Station

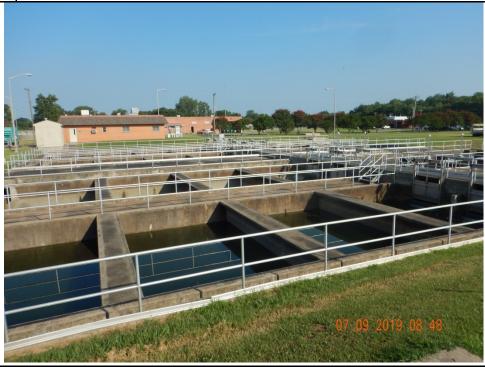
Water Division Photographic Evidence Sheet						
Location: I	NLR	Faulkner Lake Plant				
Photograph	er:	Jason Bolenbaugh	Date:	7/9/2019	Time:	08:48
Witness:					Photo #:	15

Description: Chlorine Contact Chamber

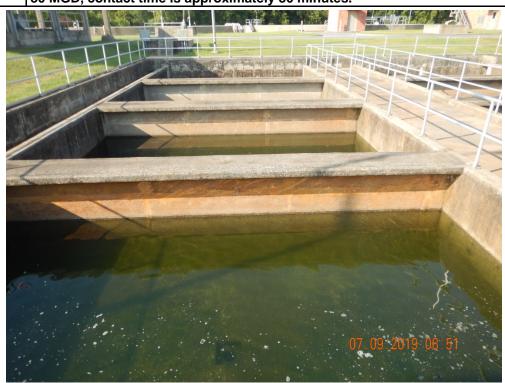
Photographer	: Jason Bolenbaugh	Date:	7/9/2019	Time:	08:51
Witness:				Photo #:	16
Description:	One of eight chlorine contact cha	mbers. If all	eight are in operation a	and the fl	low is

Description: One of eight chlorine contact chambers. If all eight 30 MGD, contact time is approximately 30 minutes.

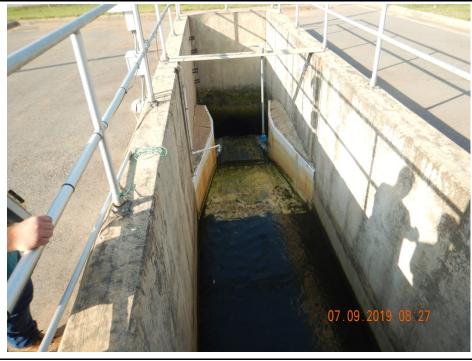
Water Division Photographic Evidence Sheet Location: NLR Faulkner Lake Plant Photographer: Jason Bolenbaugh Date: 7/9/2019 Time: 08:27 Witness: Photo #: 17

Description: Effluent discharge through a 4' Parshall Flume.

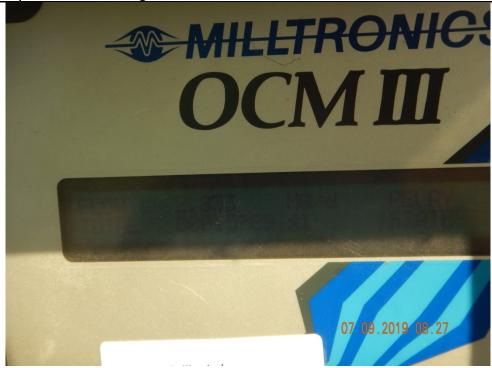
Photographer:	Jason Bolenbaugh	Date:	7/9/2019	Time:	08:27
Witness:				Photo #	: 18

Description: Flow meter reading of 2.853 MGD.

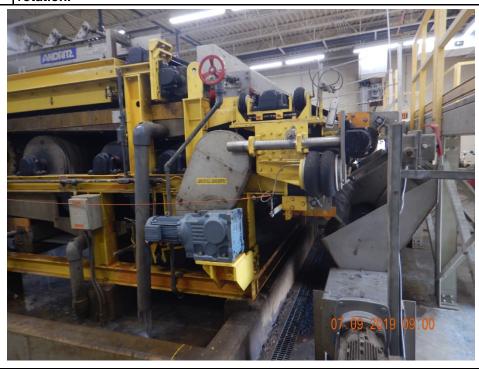
Water Division Photographic Evidence Sheet					
Location:	NLR Faulkner Lake Plant				
Photograph	ner: Jason Bolenbaugh	Date:	7/9/2019	Time:	09:00
Witness:				Photo #	: 21
Description: One of two sludge belt presses. Operation of the belt presses are on a monthly rotation.

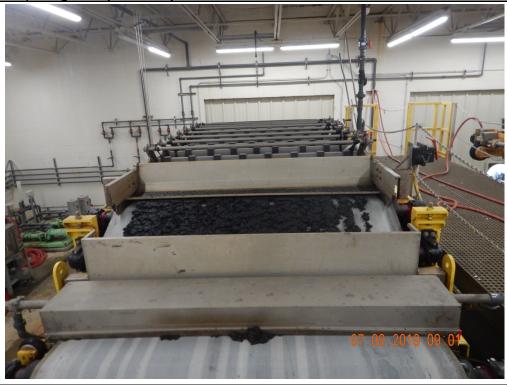
Witness: Photo #: 22	Photographer:	Jason Bolenbaugh	Date:	7/9/2019	Time:	09:01
	Witness:				Photo #

Description: Sludge belt press in operation.

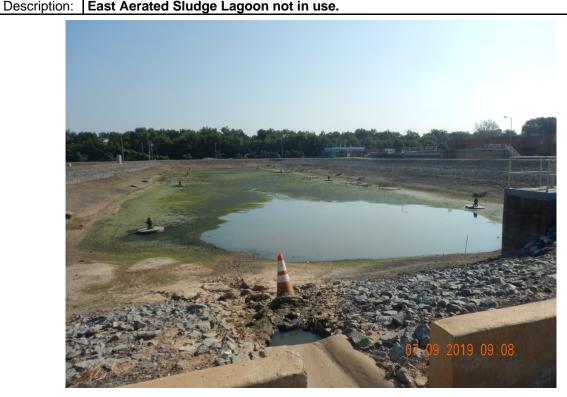
Photographer	: Jason Bolenbaugh	Date:	7/9/2019	Time:	09:08
Witness:				Photo #	#: 24
Description:	East Agrated Cludge Lagger r	ot in use

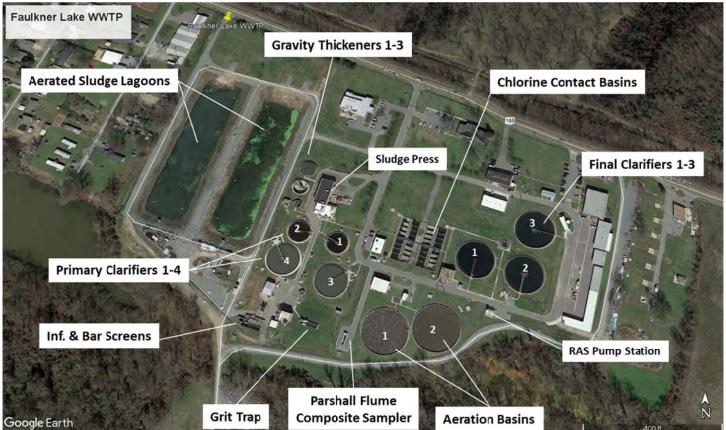
Location: NLR Faulkner Lake Plant
Photographer: Jason Bolenbaugh Date: 7/9/2019 Time: 09:09
Witness: Photo #: 25

Description: West Aerated Sludge Lagoon in operation.
