RE: Quarterly Inspection conducted on August 29, 2019
AFIN 03-00051
Permit Number 0249-S1-R2

**Arkansas Division of Environmental Quality
Office of Land Resources - Solid Waste Management
Class 1 Landfill Inspection**

Site Name	NABORS Class 1 Landfill	County	Baxter	AFIN	03-00051
Facility Address	Hwy 5 N to CR 16 to site entrance- Three Brothers	Phone Number	870-425-3213	Permit Number	0249-S1-R2
Permittee Address	P.O. Box 1715, Mountain Home, AR 72602	E-Mail Address		PDS #	109199
Date	8/29/2019	Entry Time	1029	Exit Time	1135

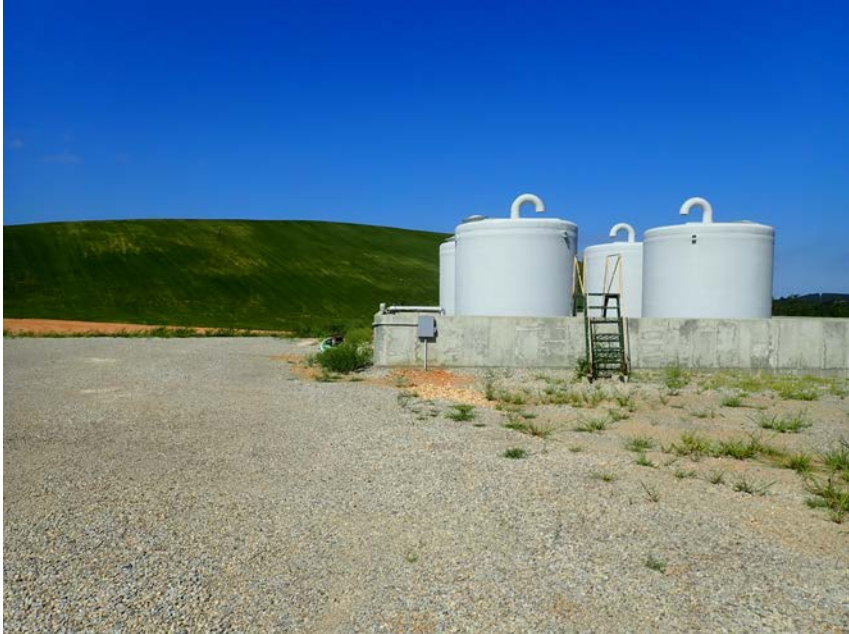
Location	NABORS Class 1			Permit	0249-S1-R2	AFIN	03-00051
Photographer	Darrell Norton, ADEQ Solid Waste Inspector		<i>DN</i>	Witness	N/A		
Photo #	1	Of	6	Date	8/29/2019	Time	1045
Description	The tank farm and secondary containment unit, with the east slope of Area 1-2 in the background.

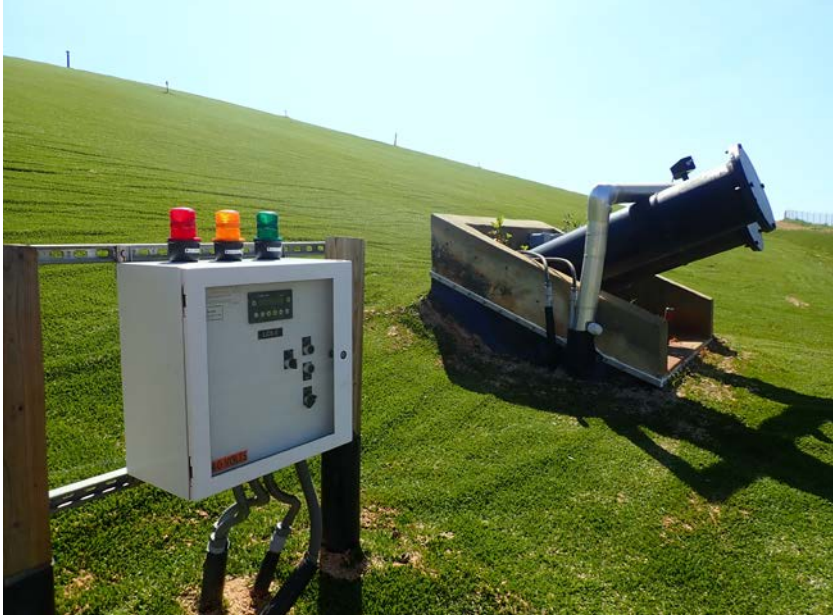
Regulation	Item Description	Comments
427	Surface Water Controls	
411(h)(1)	Contouring prevents surface water flowing into or through waste	
418(a)(b)	Run-on/off control system present and adequate	
411(h)(2)	Surface water control prevents off-site sediment accumulation	
411(i);427(f)	Adequate maintenance of intermediate/final cover vegetation	
415	Gas monitoring program	
411(o)	Leachate leaks or evidence of leachate seepage	
426	Survey controls	
429	Leachate collection system	Multiple leachate panel alarms activated at the time of the inspection. Alarms activated on the west side of Area 1-3 (LCS-5) and on the southeast corner of Area 1-2 (LCS-2). Alarm light also activated on VLCS-1.
420	Liquid Restrictions

Location	NABORS Class 1			Permit	0249-S1-R2	AFIN	03-00051
Photographer	Darrell Norton, DEQ Solid Waste Inspector		<i>DN</i>	Witness	N/A		
Photo #	2	Of	6	Date	8/29/2019	Time	1049
Description	LCS-5 with active alarm on the west slope of Area 1-3.
