RE: City of Bentonville WWTP Inspection

AFIN: 04-00154 Permit No.: AR0022403

SUMMARY OF FINDINGS

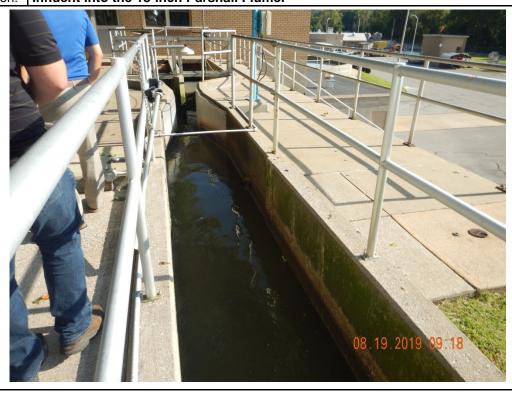
Water Division Photographic Evidence Sheet								
Location: C	Location: City of Bentonville WWTP							
Photographe	Photographer: Jason Bolenbaugh Date: 8/19/2019 Time: 09:18							
Witness:	Witness: Photo #: 1							
Description:	Posserintion: Influent into the 19 inch Perchall Flums

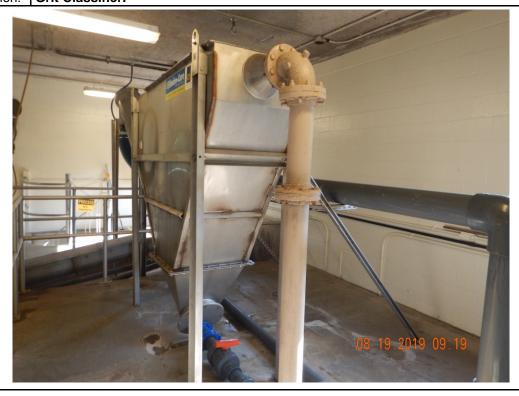
Water Division Photographic Evidence Sheet							
Location:	Location: City of Bentonville WWTP							
Photograp	Photographer: Jason Bolenbaugh Date: 8/19/2019 Time: 09:19							
Witness:	Witness: Photo #: 3							
Description	n· (Prit Classifier

- The permittee was and continues to conduct significant maintenance to the facility's treatment units. For example, rehabilitation of Secondary Clarifier #1 was in the final stages of completion during the inspection; the grit classifier was replaced in 2019; the sludge belt press was replaced with a more efficient sludge dewatering press; a new panel board was installed in a closed area to prevent H₂S corrosion; and, future projects that were to begin in October consisted of changing diffusers and replacing the rotors assembly in the oxidation ditches.

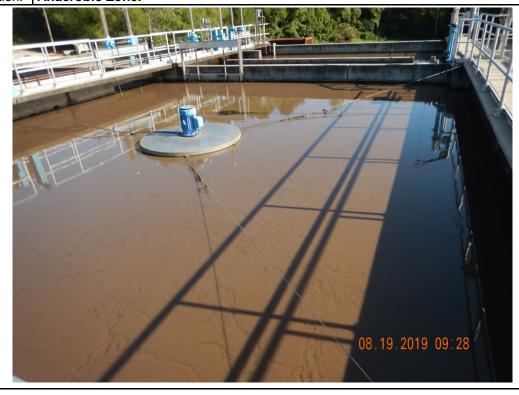
Water Division Photographic Evidence Sheet							
Location: (City of Be	ntonville WWTP						
Photographo	Photographer: Jason Bolenbaugh Date: 8/19/2019 Time: 09:28							
Witness:	Witness: Photo #: 5							
Description:	Angero	hic Zone

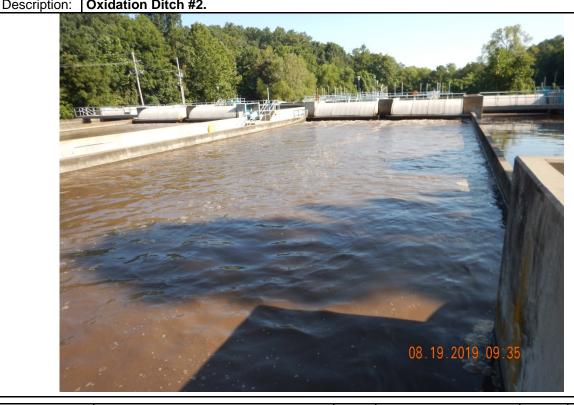
Water Division Photographic Evidence Sheet							
Location:	City	of Bentonville WWTP						
Photograph	Photographer: Jason Bolenbaugh Date: 8/19/2019 Time: 09:35							
Witness:	Witness: Photo #: 7							
Docorintion	. [Vidation Ditab #2

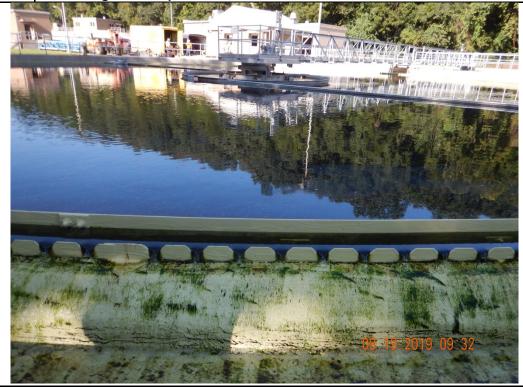
Photographer:Jason BolenbaughDate:8/19/2019Time:09:32Witness:Photo #:8

Description: Secondary Clarifier #2. Permittee will scrub each clarifier at least once per week to remove algae buildup.

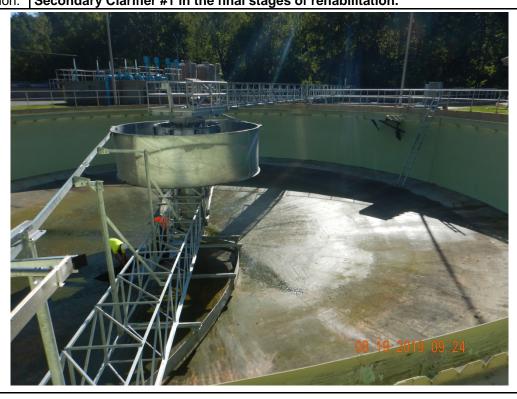
Water Division P	hotographic Evi	dence Sheet		
Location: C	ity of Bentonville WWTP				
Photographe	er: Jason Bolenbaugh	Date:	8/19/2019	Time:	09:24
Witness:				Photo #:	9
Description:	Secondary Clarifier #1 in the f	inal stages of re	habilitation

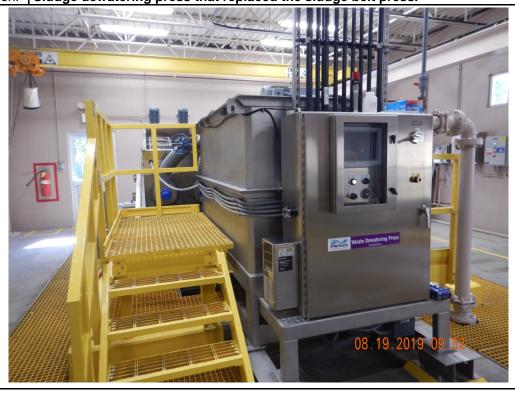
Water Division Ph	notographic Evi	dence Sheet		
Location: C	ity of Bentonville WWTP				
Photographe	r: Jason Bolenbaugh	Date:	8/19/2019	Time:	09:52
Witness:				Photo #	# : 13
Description:	Sludge dewatering press that	replaced the slu	idge belt press.

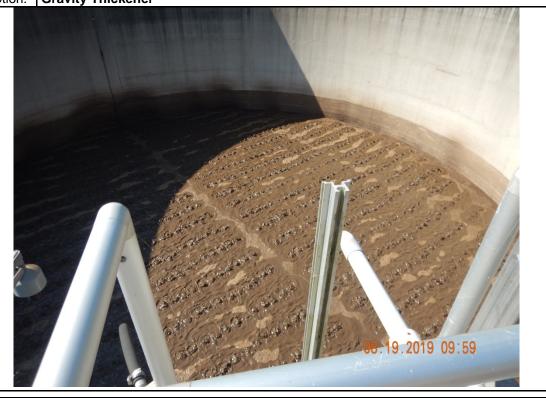
Water Divis	sion Photographic Evi	dence Sheet		
Location:	City	of Bentonville WWTP				
Photograpl	her:	Jason Bolenbaugh	Date:	8/19/2019	Time:	09:59
Witness:					Photo #	<i>‡</i> : 15
Description	n: G	Fravity Thickener
