RE: City of West Memphis WWTP Inspection

AFIN: 18-00879 Permit No.: AR0022039 & ARR00C405

On August 14, 2019, I performed Compliance Evaluation, SSO/Collection System, and Industrial Stormwater Inspections of the above referenced facility in accordance with the provisions of the Federal Clean Water Act, the Arkansas Water and Air Pollution Control Act, and the regulations promulgated thereunder. Copies of the inspection reports are enclosed for your records.

Re: City of West Memphis WWTP Inspection

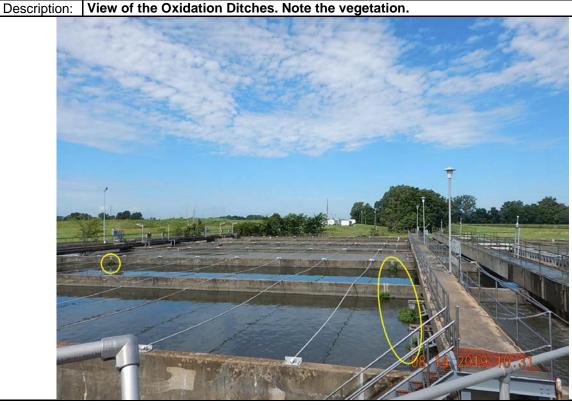
Photographer:Sarah FrasherDate:8/14/2019Time:10:38Witness:NonePhoto #:6

- 1. Vegetation was observed growing in the Oxidation Ditches (Photos 4-6).
- 2. Accumulation of algae in the northwest and southwest Clarifier weirs (Photo 12 and 15-16).
- 3. Vegetation was observed growing in the southwest Clarifier (Photos 13-14).

Description: View of the Oxidation Ditches. Note the residue from the influent overflow and the vegetation.

Vegetation was removed from the Oxidation Ditches. Currently, we are using Roundup. We will look for another product to use.

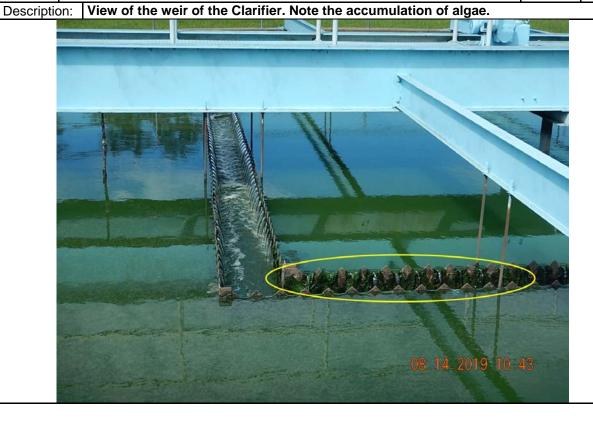
Witness: None Photo #: 13

Description: View of the southwest Clarifier. Note the vegetation.

- **2.** Accumulation of algae in the northwest and southwest clarifier weirs. We will perform routine cleaning program on the weirs.
- **3. Vegetation was observed growing in the southwest clarifier.**Vegetation was removed. Will establish a cleaning program to monitor plant growth throughout the plant site.

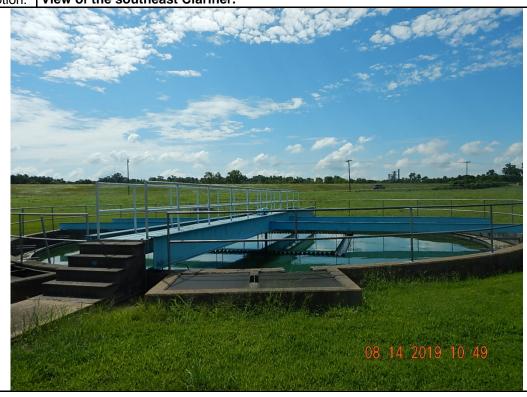
Description: View of the southeast Clarifier.

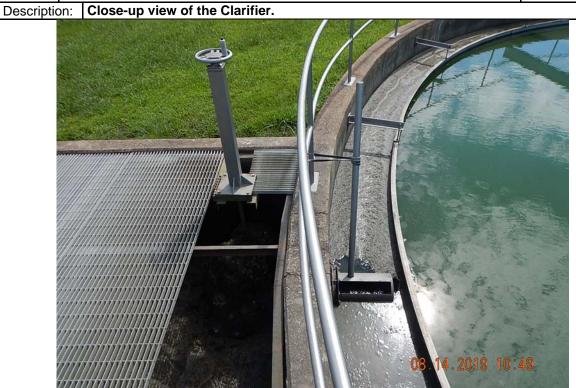
Description: View of the weir of the Clarifier.

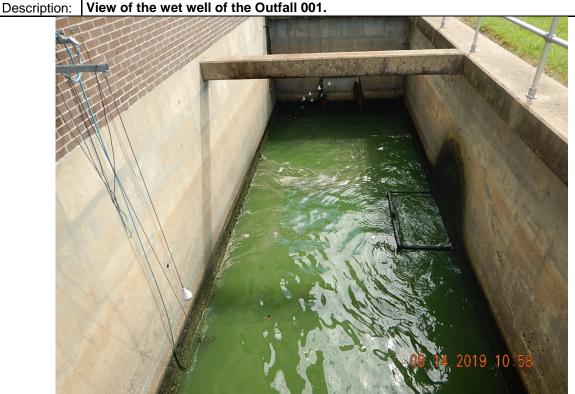
Photographer:Sarah FrasherDate:8/14/2019Time:10:58Witness:NonePhoto #:24

Description: View of the wet well for the Outfall 001. Note the pump has been turned on.

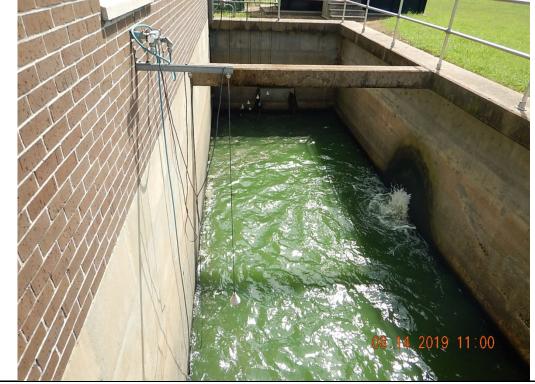
Photographer:Sarah FrasherDate:8/14/2019Time:11:09Witness:NonePhoto #:26

Some high vegetation was observed near the EQ Basin levee that should be controlled (Photos 26-27). Mr. Holloway reported that Roundup® was used on vegetation around the plant. He was informed to discontinue use where it has the reasonable potential to contaminate the wastewater treatment system.

Description: View of the EQ Basin. Note the vegetation.

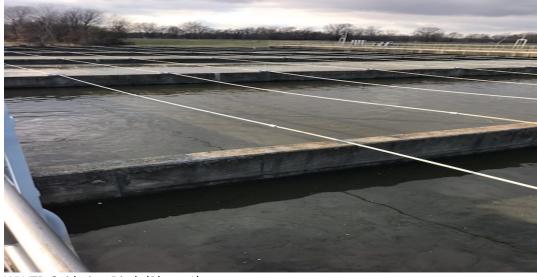
WWTP-Oxidation Ditch (Photo 1)

1. Vegetation was observed growing in the Oxidation Ditches.

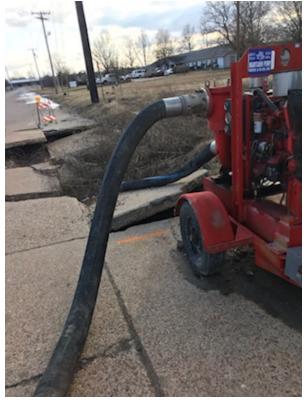
Collection System-Woods (Photo1)

The hose used for the line collapse on Woods Street had a hole in it that was resulting in an unpermitted discharge of untreated wastewater, in violation of A.C.A. 8-4-217(b)(1).

Leaking hose on the discharge side of the pump on Woods street. The hose was replaced the day of the inspection.
