OFFICE OF WATER QUALITY INSPECTION REPORT				
	AFIN: 61-00055	PERMIT #: AR0034835	DATE: 4/17/2020		
	COUNTY: 61 Randolph	PDS #: 112107	MEDIA: WN		
	GPS LAT: 36.25771 LONG: -90.971666 LOCATION: General Area				
FACILITY INFORMATION		INSPECTION INFORMATION			
NAME: City of Pocahontas LOCATION: Marr Creek aerial sewage line crossing CITY: Pocahontas		FACILITY TYPE: 1 - Municipal INSPECTOR ID#: 93162 S - State FACILITY EVALUATION RATING: 2 - Marginal INSPECTION TYPE: Reconnaissance			
RESPONSIBLE OFFICIAL		DATE(S): 4/17/2020 ENTRY TIME: 11:30 EXIT TIME: 12:00 PERMIT EFFECTIVE DATE: 5/1/2019 PERMIT EXPIRATION DATE: 4/30/2024			
NAME: / TITLE Bruce Brodell / Manager COMPANY: City of Pocahontas MAILING ADDRESS: 207 Highway 67 South CITY, STATE, ZIP: Pocahontas AR 72455 PHONE & EXT: / FAX: 870-892-3222 / EMAIL: bbrodell@suddenlinkmail.com		FAYETTEVILLE SHALE RELATED: N FAYETTEVILLE SHALE VIOLATIONS: N

Office of Water Quality Photographic Evidence Sheet

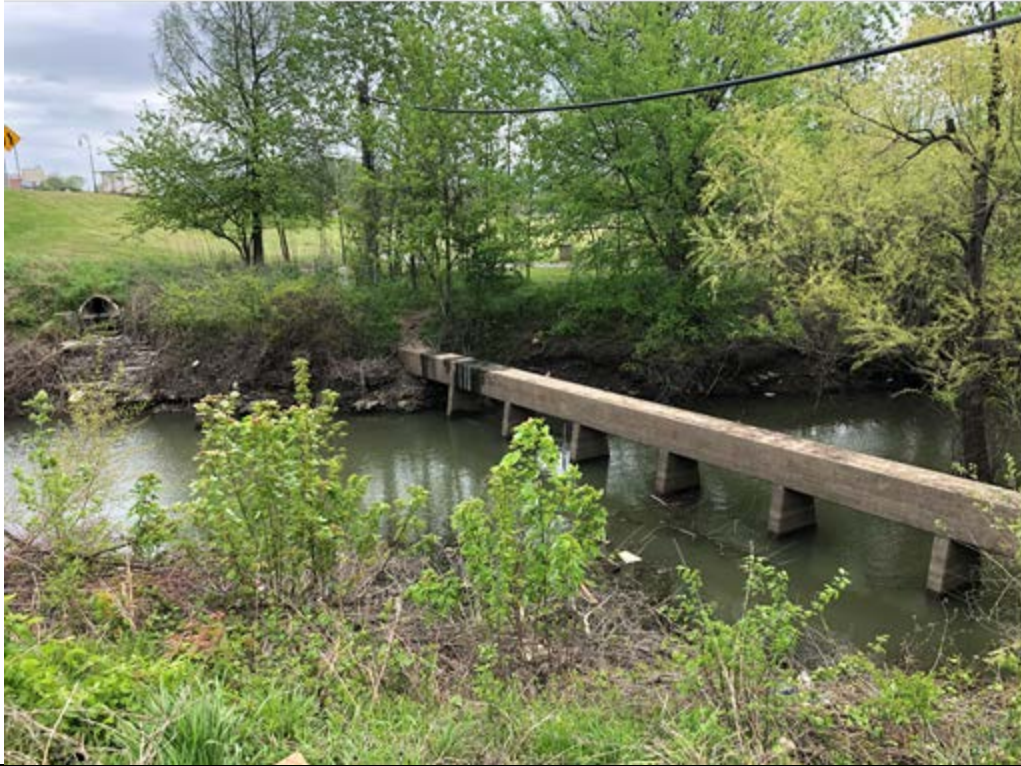
Location:	City of Pocahontas		
Photographer:	Wes Klasky	Date:	4/17/2020
Witness:	None	Time:	11:35
		Photo #:	1
Description:	View of sewer line leak from the South side of Marr Creek.

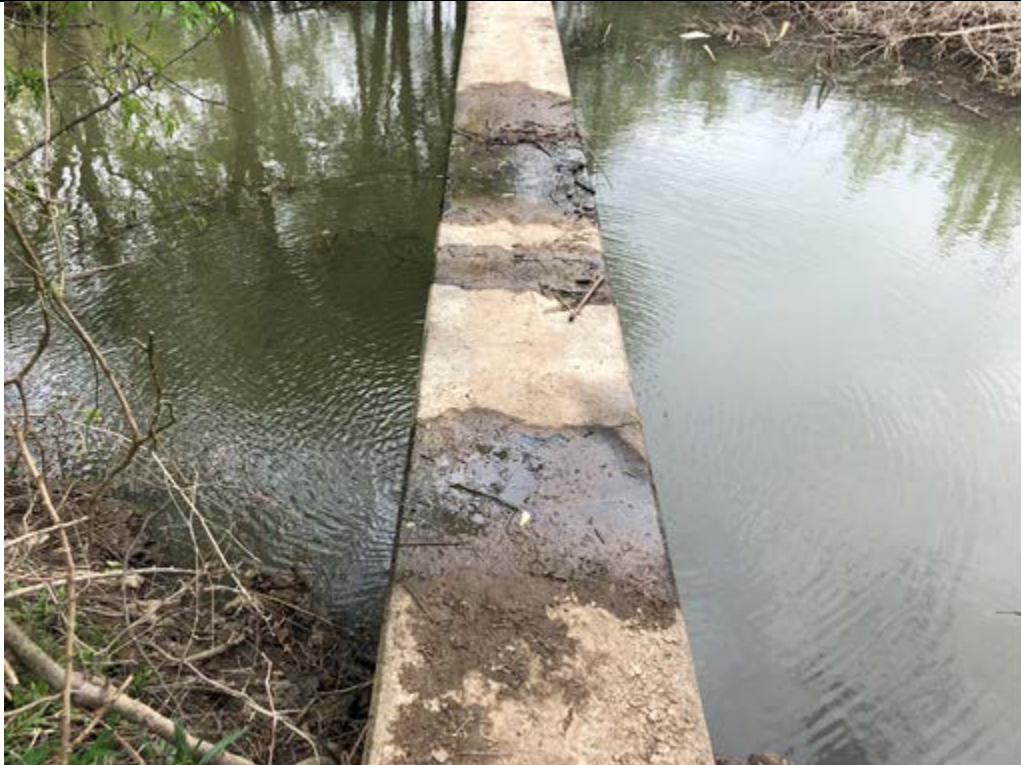
Photographer:	Wes Klasky	Date:	4/17/2020
Witness:	None	Time:	11:44
		Photo #:	2
Description:	View from North side of Marr Creek of aerial crossing and the seepage.

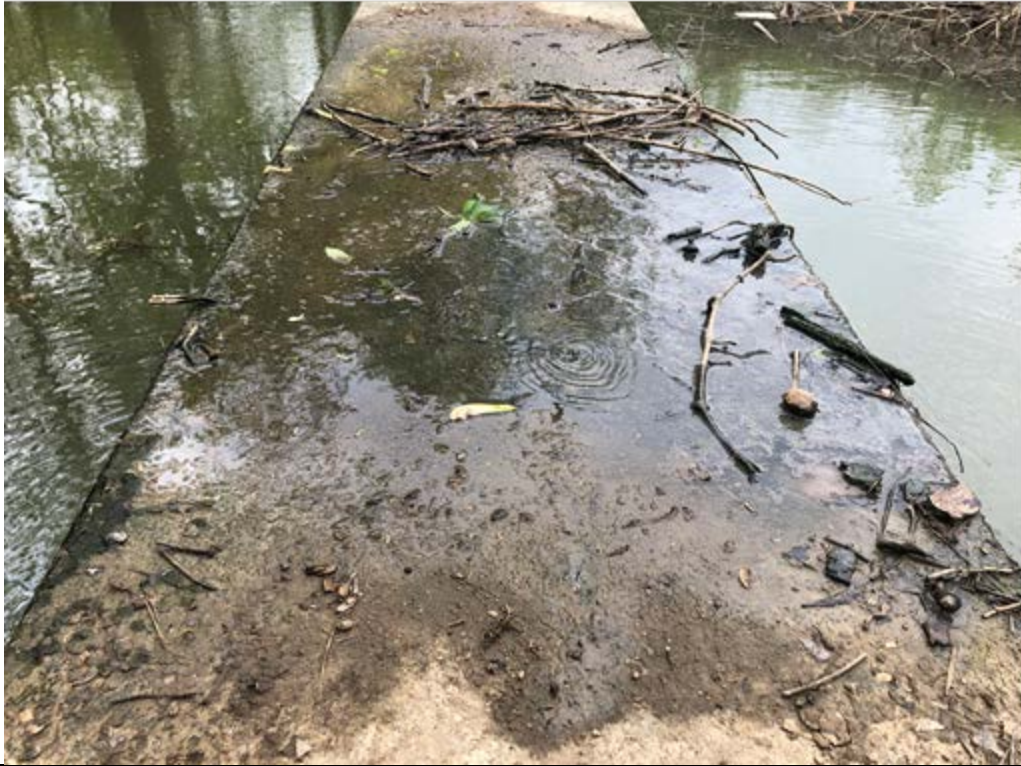
Location:	City of Pocahontas				
Photographer:	Wes Klasky	Date:	4/17/2020	Time:	11:45
Witness:	None	Photo #:	3		
Description:	Close up view of one of the seepage spots.

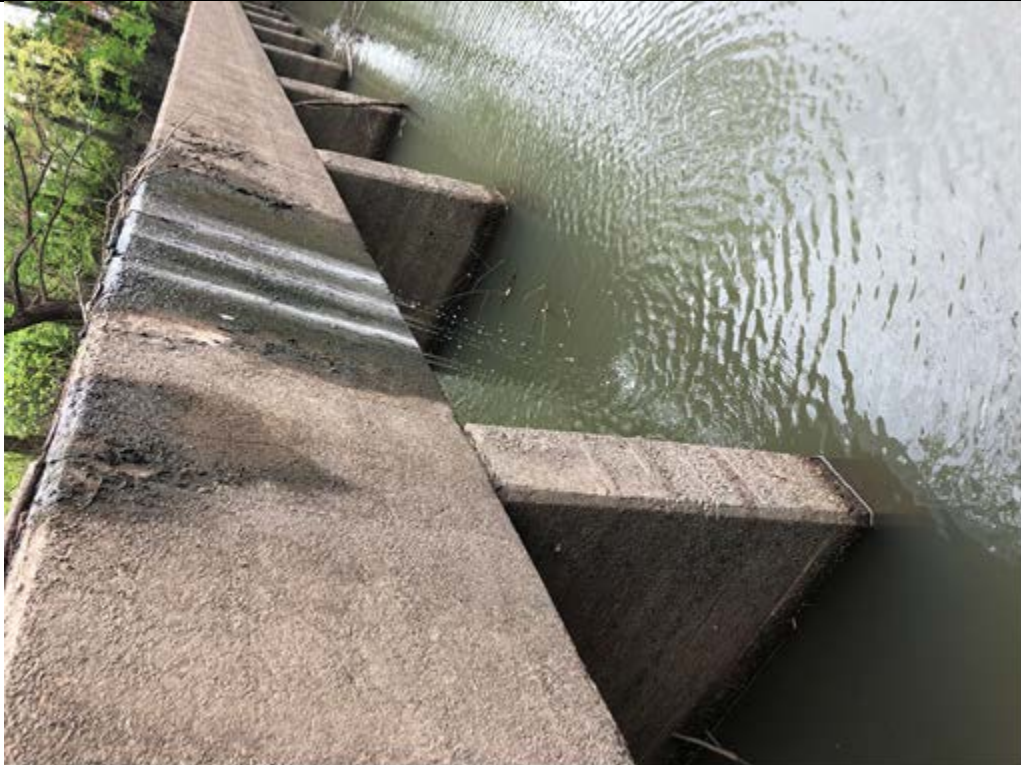
Photographer:	Wes Klasky	Date:	4/17/2020	Time:	11:54
Witness:	None	Photo #:	4		
Description:	View from the side of the structure showing active release of sewage to Marr Creek.
