RE: Georgia-Pacific Consumer Operations Inspection (Ashley Co)

AFIN: 02-00013 NPDES Permit No.: AR0001210

ADEQ		WATER	DIVISION I	NSP	ECTIO	N RE	PORT
AULU	ERMIT #: <b>AR0001210</b>			DATE:	5/20/2020		
ARKANSAS	CC	OUNTY: 02 Ashle	у	PDS 7	#: <b>112276</b>	•	MEDIA: WN
Department of Environmental Quality	GF	PS LAT: <b>33.13639</b>	3 LONG: -91.967	<b>7238</b> L	OCATION:	Entrance	9
FACILITY INFORMAT	ION		IN	ISPEC <sup>*</sup>	TION INFO	RMATIO	N
Georgia-Pacific Consumer Opera			FACILITY TYPE:  2 - Industrial		31 S - Stat	-	
100 Mill Supply Road			FACILITY EVALUATION RATIN  5 - Satisfactory	,	Cor	npliance	Evaluation
Crossett, AR			. ,	O:20	EXIT TIME: 13:02		FECTIVE DATE:
RESPONSIBLE OFFIC	CIAL		0/20/2020	0.20	10.02	11/1/2 PERMIT EX	<b>2010</b> (PIRATION DATE:
NAME: / TITLE				10/31	/2015		
Tommy D. Smith / Vice President o	FAYETTEVILLE	SHAL	E RELATEI	D: <b>N</b>			
Georgia-Pacific Consumer Operations LLC - Crossett			FAYETTEVILLE SHALE VIOLATIONS: N				
Paper Operations			INSPECTION PARTICIPANTS				
MAILING ADDRESS: P.O. Box 3333			NAME/TITLE/PHONE/FAX/EMA	AL/ETC.:

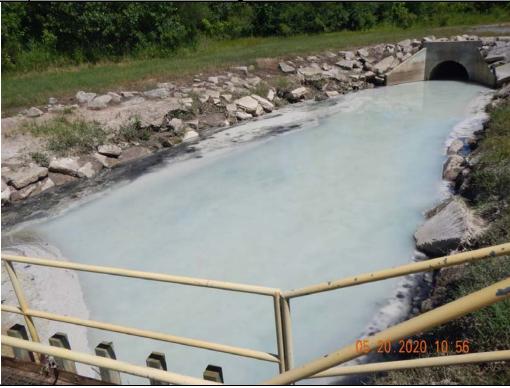
Water Division Photographic Evidence Sheet										
Location: Georgia-Pacific Consumer Opera										
Photograp	her:	Michael Yo	oung	Date:	05/20/2020	Time:	10:56			
Witness:						Photo #:	1

Description: Raw influent wastewater entering the bar screen and clarifier.

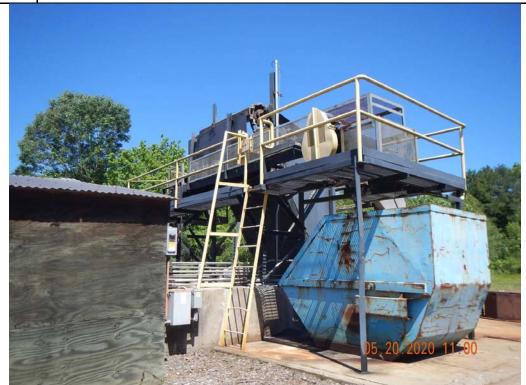
Photographer:	Michael Young	Date:	05/20/2020	Time:	11:00
Witness:				Photo #:	2

Description: Bar screen utilized on waste stream.

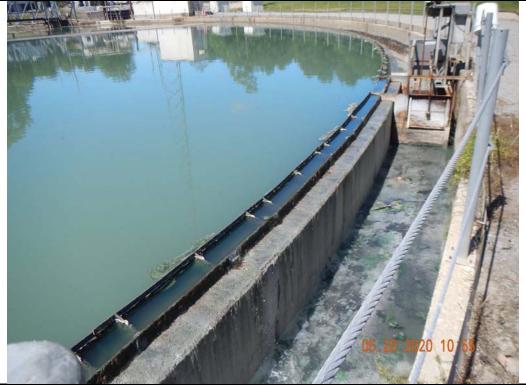
# Water Division Photographic Evidence Sheet Location: Georgia-Pacific Consumer Opera Photographer: Michael Young Date: 05/20/2020 Time: 10:55 Witness: Photo #: 3

Description: Discharge from clarifier.

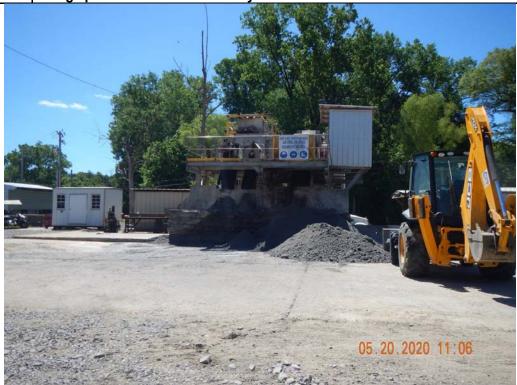
Photographer: Michael Young Date: 05/20/2020 Time: 11:06
Witness: Photo #: 4

Description: Sludge press that is contracted by GP-Crossett.

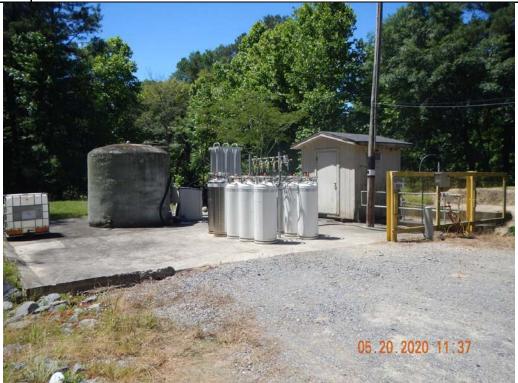
Photographer: Michael Young Date: 05/20/2020 Time: 11:37 Witness: Photo #: 8

Description: Carbon dioxide containers at Outfall 001.

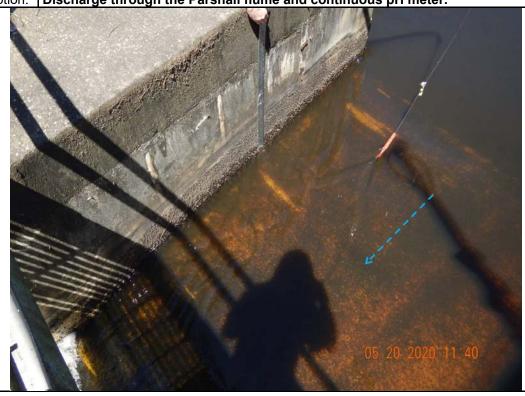
# Water Division Photographic Evidence Sheet Location: Georgia-Pacific Consumer Opera Photographer: Michael Young Date: 05/20/2020 Time: 11:40 Witness: Photo #: 11 Description: Discharge through the Parshall flume and continuous pH meter.

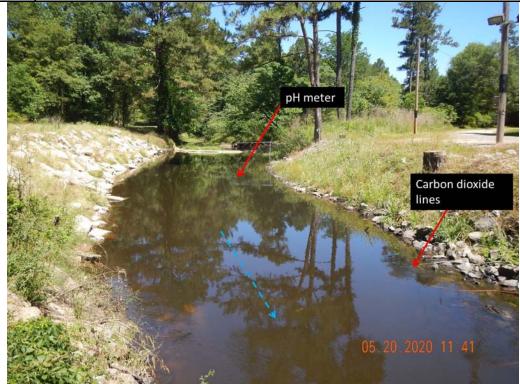
Photographer: Michael Young Date: 05/20/2020 Time: 11:41
Witness: Photo #: 12

Description: Discharge after aeration stabilization basin. Location of pH meter and carbon dioxide lines identified.

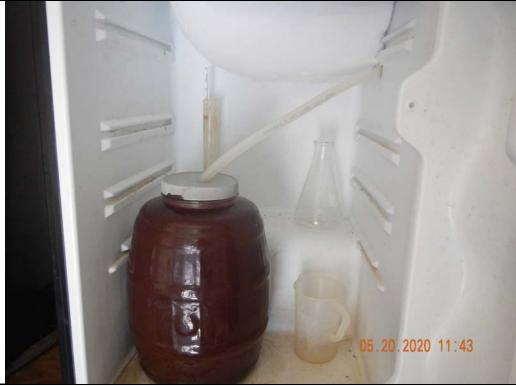
## Water Division Photographic Evidence Sheet Location: Georgia-Pacific Consumer Opera Photographer: Michael Young Date: 05/20/2020 Time: 11:43 Witness: Photo #: 13

Description: Composite sampler utilized in refrigerator.

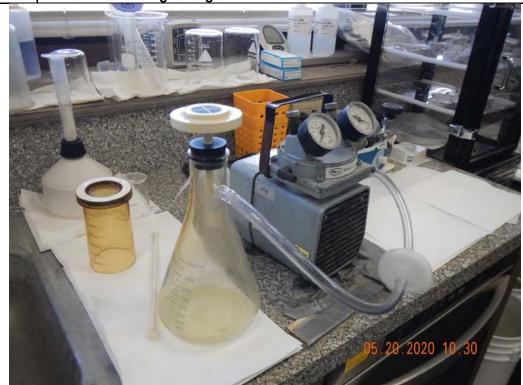
Photographer: Michael	Young	Date:	05/20/2020	Time:	10:30
Witness:				Photo #	14

Description: Vacuum for filtering through TSS filters.

GP-Crossett analyzes Biochemical Oxygen Demand (BOD5), Total Suspended Solids (TSS), pH, and Dissolved Oxygen (DO). I conducted a laboratory inspection by viewing the analytical methods and instrumentation. A vacuum filtering apparatus (see Photo 14) is used to filter water through filter papers (see Photo 15); and after filtering, the paper is placed in the drying oven and desiccant (see Photos 16-17). After drying, the paper is weighed on a scale that had been recently calibrated (see Photos 18-19). Field meters are utilized to collect DO and pH measurements, and the instruments were following the correct calibration methods (see Photos 20-21). I observed the refrigerator for the BOD5 analysis (see Photo 22) and did not identify any laboratory issues.

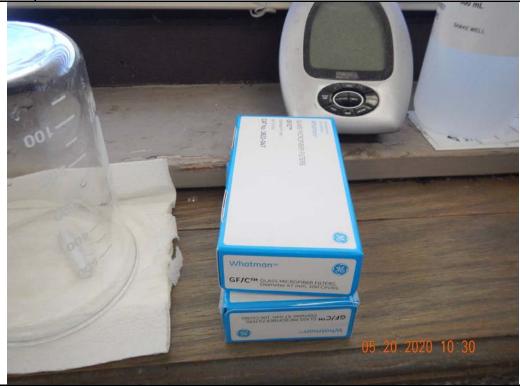
## Water Division Photographic Evidence Sheet Location: Georgia-Pacific Consumer Opera Photographer: Michael Young Date: 05/20/2020 Time: 10:30 Witness: Photo #: 15

Description: Filters used for TSS measurement.

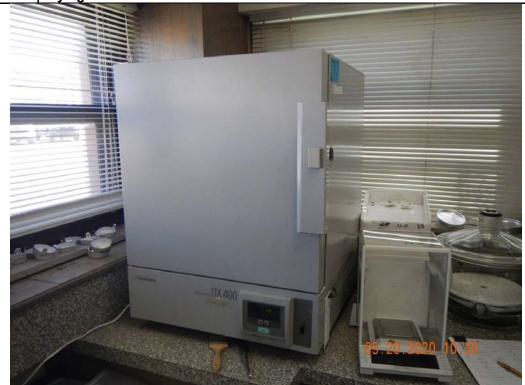
Photographer:	Michael Young	Date:	05/20/2020	Time:	10:30
Witness:				Photo #:

Description: Drying oven used for TSS filters.

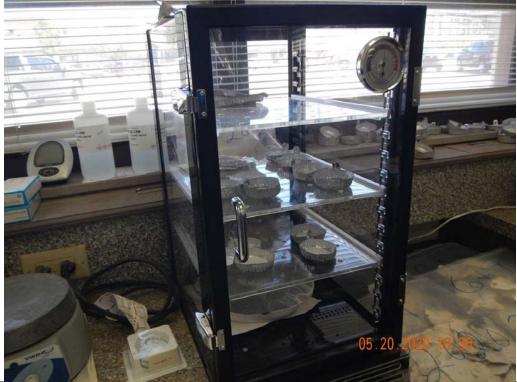
#### **Water Division Photographic Evidence Sheet** Georgia-Pacific Consumer Opera Location: Photographer: Michael Young Date: 05/20/2020 Time: 10:30 Witness: Photo #: 17

Description: Desiccant for TSS filters.

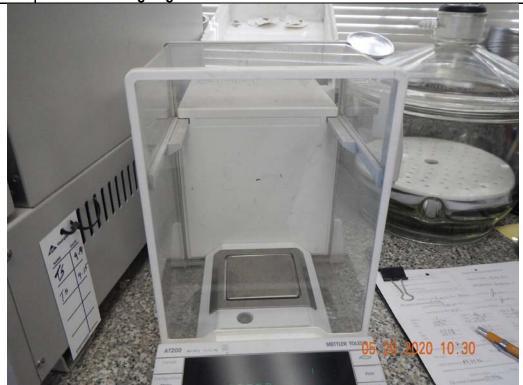
Photographer: Michael Young Date: 05/20/2020 10:30 Time: Witness: Photo #: 18

Description: Balance for weighing TSS filters.

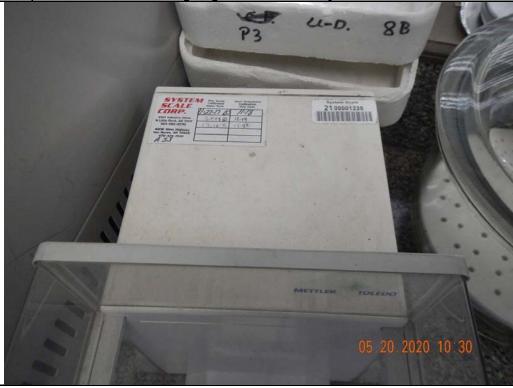
Water Division Photographic Evidence Sheet						
Location:	Geo	rgia-Pacific Consumer Op	era			
Photograph	her:	Michael Young	Date:	05/20/2020	Time:	10:30
Witness:					Photo #	19

Description: Scale used for TSS weighing has been recently calibrated.

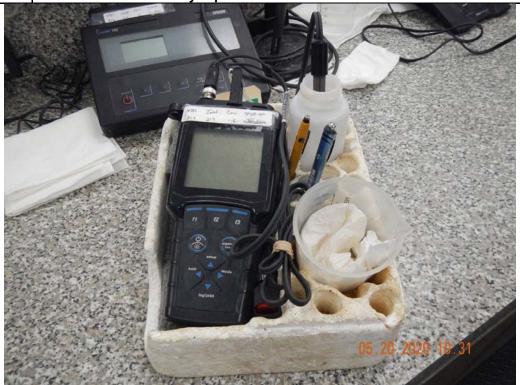
Photographer: Michael Young	Date: 05/20/2020	Time:	10:31
Witness:		Photo #:	20

Description: Field meter used to analyze pH.

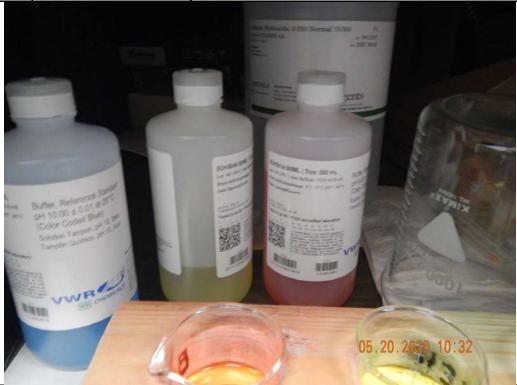
Water Division Photographic Evidence Sheet					
Location: Georgia-Pacific Consumer Opera					
Photographer: Michael Young	Date:	05/20/2020	Time:	10:32	
Witness:			Photo #:	21

Description: **Buffer used to calibrate pH meter.**

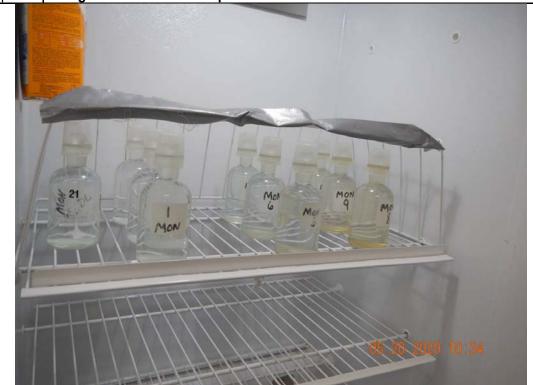
Photographer:	Michael Young	Date:	05/20/2020	Time:	10:34
Witness:				Photo #	. 22

Description: Refrigerator with BOD samples.

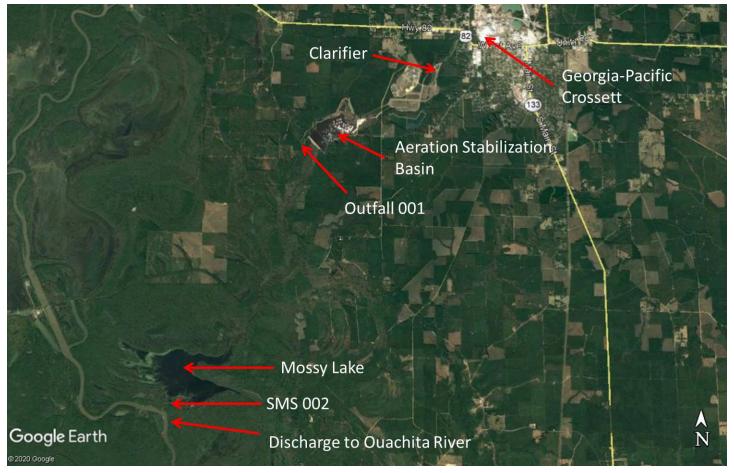
Figure 1. Overview of Georgia-Pacific Consumer Operations LLC - Crossett Paper Operations with the clarifier, aeration stabilization basin, Outfall 001, Mossy Lake, SMS 002, and the point of discharge to the Ouachita River identified.

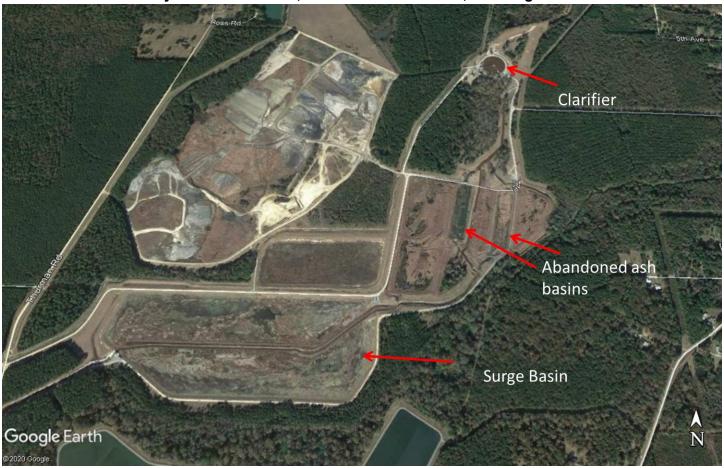
Figure 2. Overview of Georgia-Pacific Consumer Operations LLC - Crossett Paper Operations wastewater treatment system with clarifier, abandoned ash basins, and surge basin identified.

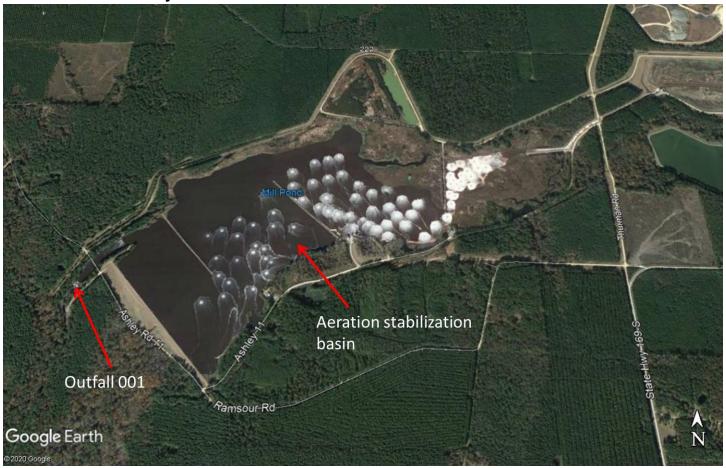
Figure 3. Overview of Georgia-Pacific Consumer Operations LLC - Crossett Paper Operations wastewater treatment system with aeration stabilization basin and Outfall 001 identified.
