**RE: Quarterly Inspection conducted on June 11, 2020**  
**AFIN 63-00155**  
**Permit Number 0261-S1-R3**

**Division of Environmental Quality**  
**Office of Land Resources - Solid Waste Management**  
**Class 1 Landfill Inspection**

## Official Photograph Sheet

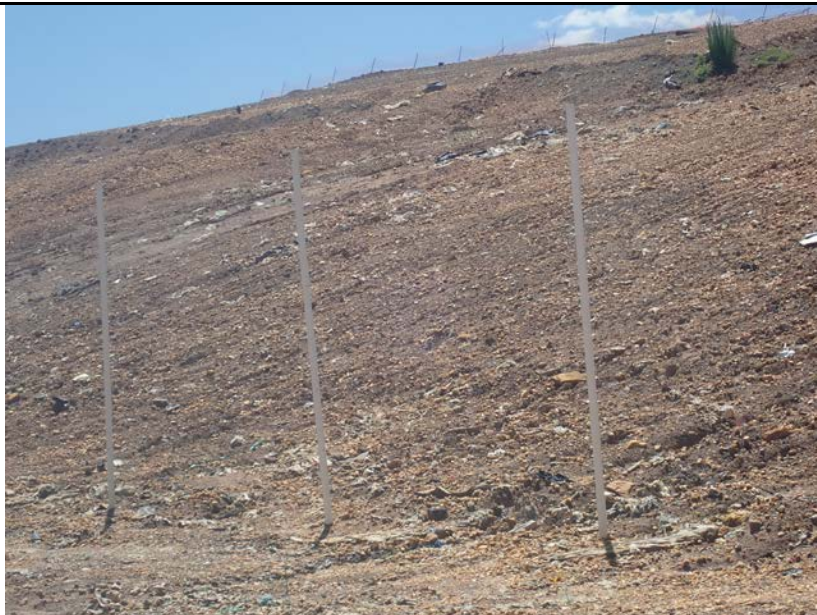
<b>Location</b>	BFI Waste Systems of Arkansas, LLC				<b>Permit</b>	0261-S1-R3	<b>AFIN</b>	63-00155
<b>Photographer</b>	Kim Davenport, Inspector		<i>KD</i>		<b>Witness</b>	N/A		
<b>Photo #</b>	1	<b>Of</b>	6		<b>Date</b>	6/11/2020	<b>Time</b>	1150
<b>Description</b>	Litter observed on the north slope of Cell #5 and litter fencing not in place.

<b>Regulation</b>	<b>Item Description</b>	<b>Comments</b>
	411(a)	Operations in accordance with permit documents	
	417(c)	Adequate all weather operational roads	
	411(c)	Smallest practical area, unloading supervised, single working face	
	411(e)	Salvage operations meet approved conditions	
	411(f)(1)	Scavenging of waste prohibited	
	411(p)	Proper wet weather repairs	
	411(b)	Operations by licensed on-site personnel at all times	
	411(d)	Waste spread and compacted as unloaded	
<b>X</b>	411(g)	Litter control provisions maintained	Litter observed on the north slope of Cell 5 and unconstructed Cells #6 - #8. (Refer to Photos #1 - #5.)
	414(a)	Disease vectors controlled

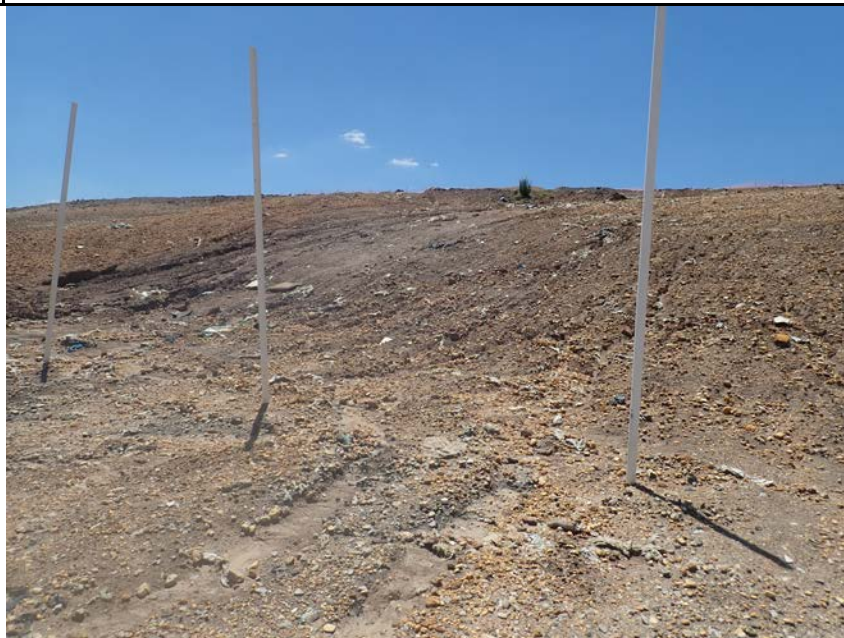
<b>Location</b>	BFI Waste Systems of Arkansas, LLC				<b>Permit</b>	0261-S1-R3	<b>AFIN</b>	63-00155
<b>Photographer</b>	Kim Davenport, Inspector		<i>KD</i>		<b>Witness</b>	N/A		
<b>Photo #</b>	2	<b>Of</b>	6		<b>Date</b>	6/11/2020	<b>Time</b>	1152
<b>Description</b>	Another angle of the area shown in Photo #1, to show litter fencing is not in place.

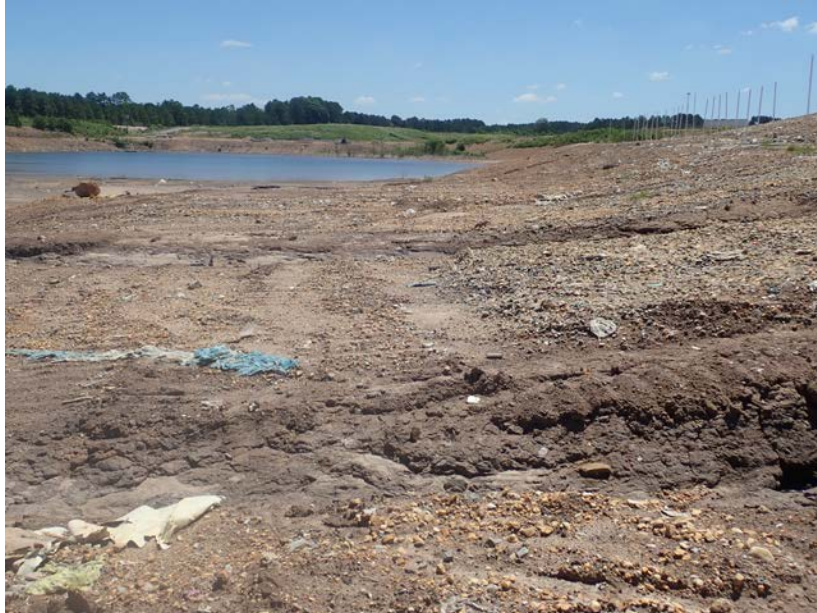
<b>Location</b>	BFI Waste Systems of Arkansas, LLC				<b>Permit</b>	0261-S1-R3	<b>AFIN</b>	63-00155
<b>Photographer</b>	Kim Davenport, Inspector			<i>KD</i>	<b>Witness</b>	N/A		
<b>Photo #</b>	3	<b>Of</b>	6		<b>Date</b>	6/11/2020	<b>Time</b>	1152
<b>Description</b>	Litter observed in unconstructed Cells #6 - #8.

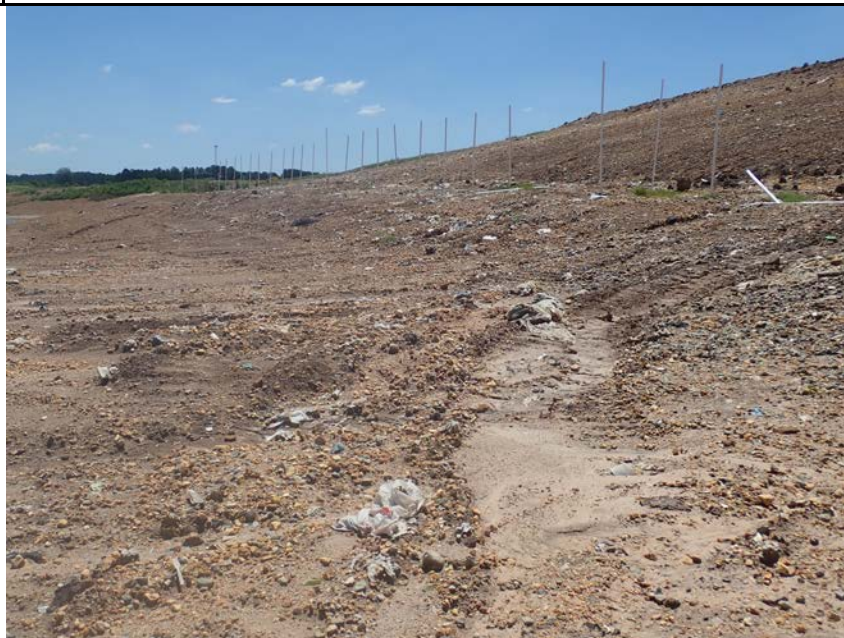
<b>Location</b>	BFI Waste Systems of Arkansas, LLC				<b>Permit</b>	0261-S1-R3	<b>AFIN</b>	63-00155
<b>Photographer</b>	Kim Davenport, Inspector			<i>KD</i>	<b>Witness</b>	N/A		
<b>Photo #</b>	4	<b>Of</b>	6		<b>Date</b>	6/11/2020	<b>Time</b>	1153
<b>Description</b>	An overall view below the toe of Cell 5 to show litter in future Cells #6 - #8.

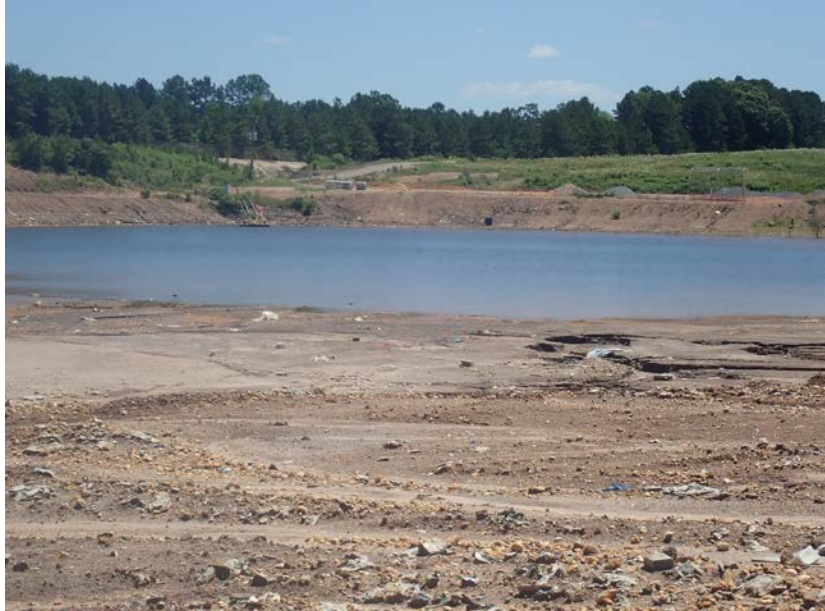
<b>Location</b>	BFI Waste Systems of Arkansas, LLC				<b>Permit</b>	0261-S1-R3	<b>AFIN</b>	63-00155
<b>Photographer</b>	Kim Davenport, Inspector		<i>KD</i>		<b>Witness</b>	N/A		
<b>Photo #</b>	5	<b>Of</b>	6		<b>Date</b>	6/11/2020	<b>Time</b>	1153
<b>Description</b>	Litter observed accumulated in sediment in unlined, future Cells #7 & #8.

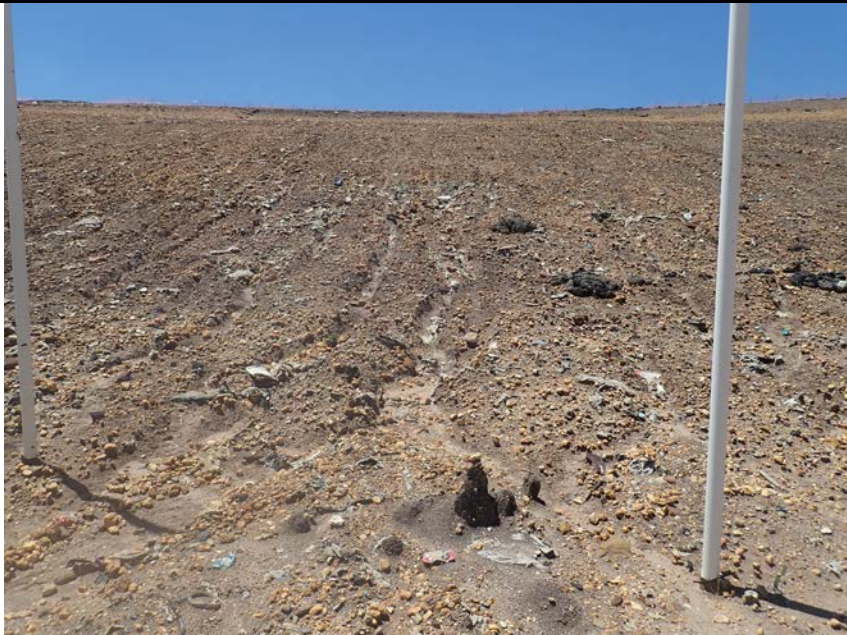
419	Cause discharge/leachate discharge leaving landfill											
411(f)(3),419(a)(4)	Depositing waste in standing water prohibited											
X 411(o)	Erosion or other cover defects resulting in exposed refuse				Erosion with exposed waste observed on the north exterior slope of Cell 5. (Refer to Photo #6.)							
309(c)	Overfill/Off lined area											
Regulation 22 - Records												
421(a)(8), 1203(k)	Date of last groundwater monitoring report			1/7/2020	Site Conditions		Dry					
423(b)	Date of last engineering report			3/30/2020	Weather Conditions		Sunny					
428	Liner construction in progress		Yes/No	No	Notice of liner construction		Yes/No	No	Third party CQA on-site during construction			
412(a)	Date of last random inspection for unauthorized waste			6/5/2020	Total # for month		4 May					
415, 421(e)	Date of last quarterly methane monitoring			5/11/2020	Detection level		>100 @ 3 locations	415(a)	Explosive gas records current?		Yes/No	Yes

<b>Location</b>	BFI Waste Systems of Arkansas, LLC				<b>Permit</b>	0261-S1-R3	<b>AFIN</b>	63-00155
<b>Photographer</b>	Kim Davenport, Inspector		<i>KD</i>		<b>Witness</b>	N/A		
<b>Photo #</b>	6	<b>Of</b>	6		<b>Date</b>	6/11/2020	<b>Time</b>	1151
<b>Description</b>	Erosion with exposed waste observed on the north exterior slope of Cell #5.
