**RE:** City of Flippin POTW Inspection (Marion Co)

AFIN: 45-00021 NPDES Permit No.: AR0021717

A	D.V.A.N.C.A.C.	OFFICE OF WATER QUALITY INSPECTION REPORT							
	RKANSAS ERGY & ENVIRONMENTAL QUALITY	AFIN	AFIN: <b>45-00021</b> PERMI		RMIT #: <b>AR0021</b> 7	717		DATE: <b>8/18/2020</b>	
		COL	JNTY: <b>45 M</b> ar	rion		PDS #	#: <b>113170</b>		MEDIA: WN
		GPS	LAT: <b>36.282</b>	126	LONG: -92.5843	51 L	OCATION:	Entrance	9
	FACILITY INFORMAT	ION			INS	PEC	TION INFO	RMATIO	N
	y of Flippin POTW				ACILITY TYPE:  1 - Municipal	8402	or id#: 22 S - State		
222 East Industrial Drive				2	acility evaluation rating:  2 - Marginal		Con	npliance	Evaluation
Fli	ppin, AR				(-)	RY TIME:	EXIT TIME: 11:45		FFECTIVE DATE:
RESPONSIBLE OFFICIAL					3/10/2020 03	.00	11.43	11/1/2 PERMIT EX	<b>201 /</b> XPIRATION DATE:
NAME: / TITLE								10/30	/2022
Honorable Jerald Marberry / Mayor			-	FAYETTEVILLE S	SHAI	F RFI ATFI	)· N		
	y of Flippin			_	FAYETTEVILLE				
	ING ADDRESS:  D Box 40			<u> </u>	INSPECTION PARTICIPANTS

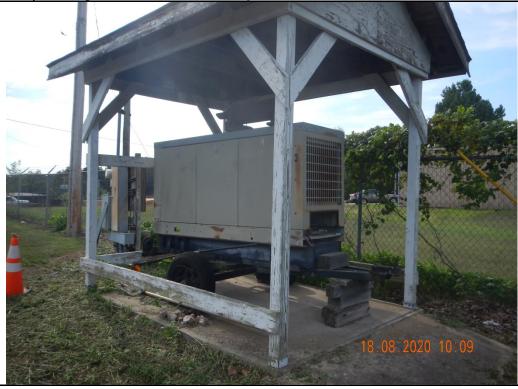
### Office of Water Quality Photographic Evidence Sheet Location: City of Flippin POTW Photographer: Kerri McCabe Date: Aug 18, 2020 Time: 1009 Witness: Photo #: 3

Description: Onsite generator for mechanical plant.

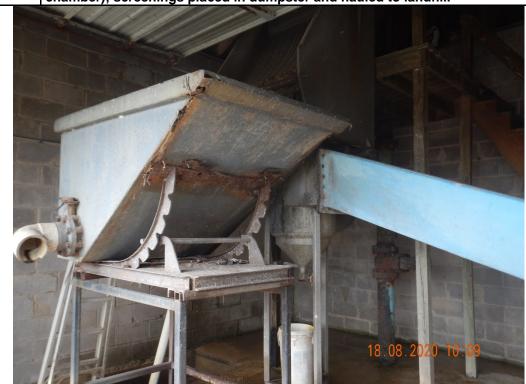
Photographer: Kerri McCabe Date: Aug 18, 2020 Time: 1009
Witness: Photo #: 4

Description: Preliminary consisting of vortex screening and grit removal (funnel-shaped chamber); screenings placed in dumpster and hauled to landfill.

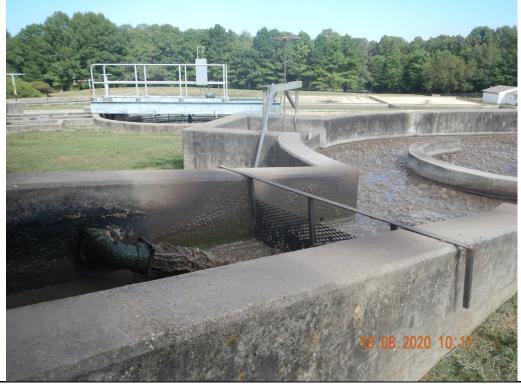
Office of Water Quality Photographic Evidence Sheet												
Office of Water Quality Photographic Evidence Sheet												
Location: (	City o	f Flippin POT	W									
Photographe	er: K	erri McCabe			Date:	Aug 18,	2020	Time:	1011			
Witness:								Photo #	: 5			
Description:		S and influen		• .	o oxidation	ditch; s	creening insta	lled for v	when

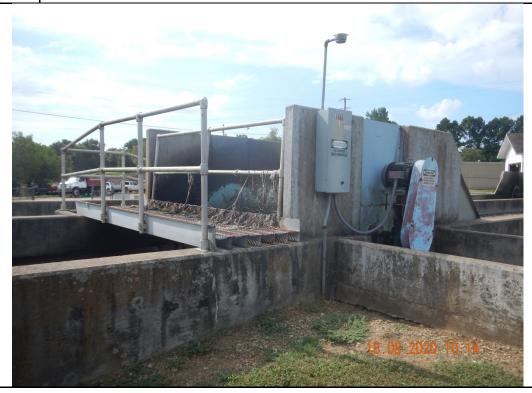
Photographer:	Kerri McCabe	Date:	Aug 18, 2020	Time:	1014
Witness:				Photo #:	8

Description: Flows into oxidation ditch cause excessive turbulence.

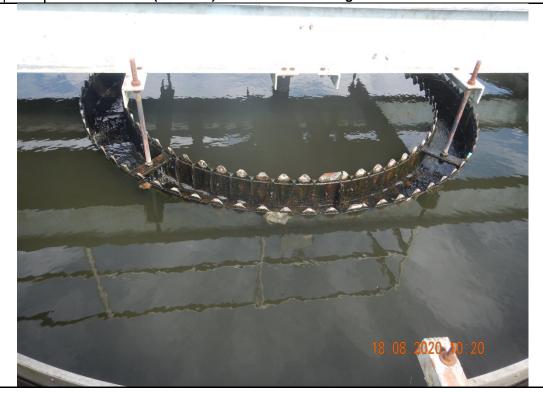
Photographer:	Kerri McCabe	Date:	Aug 18, 2020	Time:	1020
Witness:				Photo #:	10

Description: Second clarifier (in series) with little to no sludge.

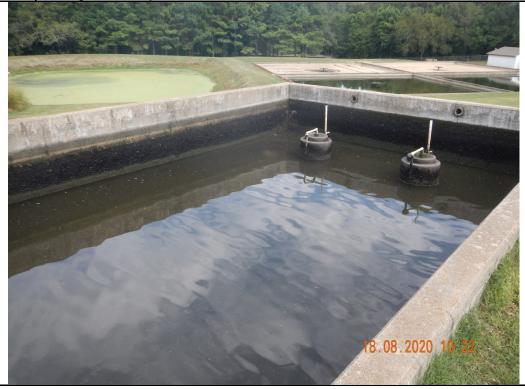
## Office of Water Quality Photographic Evidence Sheet Location: City of Flippin POTW Photographer: Kerri McCabe Date: Aug 18, 2020 Time: 1022 Witness: Photo #: 11

Description: Dosing tank to equalize flow into intermittent sand filters.

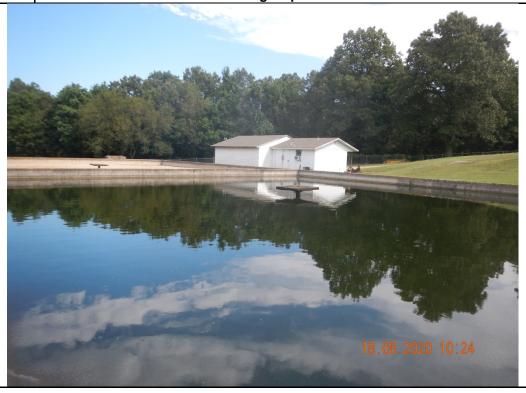
Photographer:	Kerri McCabe	Date:	Aug 18, 2020	Time:	1024
Witness:				Photo #	. 12

Description: Intermittent sand filter in use during inspection.

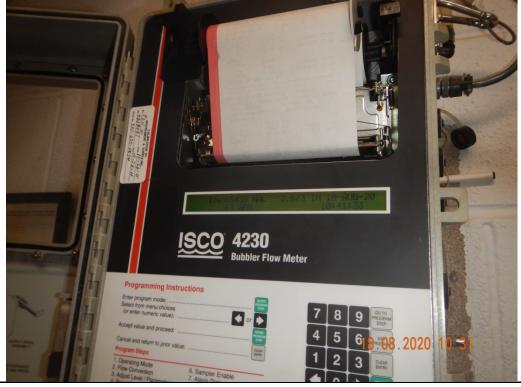
- 1.) The city has reported numerous effluent exceedances during the April Nov 2019 record review. This is a violation of Part I, Section A of the permit. These exceedances have been reported with monthly DMR and no further response is required for this item.
- 2.) The secondary flowmeter has not been calibrated by a qualified technician since Oct 2010. This is a violation of Part III, Section C, 2 of the permit. The flowmeter must be calibrated annually by a qualified technician.
- 3.) Effluent exceedances require 24-hour reporting per Part III, Section D, 6 of the permit. This reporting is in addition to reporting on monthly DMR. The city has not reported Non-compliance Reports (NCR) for the effluent exceedances for 2019. This is a violation of Part III, Section D, 6, A of the permit. The city must start submitting NCR to the Enforcement Branch for effluent exceedances.

2. FLOW MEASURED AT EACH OUTFALL AS REQUIRED:	☑Y □N □NA □NE
3. SECONDARY INSTRUMENTS (TOTALIZERS, RECORDERS, ETC.) PROPERLY OPERATED AND M. Flowmeter	AINTAINED: ISCO 4230 Bubbler
<ol> <li>CALIBRATION FREQUENCY ADEQUATE: <u>Last calibrated by qualified technician in Oct 2010; operand can calibrate meter.</u></li> </ol>	erator completes accuracy checks

Description: Secondary flowmeter; last calibrated in Oct 2010.

Instrument Supply completed the test to calibrate today.

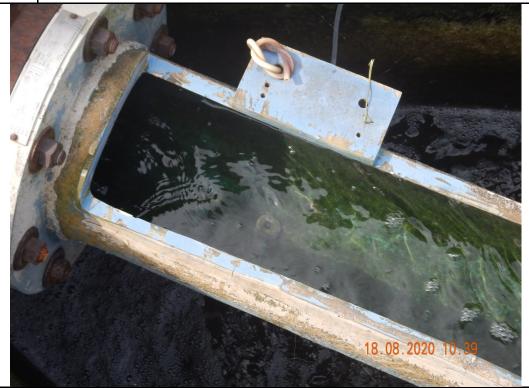
Photographer:	Kerri McCabe	Date:	Aug 18, 2020	Time:	1039
Witness:				Photo #	16

Primary flow device (parabolic nozzle) with bubbler flowmeter installed in correct location.

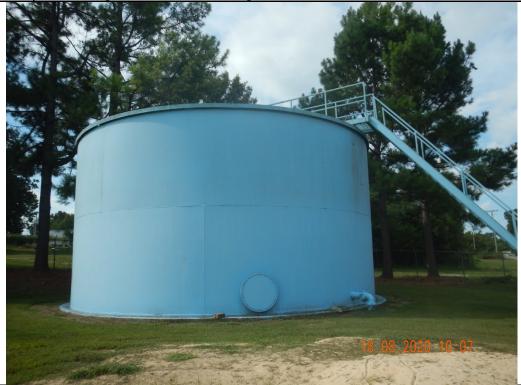
## City of Flippin POTW Photographer: Kerri McCabe Date: Aug 18, 2020 Time: 1007 Witness: Photo #: 19

Description: Aerobic digester for wasted sludge.

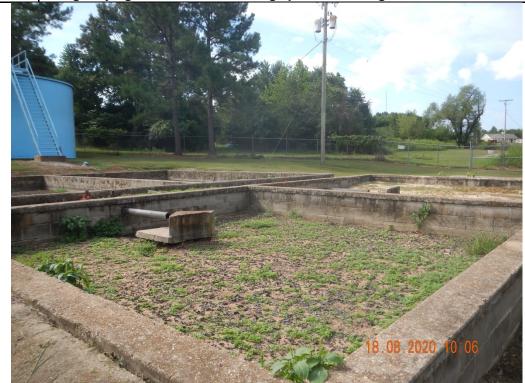
Photographer: Kerri McCabe Date: Aug 18, 2020 Time: 1006
Witness: Photo #: 20

Description: Sludge drying beds to dewater sludge prior to hauling to landfill.

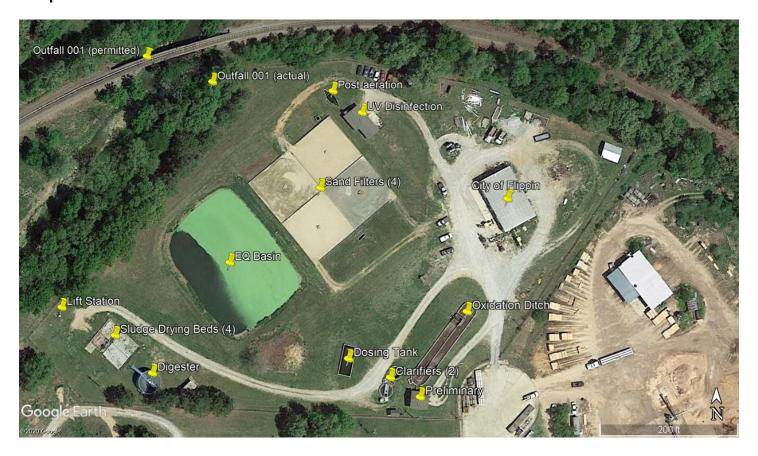
Figure 1. Google Earth image dated May 4, 2014 depicting City of Flippin POTW with major components identified.
