**RE: Quarterly Inspection conducted on August 19, 2020**  
**AFIN 03-00051**  
**Permit Number 0249-S1-R2**

**Division of Environmental Quality  
Office of Land Resources - Solid Waste Management  
Class 1 Landfill Inspection**

<b>Site Name</b>	NABORS Landfill	<b>County</b>	Baxter	<b>AFIN</b>	03-00051
<b>Facility Address</b>	Hwy 5 N to CR 16 to site entrance- Three Brothers	<b>Phone Number</b>	870-425-3213	<b>Permit Number</b>	0249-S1-R2
<b>Permittee Address</b>	P.O. Box 1715, Mountain Home, AR 72602	<b>E-Mail Address</b>	<a href="mailto:judge@baxtercounty.org">judge@baxtercounty.org</a>	<b>PDS #</b>	113276
<b>Date</b>	8/19/2020	<b>Entry Time</b>	1206	<b>Exit Time</b>	1325

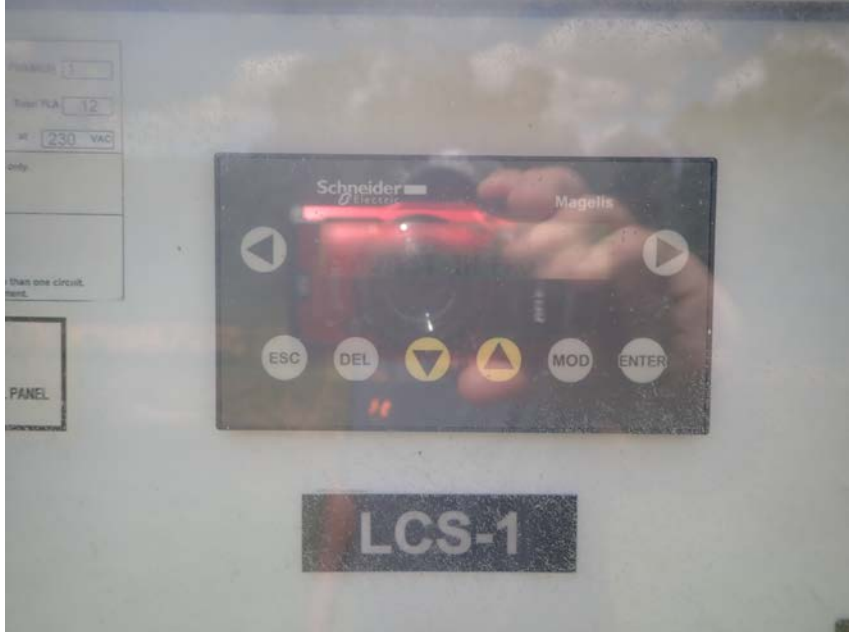
Regulation	Item Description	Comments
427	Surface Water Controls	
411(h)(1)	Contouring prevents surface water flowing into or through waste	
418(a)(b)	Run-on/off control system present and adequate	
411(h)(2)	Surface water control prevents off-site sediment accumulation	
411(i);427(f)	Adequate maintenance of intermediate/final cover vegetation	Turf roll present in multiple areas. (Refer to Photos #1 & #2.)
415	Gas monitoring program	Latest gas monitoring report 10/2019
411(o)	Leachate leaks or evidence of leachate seepage	
426	Survey controls	
429	Leachate collection system	Alarm light activated on LCS-7. Auto test on LCS-1. (Refer to Photo #3.)
420	Liquid Restrictions

<b>Location</b>	NABORS Class 1			<b>Permit</b>	0249-S1-R2	<b>AFIN</b>	03-00051
<b>Photographer</b>	Darrell Norton, Inspector		<i>DN</i>	<b>Witness</b>	n/a		
<b>Photo #</b>	3	<b>Of</b>	6	<b>Date</b>	8/19/2020	<b>Time</b>	1209
<b>Description</b>	LCS-1 with auto test in progress

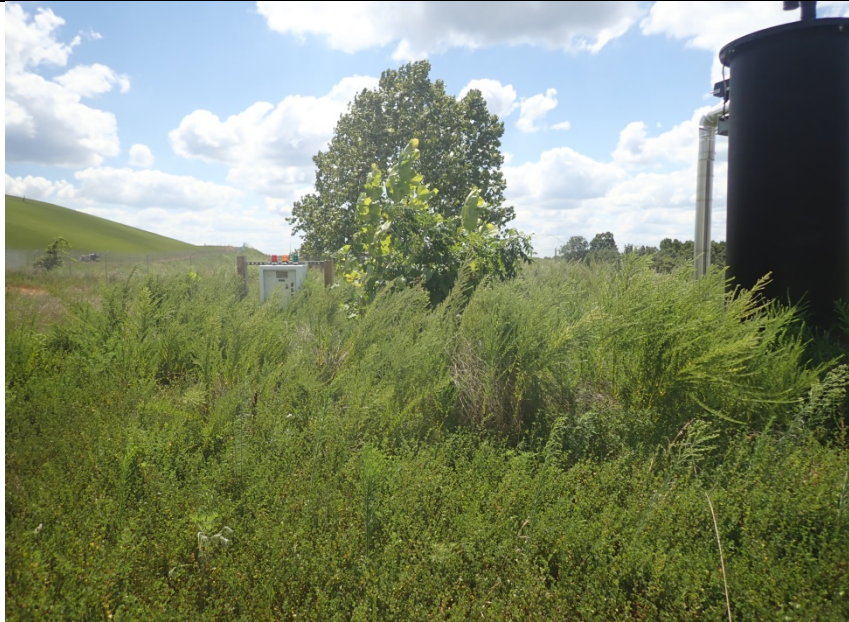
Regulation	Item Description	Comments
411(a)	Operations in accordance with permit documents	
417(c)	Adequate all weather operational roads	Road erosion present between LCS-4 and LCS-5. Vegetative control needed along roads and around LCS panels. (Refer to Photo #4. )
411(c)	Smallest practical area, unloading supervised, single working face	
411(e)	Salvage operations meet approved conditions	
411(f)(1)	Scavenging of waste prohibited	
411(p)	Proper wet weather repairs	
411(b)	Operations by licensed on-site personnel at all times	
411(d)	Waste spread and compacted as unloaded	
411(g)	Litter control provisions maintained	
414(a)	Disease vectors controlled

<b>Location</b>	NABORS Class 1			<b>Permit</b>	0249-S1-R2	<b>AFIN</b>	03-00051
<b>Photographer</b>	Darrell Norton, Inspector		<i>DN</i>	<b>Witness</b>	n/a		
<b>Photo #</b>	4	<b>Of</b>	6	<b>Date</b>	8/19/2020	<b>Time</b>	1223
<b>Description</b>	Vegetative control needed around LCS Panel.

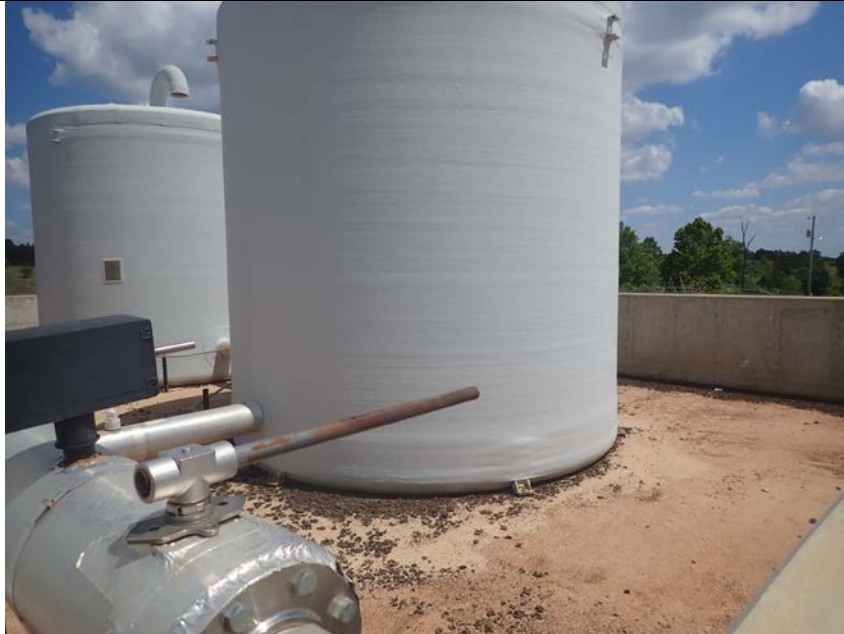
<b>Location</b>	NABORS Class 1			<b>Permit</b>	0249-S1-R2	<b>AFIN</b>	03-00051
<b>Photographer</b>	Darrell Norton, Inspector		<i>DN</i>	<b>Witness</b>	n/a		
<b>Photo #</b>	5	<b>Of</b>	6	<b>Date</b>	8/19/2020	<b>Time</b>	1229
<b>Description</b>	Secondary containment unit of tank farm.

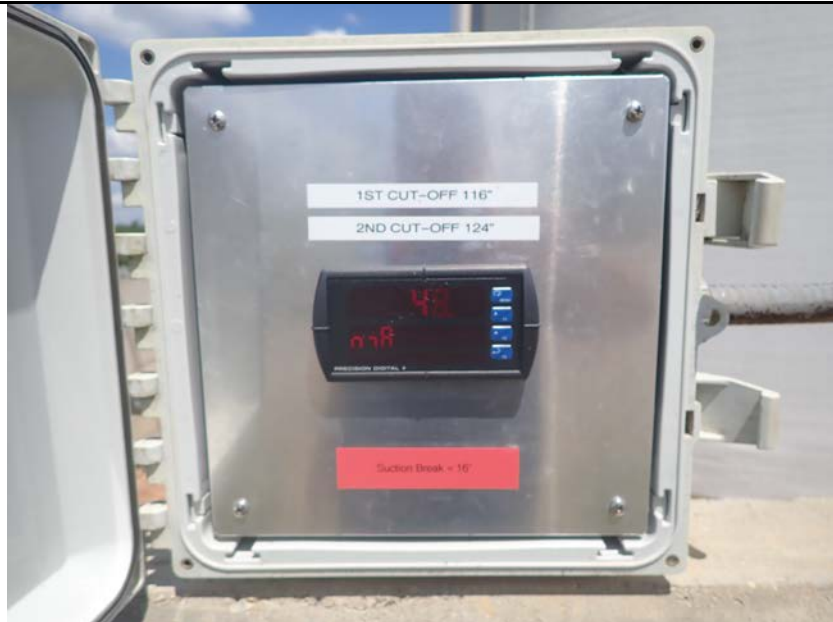
<b>Location</b>	NABORS Class 1			<b>Permit</b>	0249-S1-R2	<b>AFIN</b>	03-00051
<b>Photographer</b>	Darrell Norton, Inspector		<i>DN</i>	<b>Witness</b>	n/a		
<b>Photo #</b>	6	<b>Of</b>	6	<b>Date</b>	8/19/2020	<b>Time</b>	1229
<b>Description</b>	Level of tank farm observed.
