RE: City of Trumann WWTP Inspection

AFIN: 56-00047 Permit No.: AR0035602 & ARR000270

OFFICE OF WATER QUALITY INSPECTION REPORT

AFIN: 56-00047 PERMIT #: AR0035602 DATE: 8/19/2020

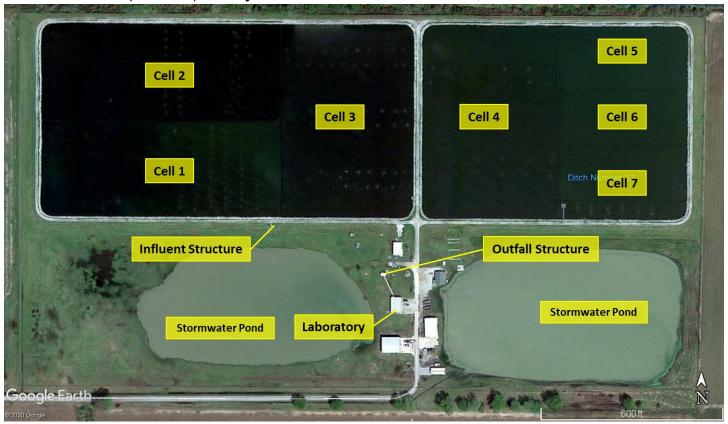
Figure 1. Google Earth image of the City of Trumann with labels for different portions of treatment.

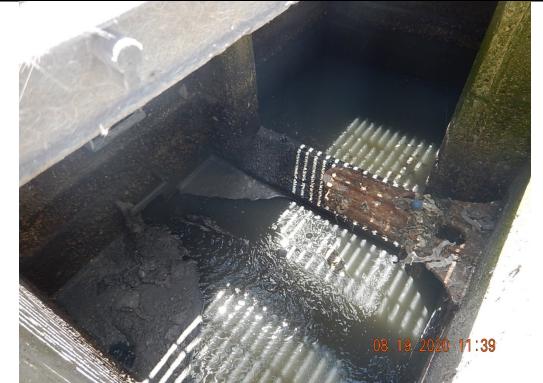
Office of Water Quality Photographic Evidence Sheet Location: City of Trumann WWTP Photographer: Sarah Frasher Date: 8/19/2020 Time: 11:41 Witness: None Photo #: 3

М	OPERATION & MAINTENANCE	S		CEIVING WATER	S			ITORING PROGRAM
S	SAMPLING	N	SLUDGE HAND	LING/DISPOSAL	N	PRE	ΓREAT	MENT
N	OTHER:							
			SUMMARY C	OF FINDINGS				
The	The following item was noted and requires a written response: Vegetation was observed on the lagoon curtains and inside the effluent structure, (Photos 3-12), in violation of Part III, Section B.1.a of the permit.							
			GENERAL (COMMENTS				
	An Industrial Stormwater Inspection for the No Exposure Exclusion, ARR000270, was performed in conjunction with this inspection. Please view that inspection report for details.

5. EFFLUENT LOADINGS CALCULATED USING DAILY EFFLUENT FLOW AND DAILY ANALYTICAL DATA:	☑Y □N □NA □NE
SECTION C: OPERATIONS AND MAINTENANCE	
TREATMENT FACILITY PROPERLY OPERATED AND MAINTAINED	□S ☑M □U □NA □NE
DETAILS: Vegetation was observed on curtains and inside effluent structure.

Description: View of Cell 3. Note the vegetation.

At Public Works we have been behind on our work since the outset of this pandemic. We have all our employees back now and expect to start making progress again when the weather permits. We have removed all the vegetation in the areas noted and our plant is running very well. We will continue to be more vigilant controlling the vegetation.

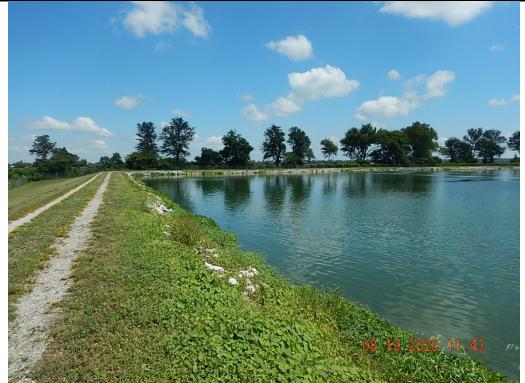
Office of Water Quality Photographic Evidence Sheet Location: City of Trumann WWTP Photographer: Sarah Frasher Witness: None Date: 8/19/2020 Time: 11:48 Photo #: 7 Description: View of Cell 3.

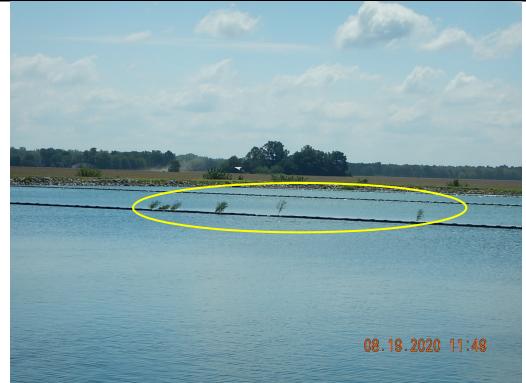
Office of Water Quality Photographic Evidence Sheet Location: City of Trumann WWTP Photographer: Sarah Frasher Date: 8/19/2020 Time: 11:52 Witness: None Photo #: 9

Description: View of the curtains dividing the Cells. Note the vegetation.

Mrs. Lorre Holt has spoken with Ms. Frazier and we are aware that an official letter concerning the finding of the inspection is overdue. The finding to be addressed is vegetation in the baffle curtains and along the banks of our lagoons, and inside the effluent structure.

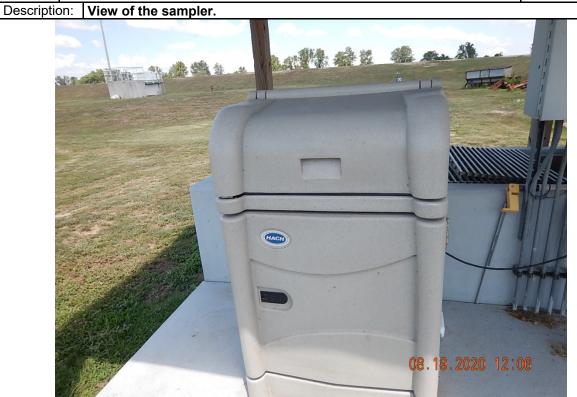
Office of Water Quality Photographic Evidence Sheet Location: City of Trumann WWTP Photographer: Sarah Frasher Date: 8/19/2020 Time: 12:06 Witness: None Photo #: **17** Description: View of the inside of the sampler. 08.19.2020 12:06
