RE: NLRWU - Pretreatment Inspection
AFIN: 60-00274 Permit No.: AR0020303

ENVIRONMENTAL QUALITY	OFFICE OF WATER QUALITY		
	INSPECTION REPORT		
	AFIN: 60-00274	PERMIT #: AR0020303	DATE: 1/26/2021
	COUNTY: 60 Pulaski	PDS #: 114956	MEDIA: WN
GPS LAT: 34.739073 LONG: -92.179918 LOCATION: Entrance			
FACILITY INFORMATION		INSPECTION INFORMATION	
NAME: NLRWU - Pretreatment LOCATION: 7400 Baucum Pike CITY: North Little Rock		FACILITY TYPE: 1 - Municipal INSPECTOR ID#: 83321 S - State FACILITY EVALUATION RATING: 4 - Satisfactory INSPECTION TYPE: Pretreatment Compliance	
RESPONSIBLE OFFICIAL		DATE(S): 1/26/2021 ENTRY TIME: 09:00 EXIT TIME: 11:50 PERMIT EFFECTIVE DATE: 6/1/2019 1/27/2021 09:00 10:15 PERMIT EXPIRATION DATE: 5/31/2024	
NAME: / TITLE Mr. Michael Clayton / Director COMPANY: North Little Rock Water Utility MAILING ADDRESS: P.O. Box 17898 CITY, STATE, ZIP: North Little Rock AR 72117 PHONE & EXT: / FAX: 501-945-7186 / EMAIL: mclayton@nlrwu.com		FAYETTEVILLE SHALE RELATED: N FAYETTEVILLE SHALE VIOLATIONS: N

PRETREATMENT COMPLIANCE INSPECTION

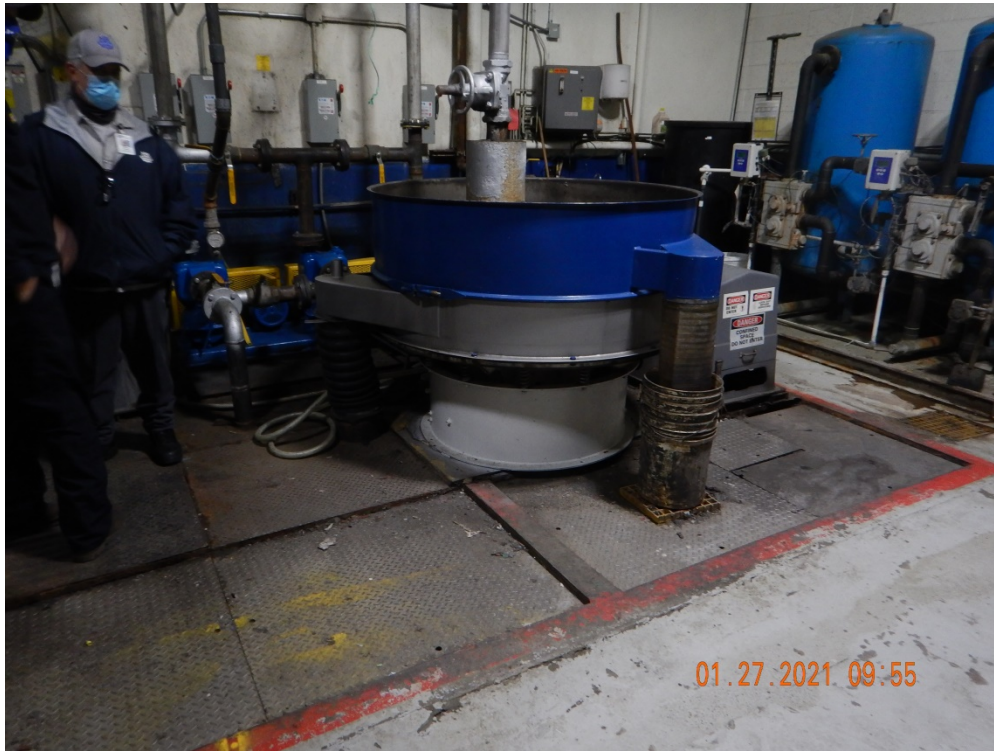
Location:	NLRWU - Pretreatment		
Photographer:	Jason Bolenbaugh	Date:	1/27/2021
Time:	09:55	Witness:	
Photo #:	1	Description: DSCN2018: Holding pits 1 and 2 with solid separator on top of the pits.

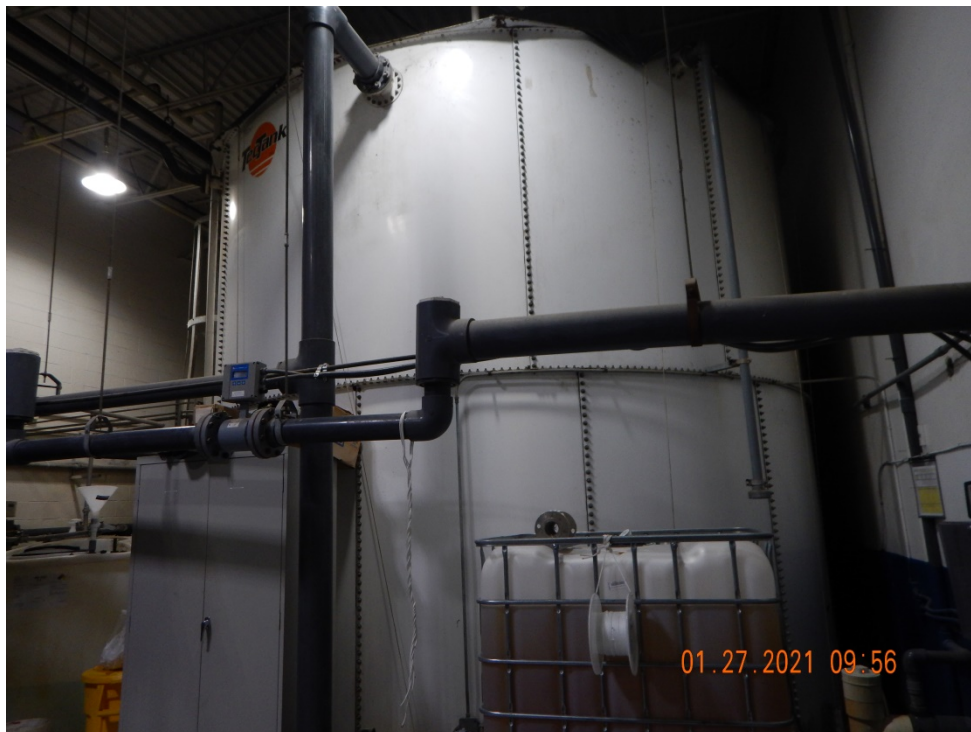
Photographer:	Jason Bolenbaugh	Date:	1/27/2021
Time:	09:56	Witness:	
Photo #:	2	Description: DSCN2021: 30,000 gallon equalization tank.

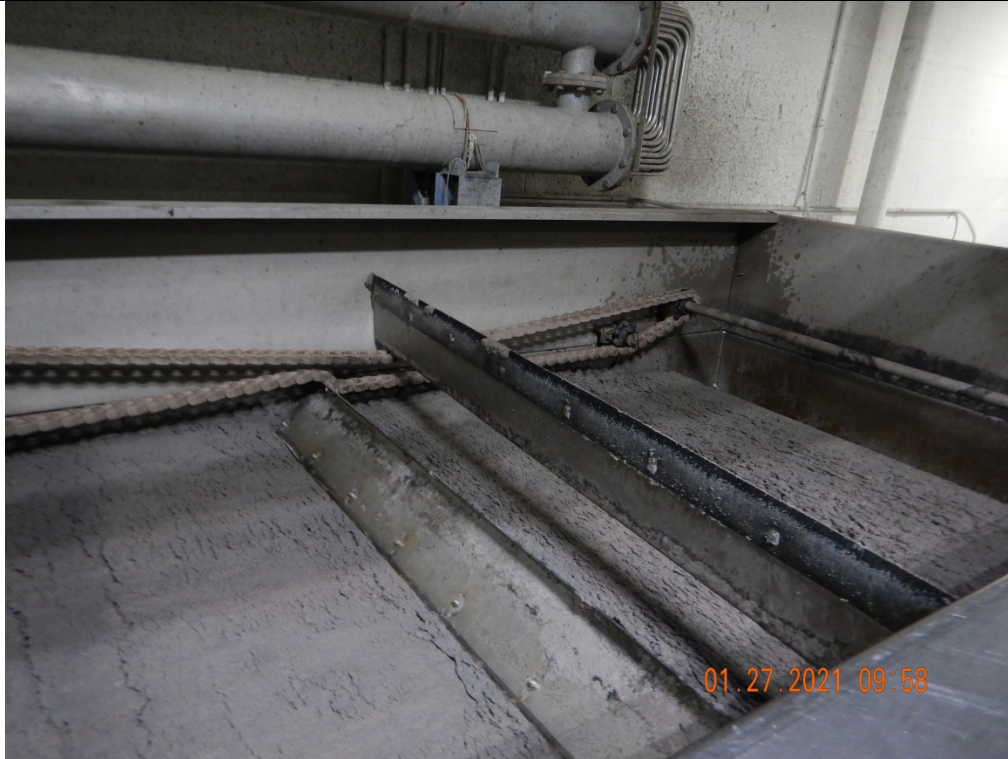
Location:	NLRWU - Pretreatment				
Photographer:	Jason Bolenbaugh	Date:	1/27/2021	Time:	09:58
Witness:		Photo #:	3		
Description:	DSCN2025: Floatables on surface of the DAF unit.

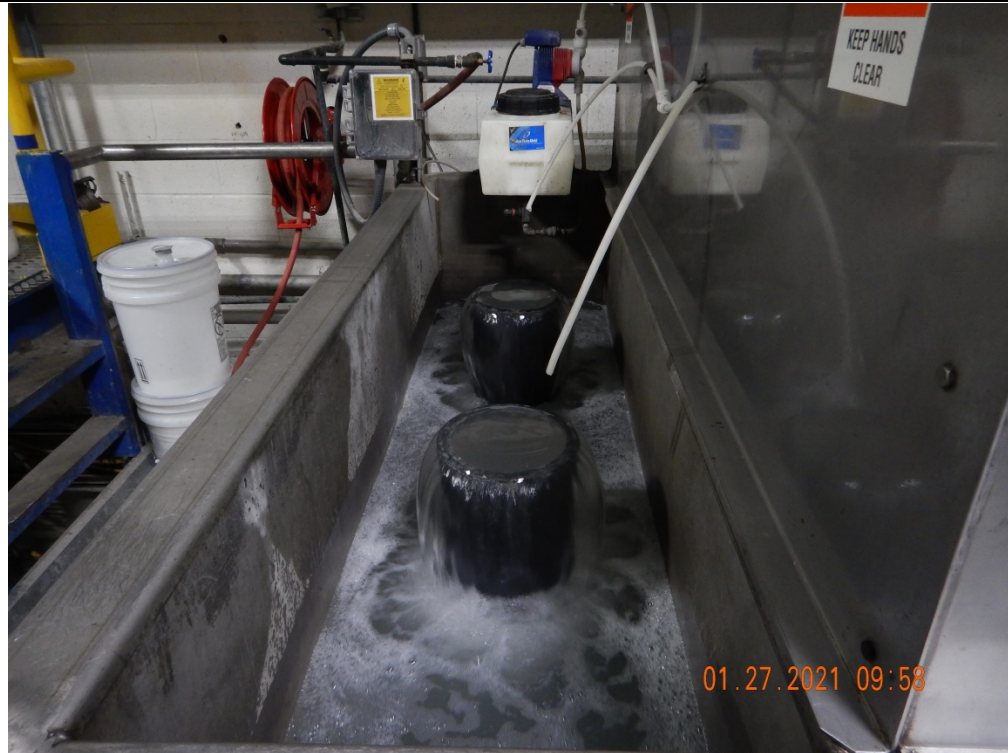
Photographer:	Jason Bolenbaugh	Date:	1/27/2021	Time:	09:58
Witness:		Photo #:	4		
Description:	DSCN2026: Water discharge from the DAF unit.

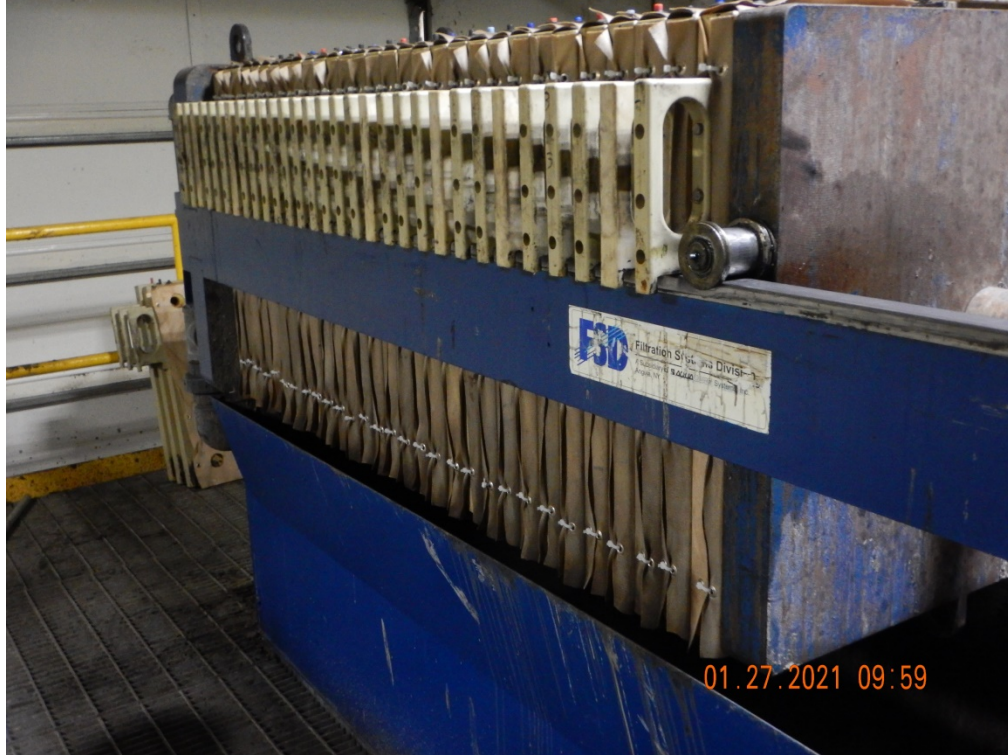
Location:	NLRWU - Pretreatment		
Photographer:	Jason Bolenbaugh	Date:	1/27/2021
Time:	09:59	Witness:	
Photo #:	5	Description: DSCN2028: Sludge filter press.

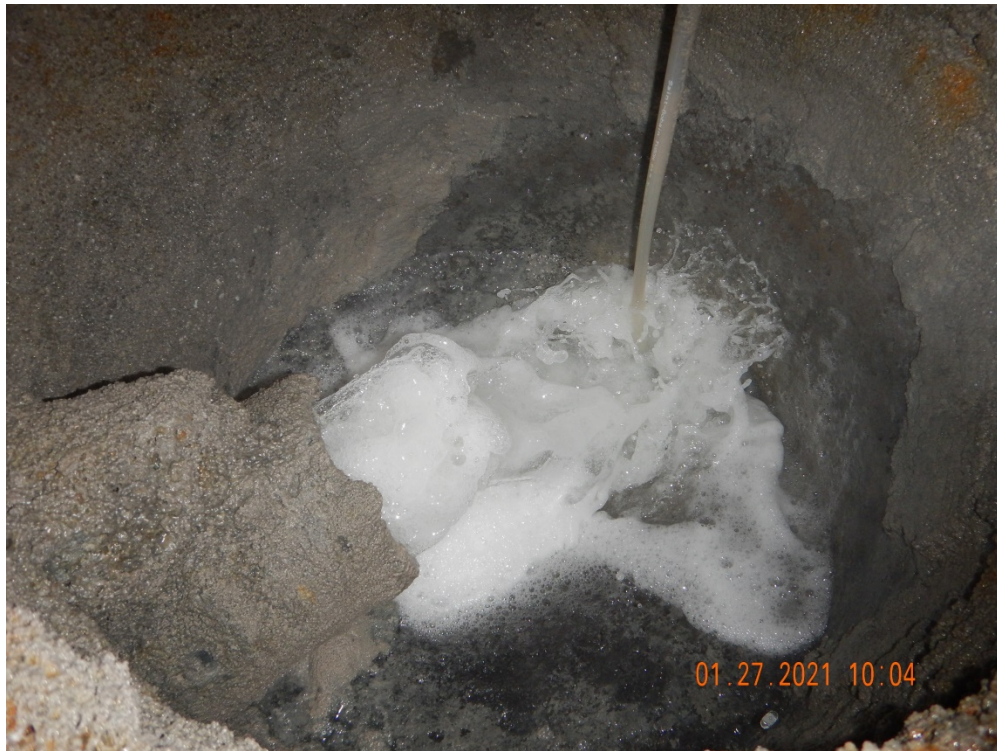
Photographer:	Jason Bolenbaugh	Date:	1/27/2021
Time:	10:04	Witness:	
Photo #:	6	Description: DSCN2032: Final discharge from pretreatment facility to NLRWU.

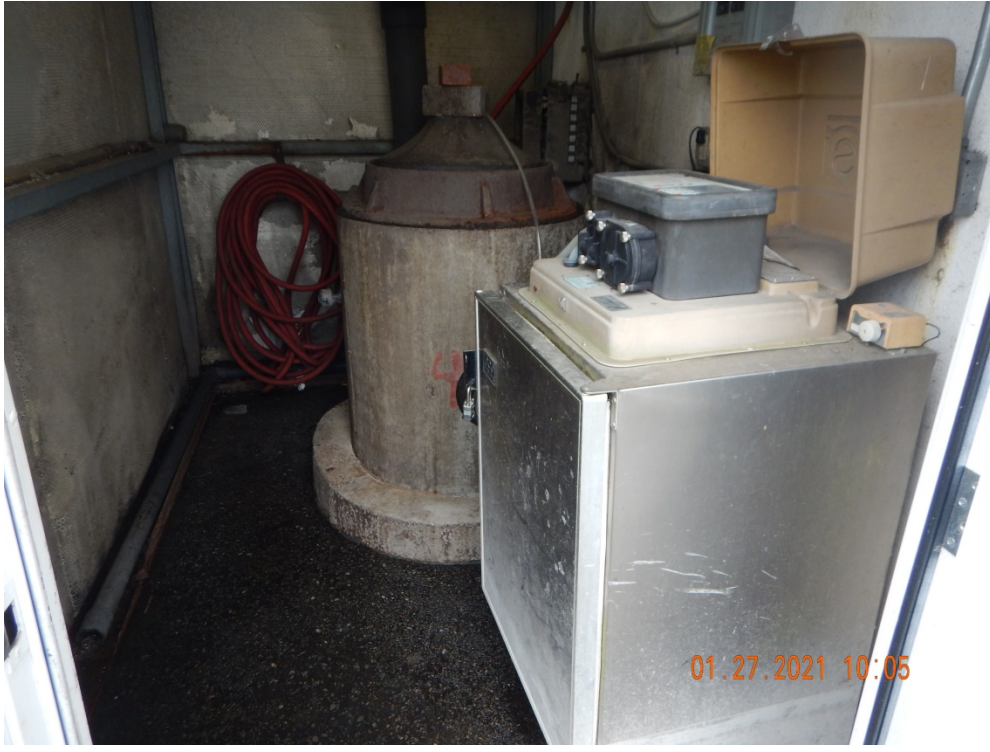
Location:	NLRWU - Pretreatment				
Photographer:	Jason Bolenbaugh	Date:	1/27/2021	Time:	10:05
Witness:				Photo #:	7
Description:	DSCN2035: Composite sampler located in a separate room to the rear of the facility.

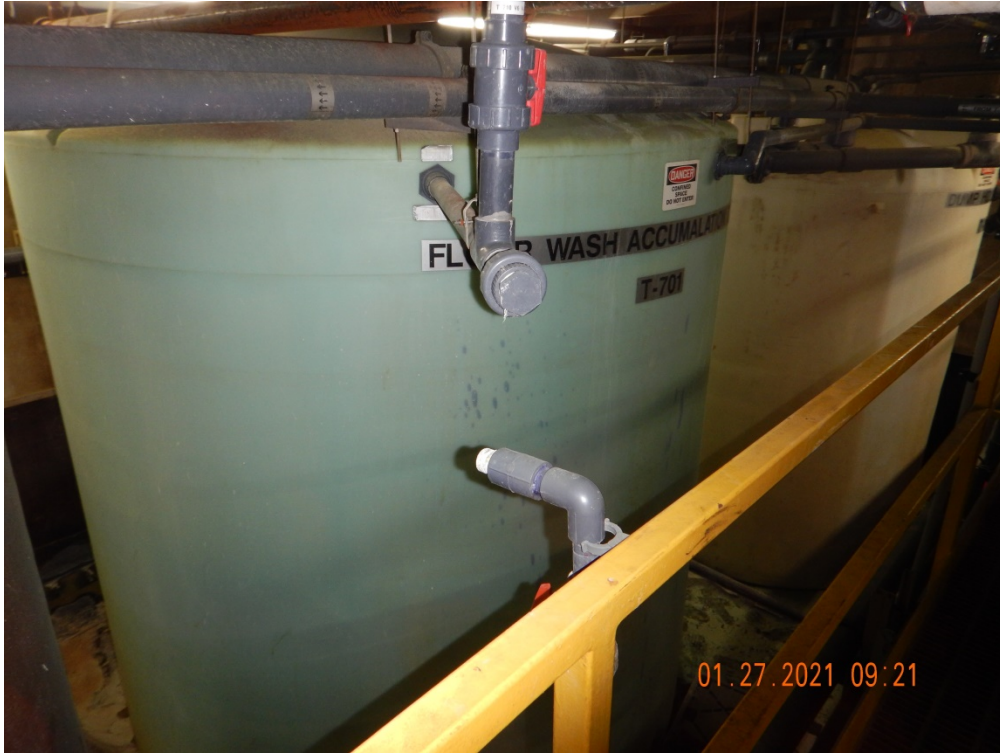
Location:	NLRWU - Pretreatment		
Photographer:	Jason Bolenbaugh	Date:	1/27/2021
Time:	09:21	Witness:	
Photo #:	1	Description:	DSCN2006: Collection tank.

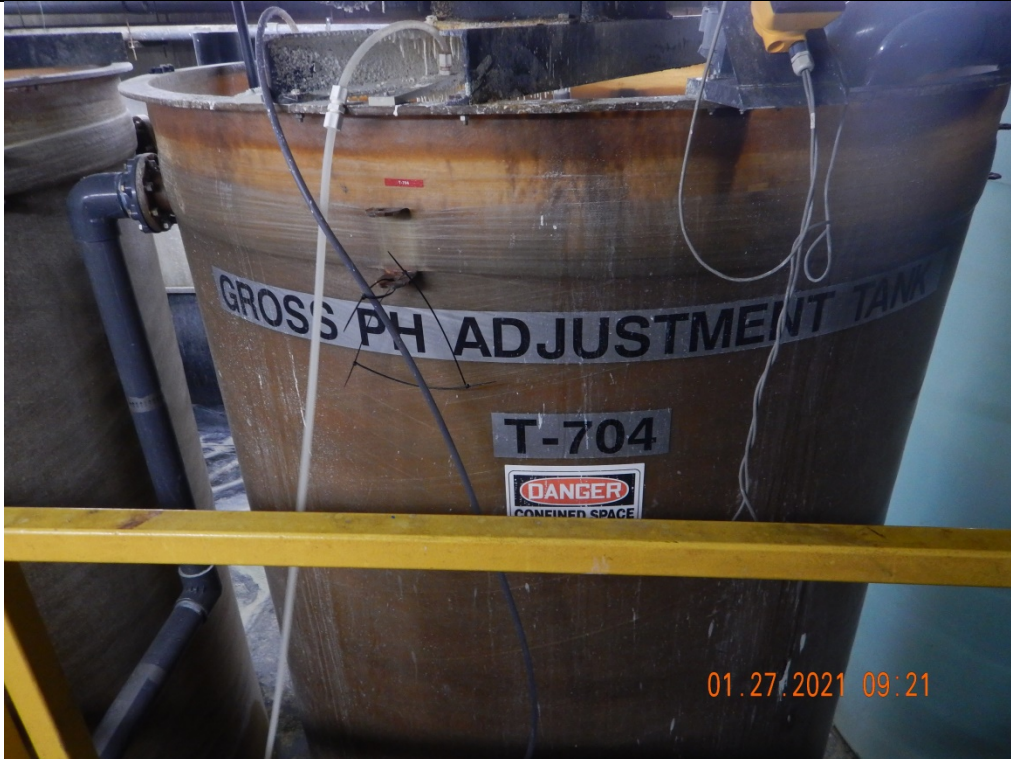
Photographer:	Jason Bolenbaugh	Date:	1/27/2021
Time:	09:21	Witness:	
Photo #:	2	Description:	DSCN2007: Gross pH adjustment tank.

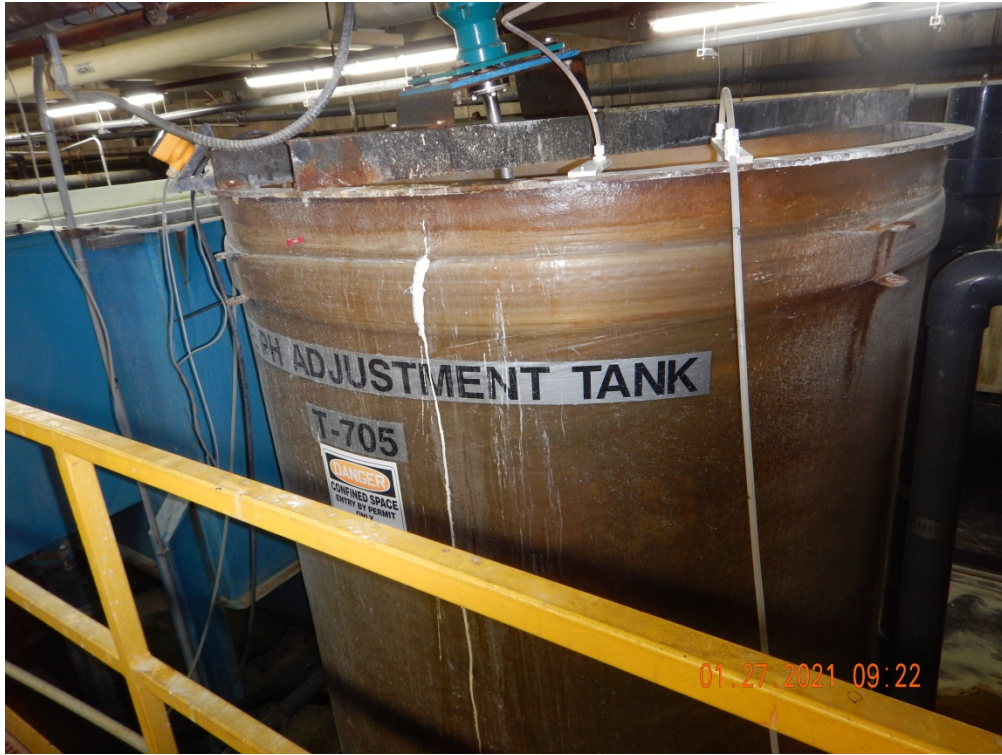
Location:	NLRWU - Pretreatment		
Photographer:	Jason Bolenbaugh	Date:	1/27/2021
Witness:		Time:	09:22
		Photo #:	3
Description:	DSCN2008: Fine pH adjustment tank.

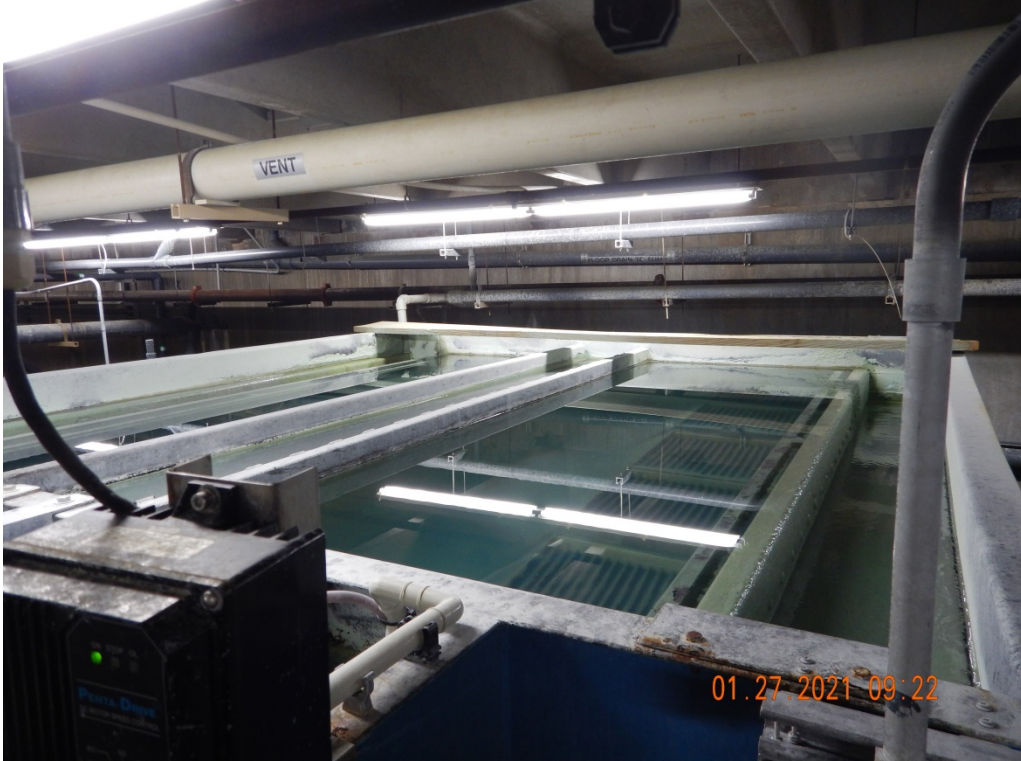
Photographer:	Jason Bolenbaugh	Date:	1/27/2021
Witness:		Time:	09:22
		Photo #:	4
Description:	DSCN2009: Clarifier unit.

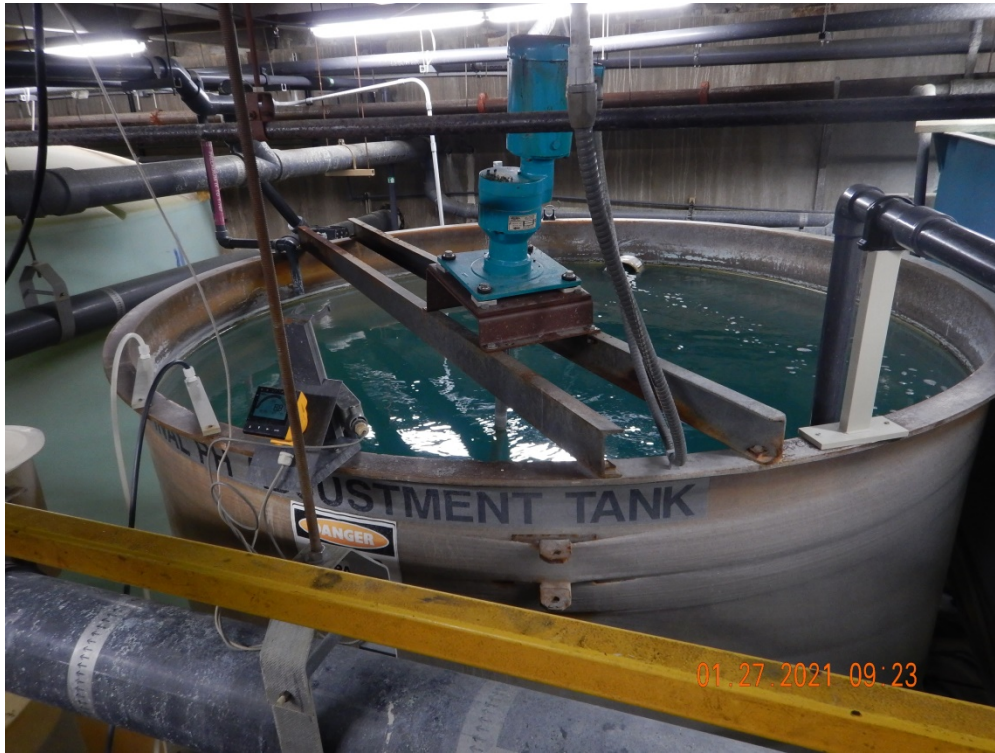
Location:	NLRWU - Pretreatment		
Photographer:	Jason Bolenbaugh	Date:	1/27/2021
Witness:		Time:	09:23
		Photo #:	5
Description:	DSCN2010: Final pH adjustment tank.

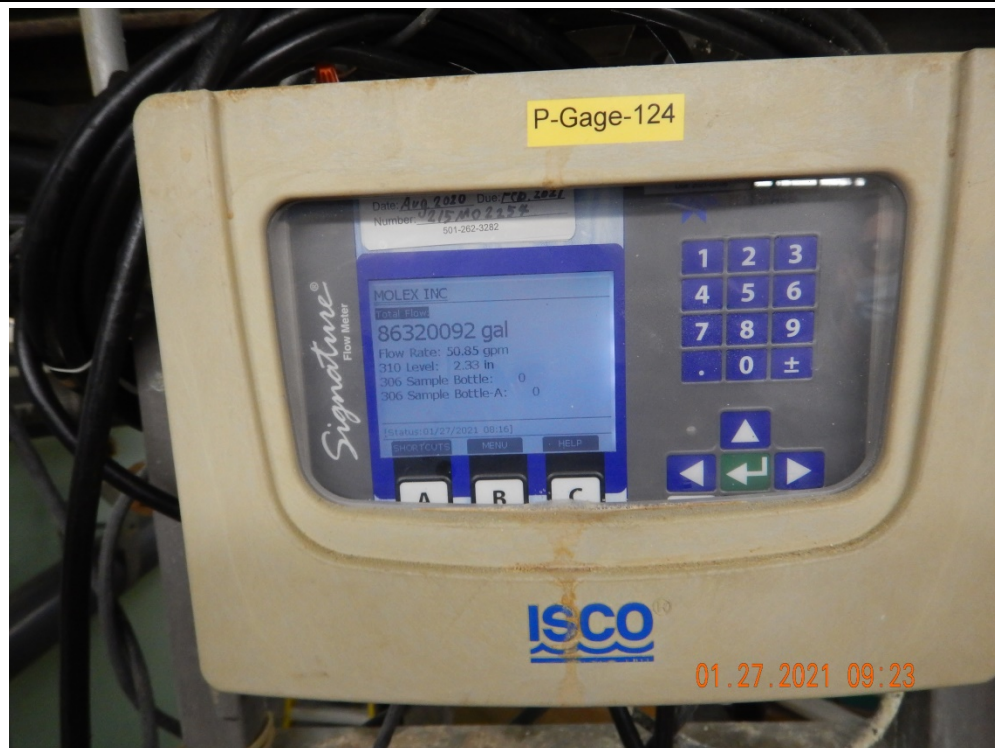
Photographer:	Jason Bolenbaugh	Date:	1/27/2021
Witness:		Time:	09:23
		Photo #:	6
Description:	DSCN2012: ISCO discharge flow meter.

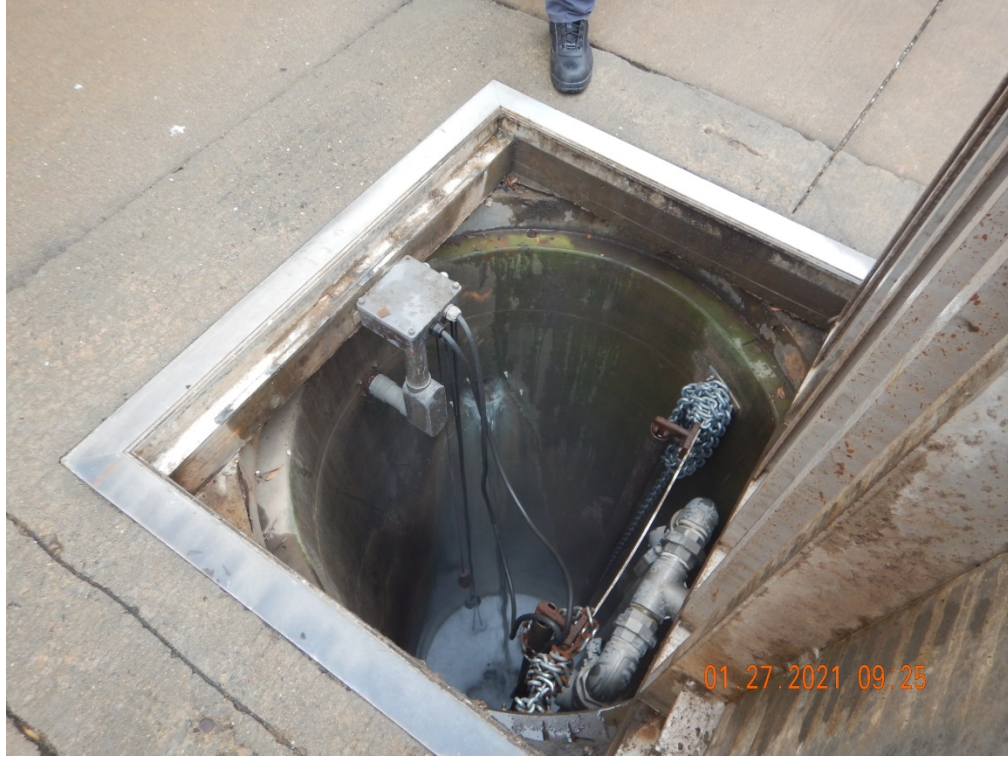
Location:	NLRWU - Pretreatment		
Photographer:	Jason Bolenbaugh	Date:	1/27/2021
Time:	09:25	Witness:	
Photo #:	7	Description: DSCN2014: Pretreated process wastewater discharge.

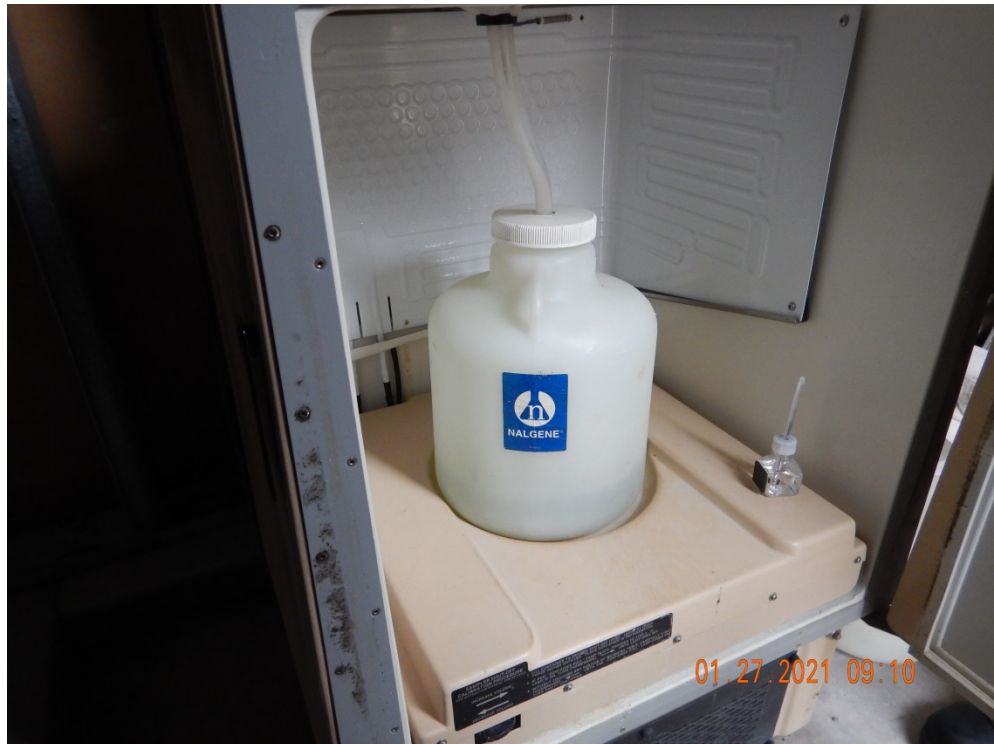
Photographer:	Jason Bolenbaugh	Date:	1/27/2021
Time:	09:10	Witness:	
Photo #:	8	Description: DSCN2004: ISCO 3710 refrigerated composite sampler bottle.

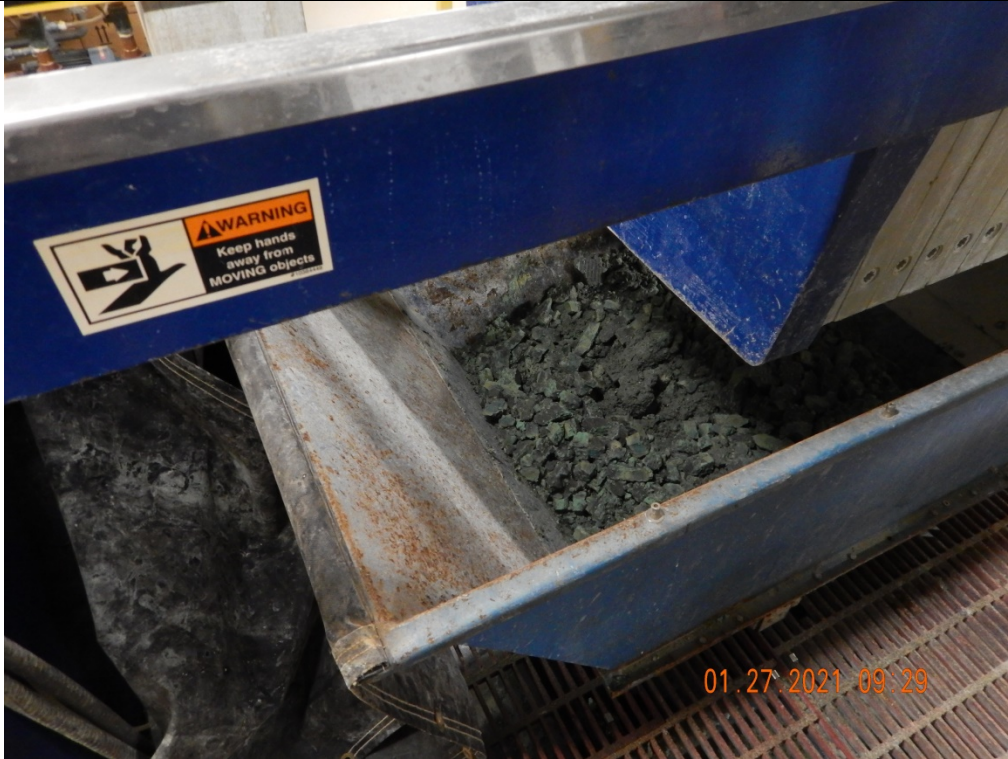
Location:	NLRWU - Pretreatment				
Photographer:	Jason Bolenbaugh	Date:	1/27/2021	Time:	09:29
Witness:				Photo #:	9
Description:	DSCN2016: Dried sludge from the filter press.
