RE: Inspection conducted on February 24, 2021
AFIN 18-00094
Permit Number 0245-S1-R2

Division of Environmental Quality
Office of Land Resources - Solid Waste Management
Class 1 Landfill Inspection

Site Name	Crittenden County Class 1	County	Crittenden	AFIN	18-00094
Facility Address	1299 Khun Rd. West Memphis, AR 72301	Phone Number	LF: 870-732-4290 Off: 870-732-6580	Permit Number	0245-S1-R2
Permittee Address	100 Court Street Marion, AR 72364	E-Mail Address	judgewheelless@crittco.com	PDS #	115035
Date	2/24/2021	Entry Time	0920	Exit Time	1100

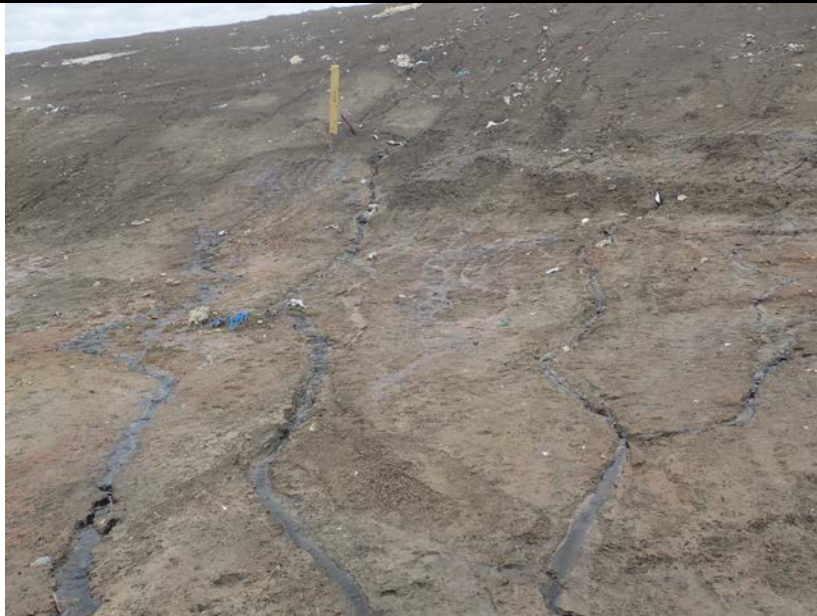
Location	Crittenden County Class 1 Landfill			Permit	0245-S1-R2	AFIN	18-00094
Photographer	Tobin Baker, Inspector			Witness	N/A		
Photo #	1	Of	3	Date	2/24/2021	Time	1010
Description	Leachate observed discharging from the south slope of Cell 4.

Regulation	Item Description	Comments
	427	Surface Water Controls	
	411(h)(1)	Contouring prevents surface water flowing into or through waste	
	418(a)(b)	Run-on/off control system present and adequate	
	411(h)(2)	Surface water control prevents off-site sediment accumulation	
	411(i);427(f)	Adequate maintenance of intermediate/final cover vegetation	
	415	Gas monitoring program	
	411(o)	Leachate leaks or evidence of leachate seepage	
	426	Survey controls	
X	429	Leachate collection system	Leachate collection system in Cell 1A observed at 96.6 inches and high level alarm light was on. (Refer to Photo #3.)
	420	Liquid Restrictions	
Category 3			
	Regulation	Item Description	Comments
	412	Implementation of hazardous/unauthorized waste exclusion plan	
	413(a)(b)	Satisfactory daily/alternative cover	
	413(c)	Satisfactory intermediate cover	
	416(b),411(f)(4)	Open burning prohibited	
X	419	Cause discharge/leachate discharge leaving landfill	Leachate observed discharging out of the south slope of Cell 4 into the storm water ditch. (Refer to Photos #1 & #2.)

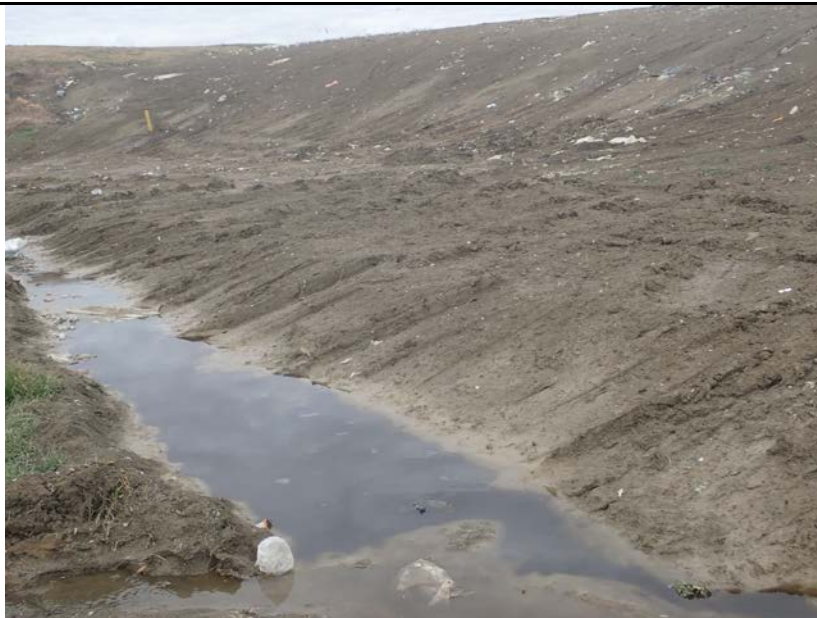
Location	Crittenden County Class 1 Landfill			Permit	0245-S1-R2	AFIN	18-00094
Photographer	Tobin Baker, Inspector			Witness	N/A		
Photo #	2	Of	3	Date	2/24/2021	Time	1016
Description	Leachate observed discharging from south slope of Cell 4 into storm water ditch.

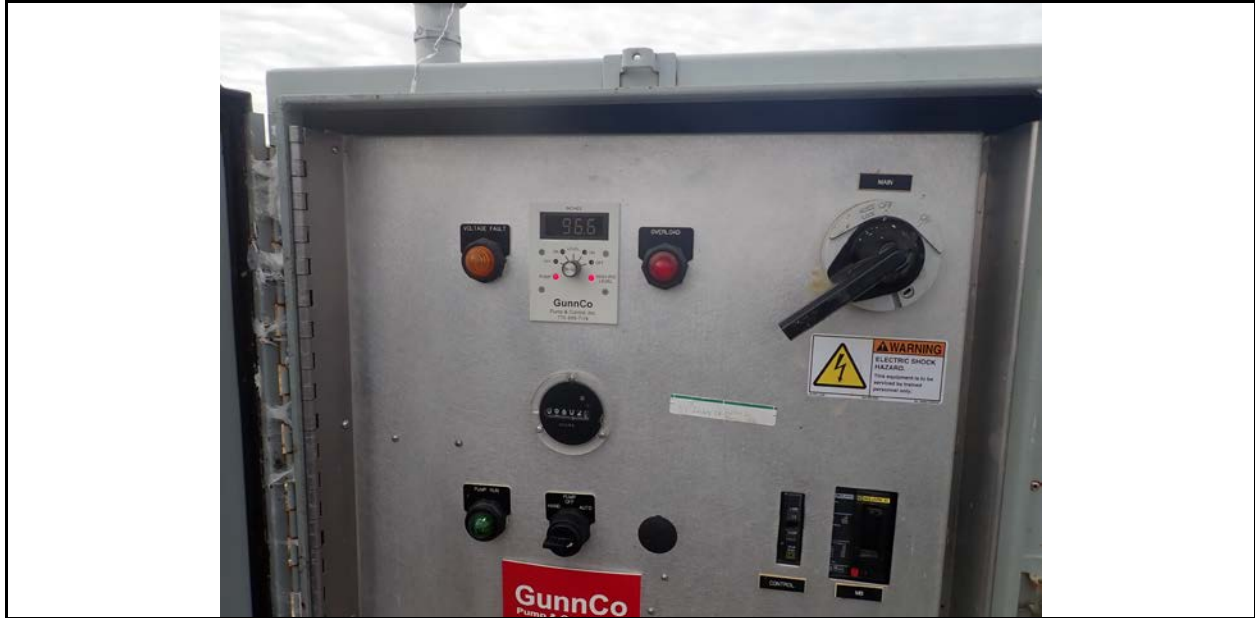
Location	Crittenden County Class 1 Landfill			Permit	0245-S1-R2	AFIN	18-00094
Photographer	Tobin Baker, Inspector			Witness	N/A		
Photo #	3	Of	3	Date	2/24/2021	Time	1023
Description	Leachate collection system in Cell 1A observed at 96.6 inches and high level alarm light was on.
