RE: City of Nashville WWTP Inspections (Howard Co)

OFFICE OF WATER QUALITY INSPECTION REPORT

AFIN: 31-00036 | PERMIT #: AR0021776 | DATE: 12/30/2020

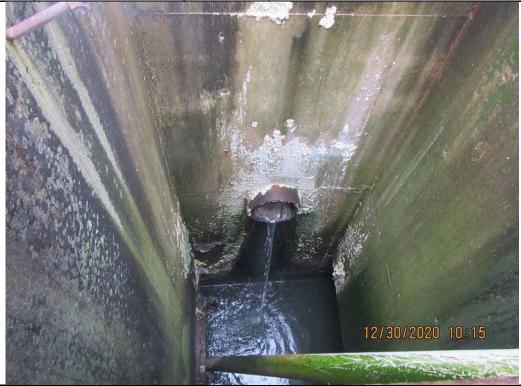
Description: View of influent coming to the facility at the time of inspection.

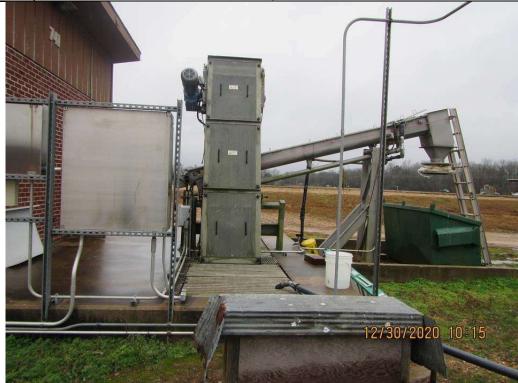
Photographer:Brittanie GloydDate:12/30/2020Time:10:15Witness:Kerri McCabePhoto #:2

Description: View of the bar screen area and dumpster.

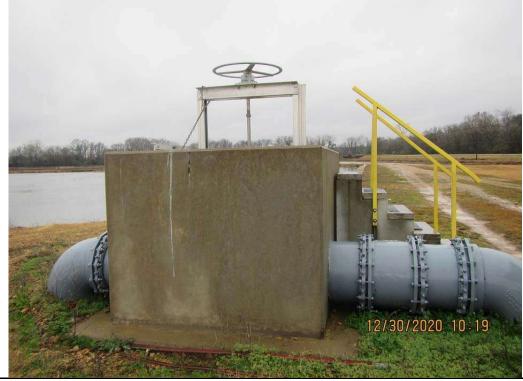
Office of Water Quality Photographic Evidence Sheet						
Location: Cit	y of Nashville WWTP					
Photographer: Brittanie Gloyd Date: 12/30/2020 Time: 10:19						
Witness: Keri	Witness: Kerri McCabe Photo #:					
Description: View of the box junction for deciding which pond influent is directed to.

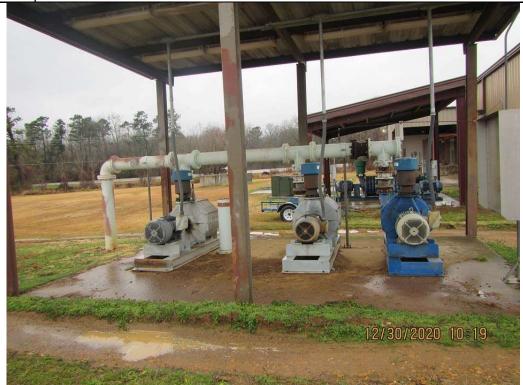
Photographer:	Brittanie Gloyd	Date:	12/30/2020	Time:	10:19
Witness: Kerri	McCabe			Photo #:	4

Description: View of the blowers.

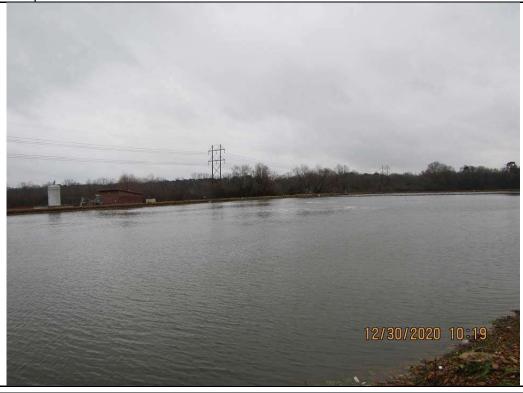
City of Nashville WWTP Photographer: Brittanie Gloyd Date: 12/30/2020 Time: 10:19 Witness: Kerri McCabe Photo #: 5 Description: Overview of Pond 1.

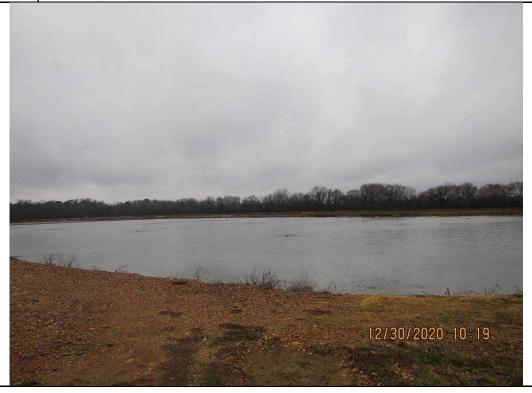
Photographer: Brittanie Gloyd	Date:	12/30/2020	Time:	10:19
Witness: Kerri McCabe			Photo #:	: 6

- 1) Build-up of sludge was noted in treatment Pond 2. This is a violation of Part III. Section B. 1. of the permit.
- 2) The facility reported "No Discharge" for their quarterly sampling requirements. The facility had flow during the 2Q 2019 and had sampled for selenium, cyanide, and WET testing, as required. The facility must submit an updated DMR to the OWQ Enforcement Branch.

1. TREATMENT UNITS PROPERLY OPERATED:	Øs □m □u □na □ne
2. TREATMENT UNITS PROPERLY MAINTAINED: Sludge build-up on north-side of Pond 2.	OS ØM OU ONA ONE

Description: **Overview of Pond 2.**

This letter is in response to your letter dated August 10, 2022. Since the inspection of the Nashville Waste Water Treatment Plant on December 30th of 2020 the sludge has been removed from pond 2.

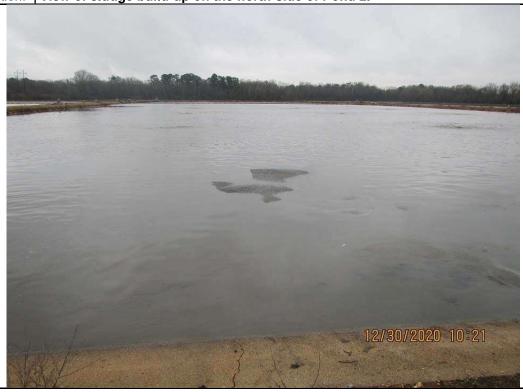
Photographer: Brittanie Gloyd Date: 12/30/2020 Time: 10:23
Witness: Kerri McCabe Photo #: 8

Description: View of the influent into the equalization pond (note the low level).

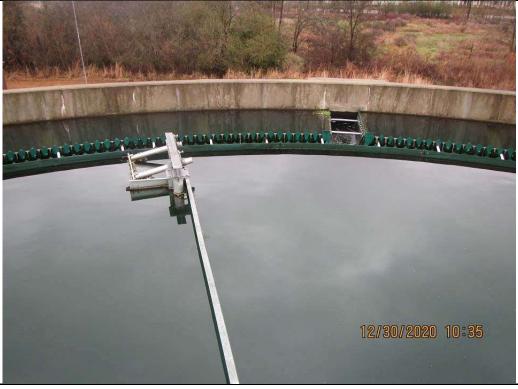
Description: View of one of the clarifiers.

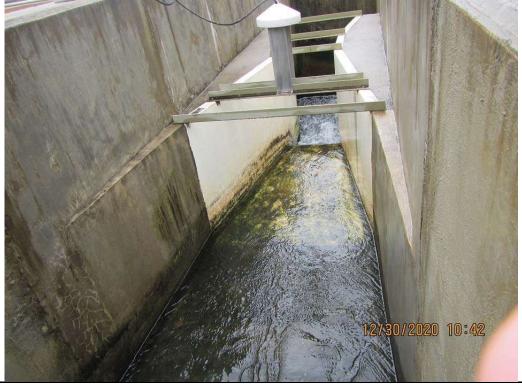
Office of Water Quality Photographic Evidence SheetLocation:City of Nashville WWTPPhotographer:Brittanie GloydDate: 12/30/2020Time: 10:42Witness:Kerri McCabePhoto #: 15

Description: View of the Parshall flume.

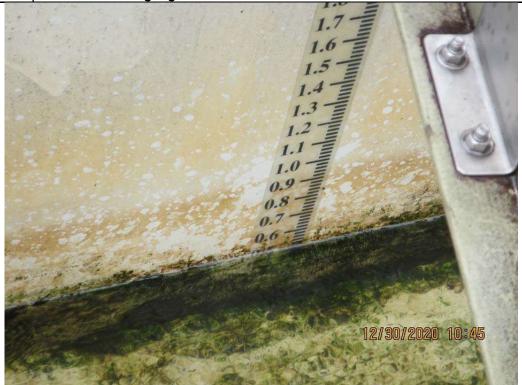
Photographer:Brittanie GloydDate:12/30/2020Time:10:45Witness:Kerri McCabePhoto #:16

FLOW CALCULATION SHEET					
Date: 12 /	30/2020 T	ime: 10:45			
Head in Inc	ches: 6.12 "	Feet: 0.51 '			
Type & Siz	e of Primary Flow I	Measurement Device: 1	8" Parshall F	lume w/ staff gauge	
Name & Mo	odel of Secondary	Flow Measurement De	vice: Totaliz e	er	
Date of last	t Calibration of Sec	ondary Flow Device:	Monthly che	cks	
Recorded F	Flow at Date & Time	e Listed Above: 994	gpm	(Facility Flow Meter)	
	Flow at Date & Tin		gpm		
(Flow is calcula	ted using flow charts in: IS	SCO Open Channel Flow Measu	<u>irement Handbook-5</u>	<u>5th Edition)</u>	
% Error =	Recorded Value Calcu	- Calculated Value lated Value	X 100		
	994	- 956			
% Error =		956	X 100		
% Error =	38 956	X 100			
% Error =	0.0397	X 100			
% Error =	3.97	%			
Comments	: Within error lin	nits.

Description: View of the staff gauge.

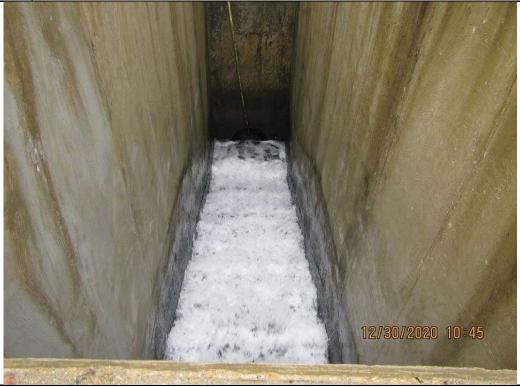
Office of Water Quality Photographic Evidence Sheet Location: City of Nashville WWTP Photographer: Brittanie Gloyd Date: 12/30/2020 Time: 10:45 Witness: Kerri McCabe Photo #: 17

Description: View of the step aeration.

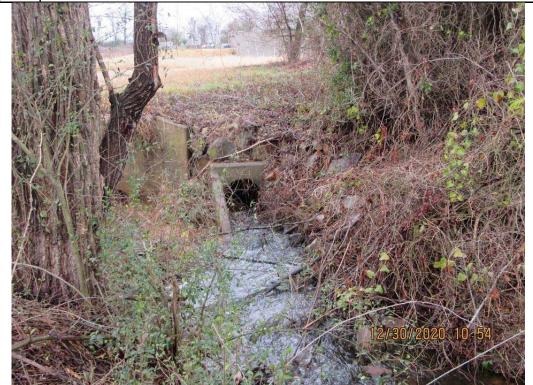
Photographer:Brittanie GloydDate:12/30/2020Time:10:54Witness:Kerri McCabePhoto #:18

•	<u>.</u>			0036, Perriii #. A	KUUZ 1776			
	SECTION G: EFFLUENT/RECEIVING WATERS OBSERVATIONS								
BASED OF	BASED ON VISUAL OBSERVATIONS ONLY								
DETAILS:_	DETAILS: Outfall 001 was discharging at the time of inspection.								
OUTFALL #:	OIL SHEEN	GREASE	TURBIDITY	VISIBLE FOAM	FLOATING SOLIDS	COLOR	OTHER		
001	None	None	None	None	None	Clear			
	1								
SECTION H	: SLUDGE DIS	POSAL							
SLUDGE D	ISPOSAL MEI	ETS PERMIT F	REQUIREMENT	ΓS			U □NA ☑NE		
DETAILS:					<u>'</u>

Description: View of Outfall 001.

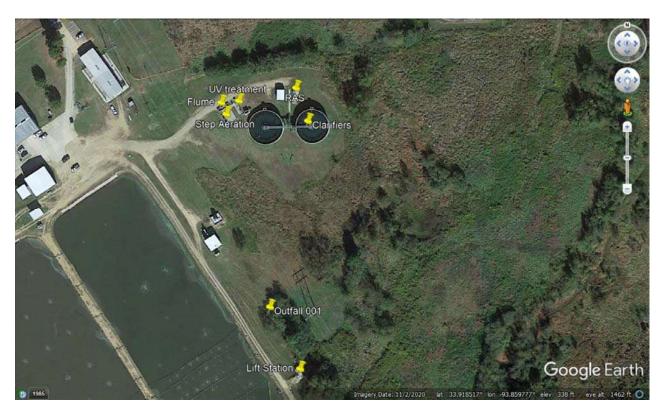
Figure 2. Google Earth aerial imagery dated Nov 2, 2020 showing the second half of treatment components.
