OFFICE OF WATER QUALITY INSPECTION REPORT

AFIN: **31-00036** PERMIT #: **AR0021776** DATE: **12/30/2020**

FACILITY INFORMATION	INSPECTION INFORMATION				
City of Nashville WWTP	FACILITY TYPE: INSPECTOR ID#: 1 - Municipal 129177 S - State FACILITY EVALUATION RATING: INSPECTION TYPE: 3 - Satisfactory SSO/Collect			State	
Tocation: 743 Highway 27 South				ON TYPE: Collection System	
Nashville		P:30 13:		PERMIT EFFECTIVE DATE: 12/1/2020	
RESPONSIBLE OFFICIAL				PERMIT EXPIRATION DATE:	
Billy Ray Jones / Mayor				11/30/2025	
COMPANY:	FAYETTEVILLE SHALE RELATED: N FAYETTEVILLE SHALE VIOLATIONS: N INSPECTION PARTICIPANTS				
City of Nashville MAILING ADDRESS:					
426 Main Street					
CITY, STATE, ZIP: Nashville AR 71852 PHONE & EXT: / FAX: 870-845-7400 / EMAIL:	NAME/TITLE/PHONE/FAX/EMAIL/ETC.: Kerri McCabe / OWQ Inspector Supervisor Larry Dunaway / Public Works Director				
npw@nashar.org					
CONTACTED DURING INSPECTION: No					
AREA EVA	LUATIONS	Evaluated)

Inspection Report: City of Nashville WWTP, AFIN: 31-00036, Permit #: AR0021776

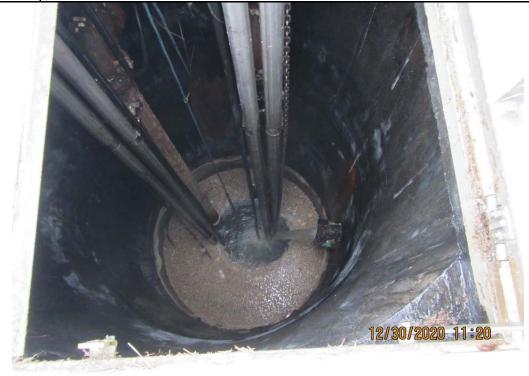
<u>Tolland Lift Station</u> (located at coordinates 33.911306; -93.869844): This lift station services residential and industrial locations. There was accumulation of grease and solids within the wet well at the time of inspection. Mr. Dunaway stated that they regularly degrease the lift station due to grease accumulation. The lift station was named and they had contact information on the control panel in case of any emergency. The system is equipped with High Tide Monitoring System, which will notify the operators of high or low levels in the lift station.

Description: View of the wet well at the Tolland Lift Station.

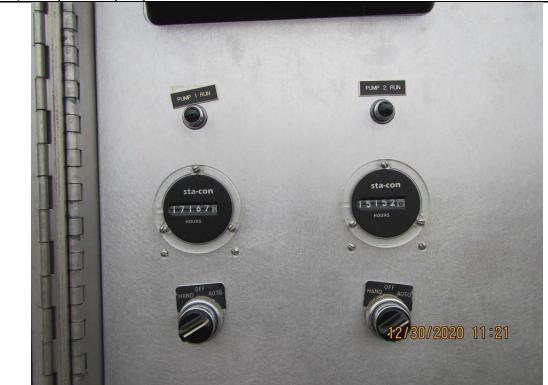
Photographer:Brittanie GloydDate:12/30/2020Time:11:21Witness:Kerri McCabePhoto #:2

Description: View of pump hours at the Tolland Lift Station.

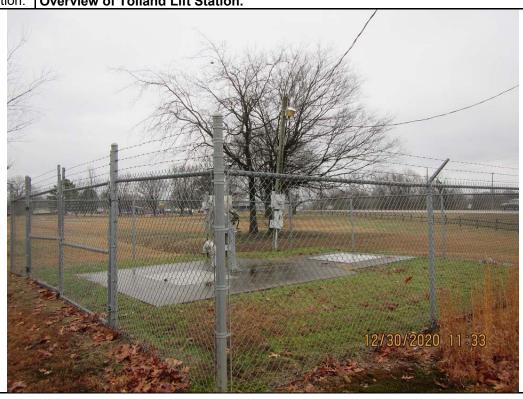
Office of Water Quality Photographic Evidence Sheet Location: City of Nashville WWTP Photographer: Brittanie Gloyd Date: 12/30/2020 Time: 11:33 Witness: Kerri McCabe Photo #: 3 Description: Overview of Tolland Lift Station.

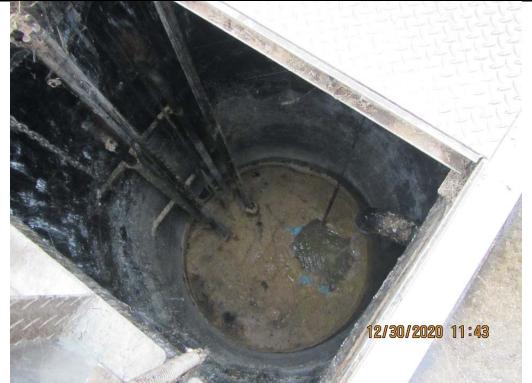
Photographer:Brittanie GloydDate:12/30/2020Time:11:43Witness:Kerri McCabePhoto #:4

<u>Hospital Lift Station</u> (located at coordinates 33.952039, -93.878405): This lift station services residential and commercial locations. There were solids and grease accumulation within the wet well, to which Mr. Dunaway stated they require the hospital to pump out the lift station regularly. There was contact information on the control panel in case of any emergency. The system is equipped with High Tide Monitoring System, which will notify the operators of high or low levels in the lift station.

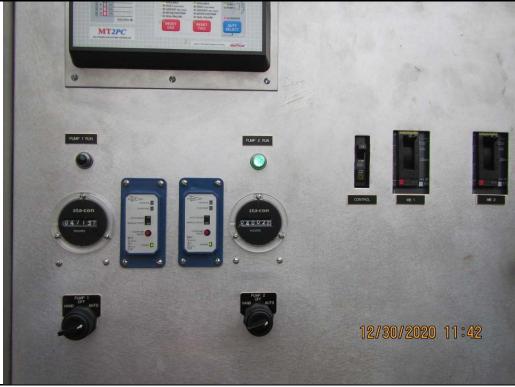
Office of Water Quality Photographic Evidence Sheet Location: City of Nashville WWTP Photographer: Brittanie Gloyd Date: 12/30/2020 Time: 11:42 Witness: Kerri McCabe Photo #: 5

Description: View of the pump hours at the Hospital Lift Station.

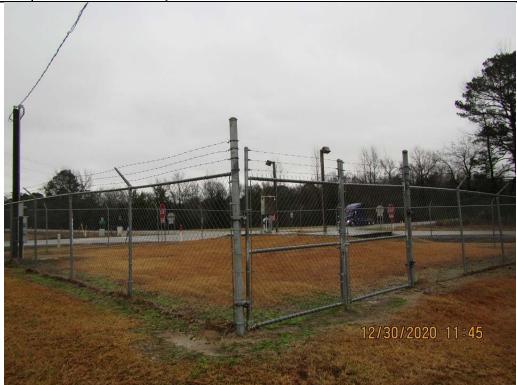
Photographer: Brittanie Gloyd	Date:	12/30/2020	Time:	11:45
Witness: Kerri McCabe			Photo #	6

Description: Overview of the Hospital Lift Station.

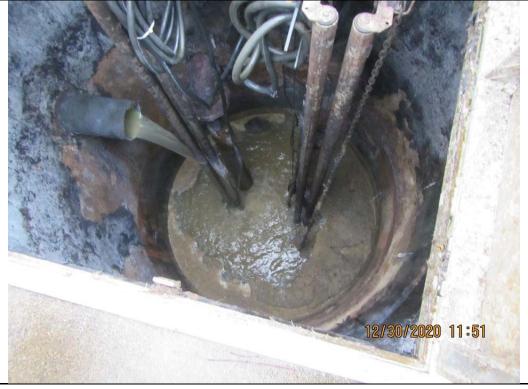
Office of Water Quality Photographic Evidence Sheet Location: City of Nashville WWTP Photographer: Brittanie Gloyd Date: 12/30/2020 Time: 11:51 Witness: Kerri McCabe Photo #: 7

<u>College Lift Station</u> (located at coordinates 33.952255, -93.869845): This lift station services residential and commercial locations. There was not an excess amount of accumulation in the wet well at the time of inspection. Contact information was posted on the control panel in case of an emergency. The system is equipped with High Tide Monitoring System, which will notify the operators of high or low levels in the lift station.

Description: View of the wet well at the College Lift Station.

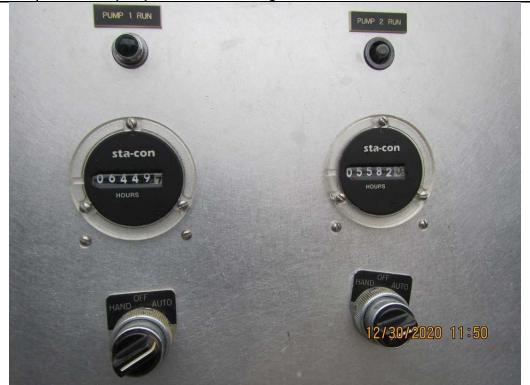
Photographer:Brittanie GloydDate:12/30/2020Time:11:50Witness:Kerri McCabePhoto #:8

Description: View of the pump hours at the College Lift Station.

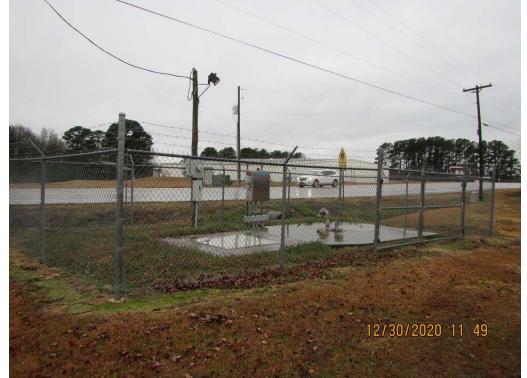
Office of Water Quality Photographic Evidence Sheet						
Location: City	y of Nashville WWTP					
Photographer:	Brittanie Gloyd	Date:	12/30/2020	Time:	11:49	
Witness: Kerr	i McCabe			Photo #	# : 9	
Description:	Overview of the College Lift Statio	n.
