**RE: Quarterly inspection conducted on March 29, 2021**  
**AFIN 32-00042**  
**Permit Number 0200-S3N-R2**

**Division of Environmental Quality**  
**Office of Land Resources - Solid Waste Management**  
**Class 3 Landfill Inspection**

<b>Site Name</b>	Entergy- Independence Plant	<b>County</b>	Independence	<b>AFIN</b>	32-00042
<b>Facility Address</b>	555 Point Ferry , Newark, AR 72562	<b>Phone Number</b>	870-799-8761 Entergy 870-799-3565	<b>Permit Number</b>	0200-S3N-R2
<b>Permittee Address</b>	555 Point Ferry , Newark, AR 72562	<b>E-Mail Address</b>	<a href="mailto:Awilso1@entergy.com">Awilso1@entergy.com</a>		<b>PDS #</b>   115535
<b>Date</b>	3/29/2021	<b>Entry Time</b>	1314	<b>Exit Time</b>	1430

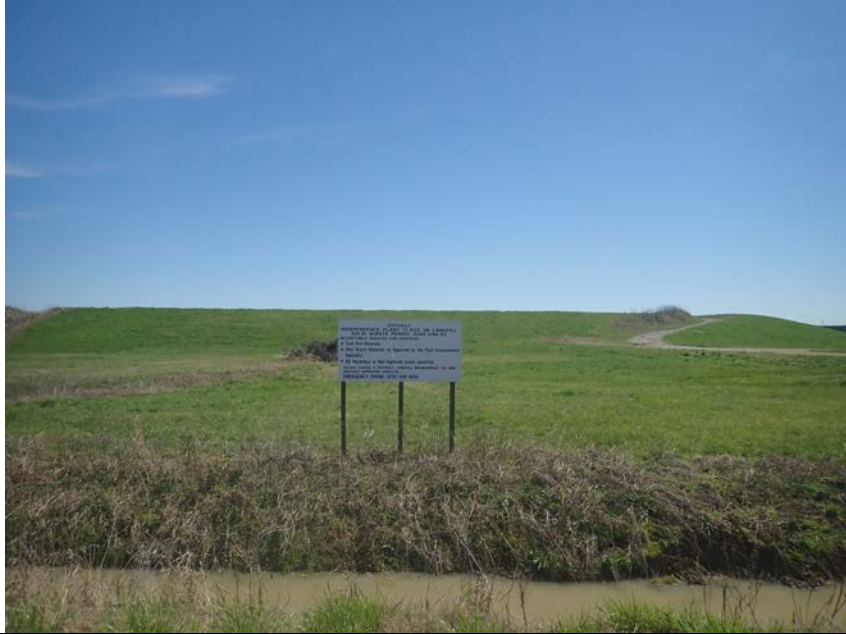
<b>Location</b>	Entergy-Independence Plant			<b>Permit</b>	0200-S3N-R2	<b>AFIN</b>	32-00042
<b>Photographer</b>	Darrell Norton , Inspector		<i>DN</i>	<b>Witness</b>	Anthony Wilson, Entergy		
<b>Photo #</b>	1	<b>Of</b>	4	<b>Date</b>	3/29/2021	<b>Time</b>	1326
<b>Description</b>	A view of the closed cells with recent mowing and signage visible.

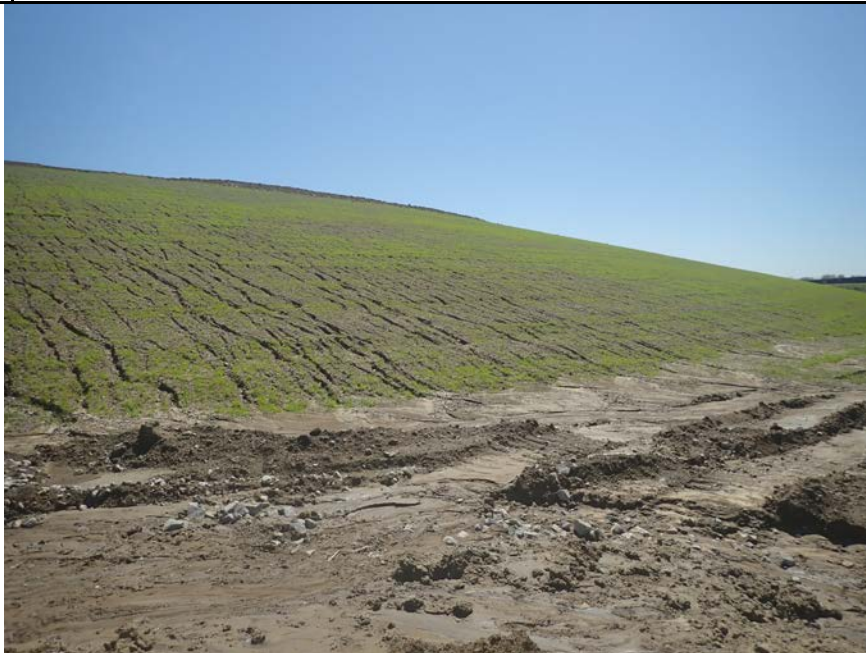
<b>Location</b>	Entergy-Independence Plant			<b>Permit</b>	0200-S3N-R2	<b>AFIN</b>	32-00042
<b>Photographer</b>	Darrell Norton, Inspector		<i>DN</i>	<b>Witness</b>	Anthony Wilson, Entergy		
<b>Photo #</b>	2	<b>Of</b>	4	<b>Date</b>	3/29/2021	<b>Time</b>	1335
<b>Description</b>	A view of Cell 14 with new vegetative growth visible. Facility observed with ongoing slope stabilization projects.

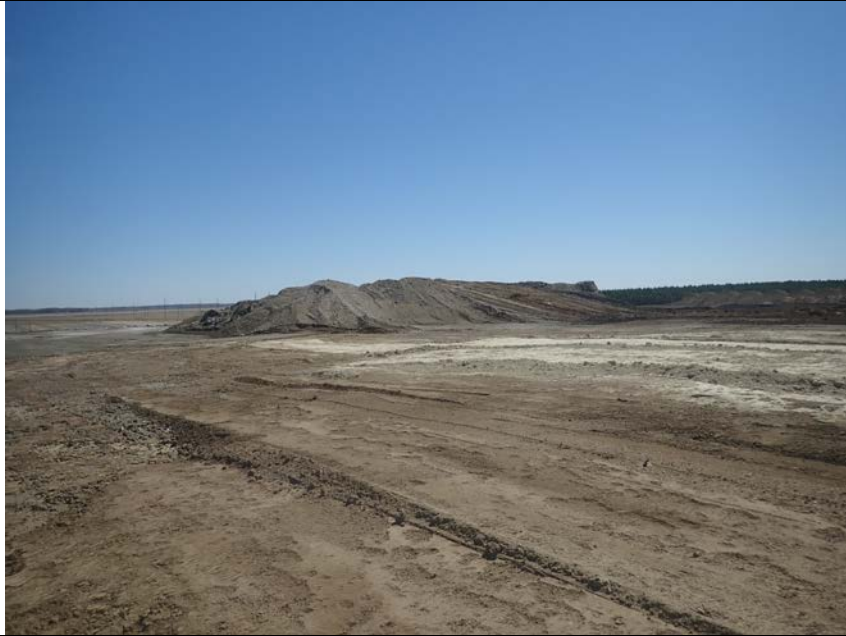
<b>Location</b>	Entergy-Independence Plant			<b>Permit</b>	0200-S3N-R2	<b>AFIN</b>	32-00042
<b>Photographer</b>	Darrell Norton , Inspector		<i>DW</i>	<b>Witness</b>	Anthony Wilson, Entergy		
<b>Photo #</b>	3	<b>Of</b>	4	<b>Date</b>	3/29/2021	<b>Time</b>	1343
<b>Description</b>	A view of stockpiled material on/near the working face.

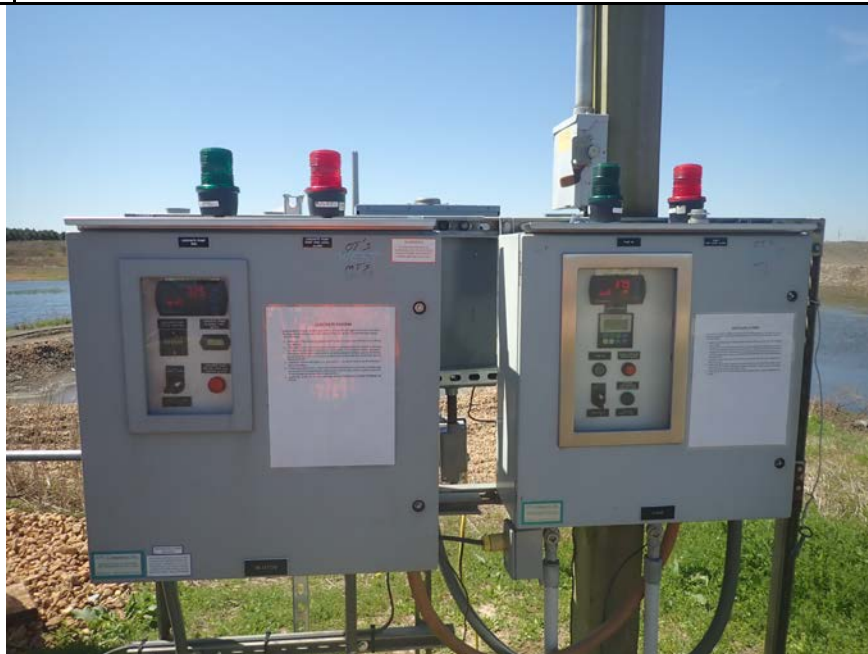
Regulation	Item Description	Comments
518	Surface water controls	
510(h)(1)	Contouring prevents surface water flowing into or through waste	
517(a)(b)	Run-on/off control system present and adequate	
510(h)(2)	Surface water control prevents off-site sediment accumulation	
510(h)(i)	Adequate maintenance of intermediate/final cover vegetation	
514	Gas monitoring program	
510(n)	Leachate leaks or evidence of leachate seepage	
526	Survey controls	
529	Leachate collection system	Leachate system currently operating with second pump in "off" position.
519	Liquid restrictions

<b>Location</b>	Entergy-Independence Plant			<b>Permit</b>	0200-S3N-R2	<b>AFIN</b>	32-00042
<b>Photographer</b>	Darrell Norton, Inspector		<i>DW</i>	<b>Witness</b>	Anthony Wilson, Entergy		
<b>Photo #</b>	4	<b>Of</b>	4	<b>Date</b>	3/29/2021	<b>Time</b>	1359
<b>Description</b>	A view of the leachate control panels for the collection system in Cell 15.
