RE: Inspection conducted on September 24, 2021
AFIN 63-00155
Permit Number 0261-S1-R3

Office of Land Resources
Regulated Waste Operations
Class 1 Landfill Inspection Form

Site Name	BFI Waste Systems of Arkansas	County	Saline	AFIN	63-00155
Facility Address	18511 W Sardis Road, Bauxite, AR	Phone #	901-873-8334 Slade 501-602-8440 Robert	Permit #	0261-S1-R3
Permittee Address	18511 W Sardis Road, Bauxite, AR	Email Address	Spatterson2@republicservices.com RSanchez2@republicservices.com	PDS #	117766
Date	9/24/2021	Entry Time	0940	Exit Time	1200

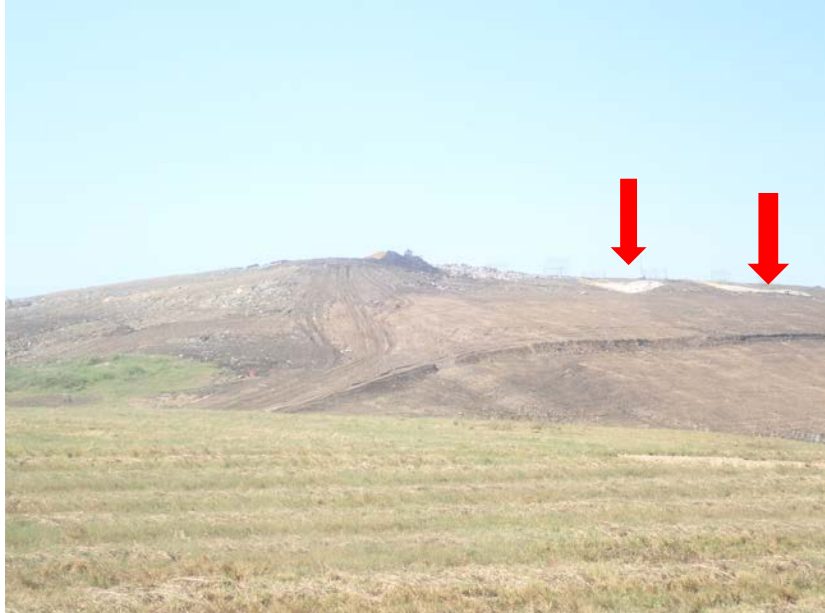
Regulation	Item Description	Comments
X	411(a)	Operations in Accordance with Permit Documents	Tarps were observed at the working face. (Refer to Photo #1.) The alternate daily cover (ADC) demonstration period of six (6) months has expired. (Refer to Doc #78988.) Should BFI wish to continue use of the tarps as an ADC, a demonstration report must be submitted so a determination can be made. (Refer to Documents #71225.)
	411(c)	Smallest Practical Area, Unloading Supervised, Single Working Face	
	411(b)	Operations by Licensed On-site Personnel at All Times	
	411(g)	Litter Control Provisions Maintained	
	427	Surface Water Controls	
	411(h)(1)	Contouring Prevents Surface Water Flowing Into or Through Waste	
	418(a)(b)	Run-on/off Control System Present and Adequate	
	411(h)(2)	Surface Water Control Prevents Off-site Sediment Accumulation	
	411(i)	Adequate Maintenance of Intermediate/Final Cover Vegetation

Location	BFI Waste Systems of Arkansas				Permit	0261-S1-R3	AFIN	63-00155
Photographer	Kim Davenport, Inspector			<i>KD</i>	Witness	N/A		
Photo #	1	Of	4		Date	9/24/2021	Time	1024
Description	ADC (Tarps) observed at the working face.

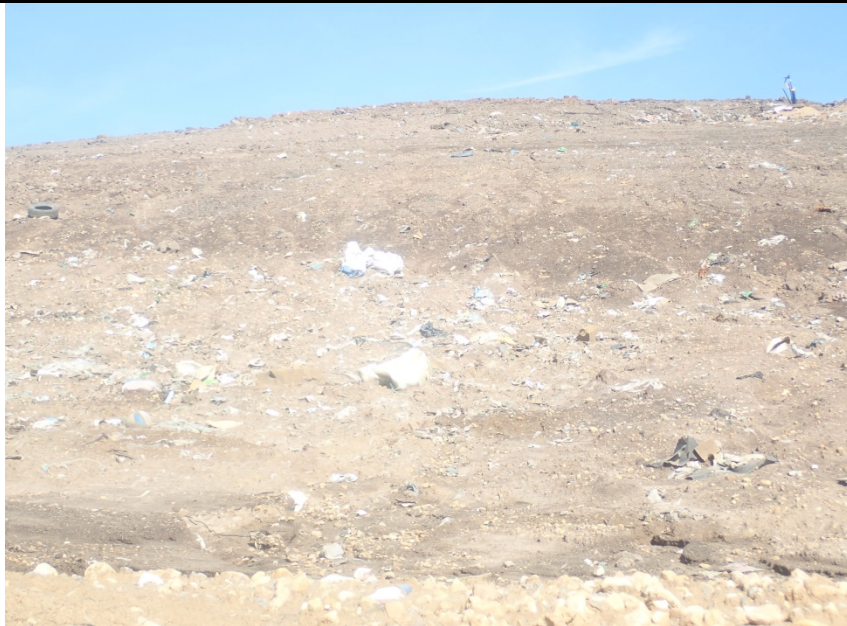
X	411(o)	Erosion or Other Cover Defects Resulting in Exposed Refuse	Exposed waste observed on the outer slopes of Cells 1 - 5, which are under interim cover. (Refer to Photos #2 - #4.)			
	309(c)	Overfill/Off Lined Area				
Records						
Date of Last Annual Report		3/31/2021	Date of Last Quarterly Methane Monitoring		8/30/2021	
Date of Last Groundwater Monitoring Report		8/19/2021	Previous Quarter Waste Received		75,424 Tons	
Operator Name & Number		Darrell Wessell - 002923	Signature of Inspector

Location	BFI Waste Systems of Arkansas				Permit	0261-S1-R3	AFIN	63-00155
Photographer	Kim Davenport, Inspector			<i>KD</i>	Witness	N/A		
Photo #	2	Of	4		Date	9/24/2021	Time	1045
Description	An example of exposed waste with interim cover on the east slope.

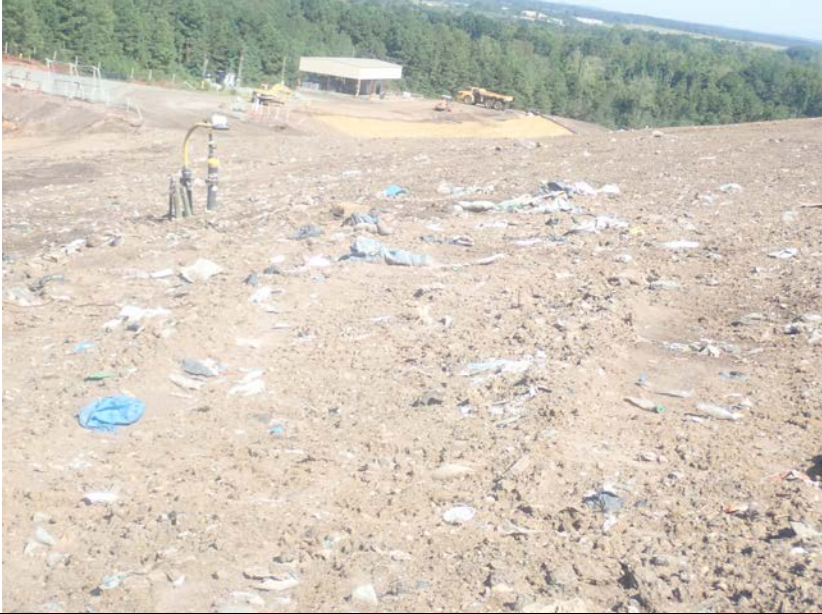
Witness	N/A		
Photo #	3	Of	4		Date	9/24/2021	Time	1053
Description	An example of exposed waste with interim cover on the west slope.
