RE: City of Pocahontas WWTP Inspection

AFIN: 61-00055 Permit No.: AR0034835

OFFICE OF WATER QUALITY **INSPECTION REPORT**

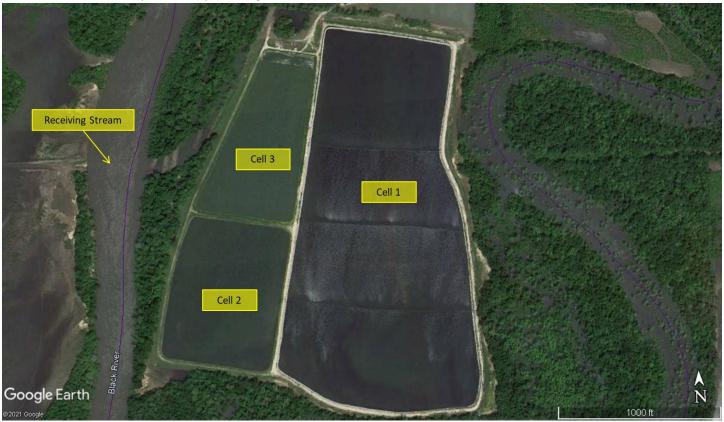
Figure 1. Google Earth image overview of the City of Pocahontas WWTP with labels for different parts treatment.

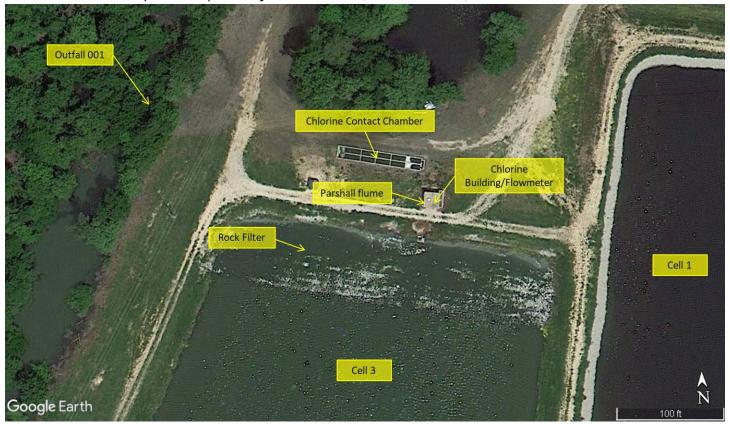
Figure 2. Google Earth image zoomed into the City of Pocahontas WWTP with labels for the specific areas of treatment.

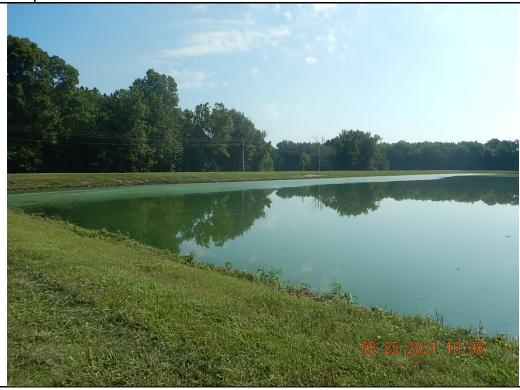
Photographer:Sarah FrasherDate:8/25/2021Time:10:08Witness:NonePhoto #:2

The levee between the cells has been evaluated and improved since the last inspection (Photo 2).

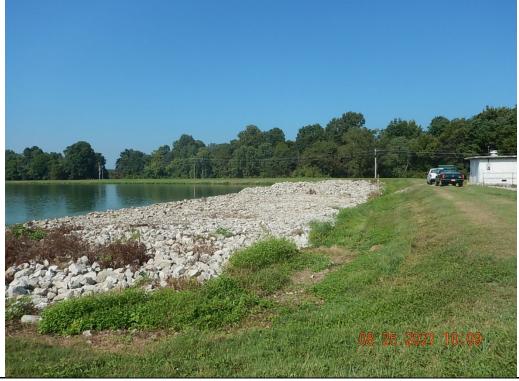
Photographe	er: Sarah Frasher	Date:	8/25/2021	Time:	10:10
Witness: No	one			Photo #:	4

Description: View of the rock filter. Note the valve to the Outfall structure.

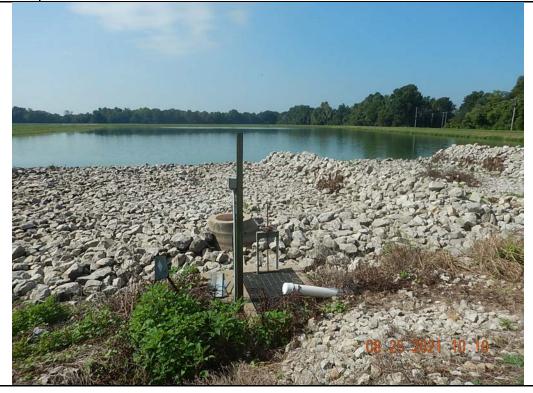
Office of Water Quality Photographic Evidence Sheet Location: City of Pocahontas Photographer: Sarah Frasher Witness: None Date: 8/25/2021 Time: 10:16 Photo #: 5

Rock filter was in the process of rehabilitation with the rotation of rocks to aid in filtration (Photo 5).

Description: View of the of the rock filter. Note the rotation of the rock.

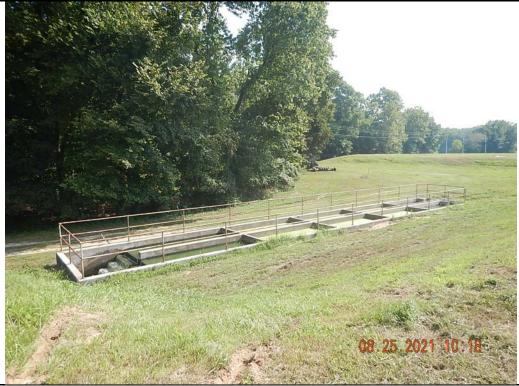
Photographer: Sarah Frasher	Date: 8/25/2021	Time:	10:12
Witness: None		Photo #:	8

- 1. Chlorine contact chamber was observed to be in need of removal of algae and duckweed (Photos 8-9) in violation of Part III, Section B.1.a of the permit. The City of Pocahontas schedules the cleaning of the chlorine contact chamber once a year that should be completed in the fall.

Description: Close-up view of the chlorine contact chamber. Note the duckweed on the surface and the color of the water.

- 1. Maintenance and cleaning of the contact chamber was done on 9/7 and 9/9/21. To remove buildup and will be repeated as necessary.
- 2. Employees will collect 4 samples instead of 3 at sampling dates as required in response to the 8/25/21 inspection.
- 3. Employees will use daily totals for sampling to ensure loading calculation on DMR.
