**RE: Inspection conducted on December 13, 2021**  
**AFIN 63-00155**  
**Permit Number 0261-S1-R3**

**Office of Land Resources**  
**Regulated Waste Operations**  
**Class 1 Landfill Inspection Form**

<b>Site Name</b>	BFI Waste Systems of Arkansas	<b>County</b>	Saline	<b>AFIN</b>	63-00155
<b>Facility Address</b>	18511 W Sardis Road, Bauxite, AR	<b>Phone #</b>	901-873-8334 (Brad Zimmerman) 501-602-8440 (Robert Sanchez)	<b>Permit #</b>	0261-S1-R3
<b>Permittee Address</b>	18511 W Sardis Road, Bauxite, AR	<b>Email Address</b>	<a href="mailto:Bzimmerman2@republicservices.com">Bzimmerman2@republicservices.com</a> <a href="mailto:RSanchez2@republicservices.com">RSanchez2@republicservices.com</a>	<b>PDS #</b>	118596
<b>Date</b>	12/13/2021	<b>Entry Time</b>	1300	<b>Exit Time</b>	1515

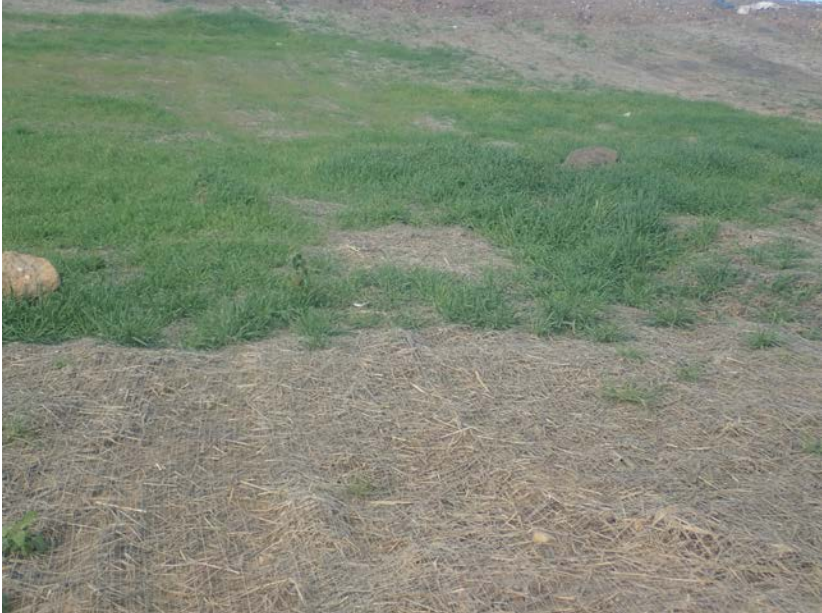
<b>Witness</b>	N/A		
<b>Photo #</b>	1	<b>Of</b>	6		<b>Date</b>	12/13/2021	<b>Time</b>	1354
<b>Description</b>	Test area at Cell 2 south is observed, looking south.

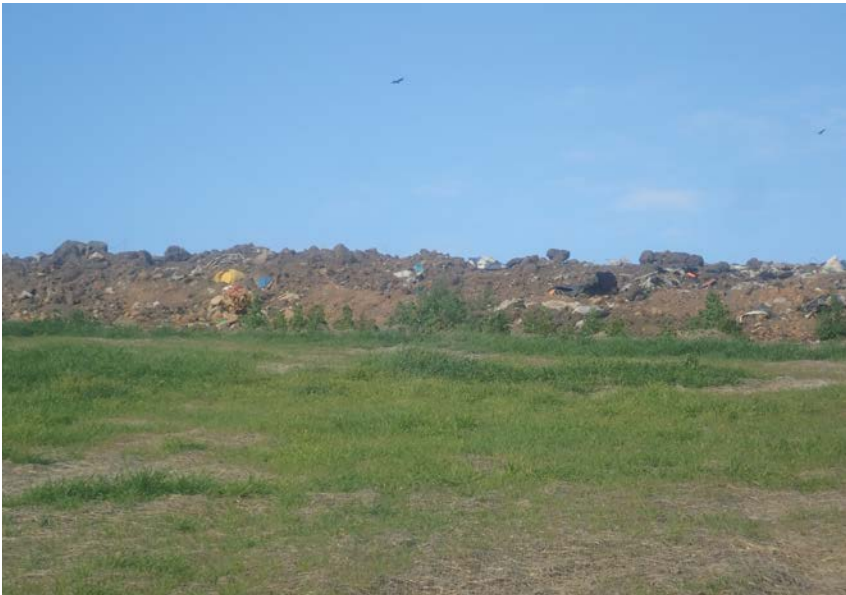
<b>Regulation</b>	<b>Item Description</b>	<b>Comments</b>
	411(a)	Operations in Accordance with Permit Documents	
	411(c)	Smallest Practical Area, Unloading Supervised, Single Working Face	
	411(b)	Operations by Licensed On-site Personnel at All Times	
	411(g)	Litter Control Provisions Maintained	
	427	Surface Water Controls	
	411(h)(1)	Contouring Prevents Surface Water Flowing Into or Through Waste	
	418(a)(b)	Run-on/off Control System Present and Adequate	
	411(h)(2)	Surface Water Control Prevents Off-site Sediment Accumulation	
	411(i)	Adequate Maintenance of Intermediate/Final Cover Vegetation	Cells 1-5, now under interim cover, as referenced in Doc #79863, have historically been unable to grow vegetation due to acidic soils. (Refer to Doc #76882.) New test areas have succeeded in growing vegetation (Refer to Photos #1 - #3); however, excluding the small test areas, all of Cells 1-5 remain un-vegetated and unable to hold a soil cover. (Refer to Photos #2 & #4 - #6.)

<b>Regulation</b>	<b>Item Description</b>	<b>Comments</b>
X	413(c)	Satisfactory Intermediate Cover	Exposed waste observed at Cells 1-5. (Refer to Photos #2 & 4 - #6.)
	419(a)(5)	Cause Discharge/Leachate Leaving Landfill	
	411(f)(3)	Depositing Waste in Standing Water Prohibited	
	411(o)	Erosion or Other Cover Defects Resulting in Exposed Refuse

<b>Witness</b>	N/A		
<b>Photo #</b>	2	<b>Of</b>	6		<b>Date</b>	12/13/2021	<b>Time</b>	1355
<b>Description</b>	Test area at Cell 2 north is observed, looking north. Exposed waste is observed across the top of Cell 4.

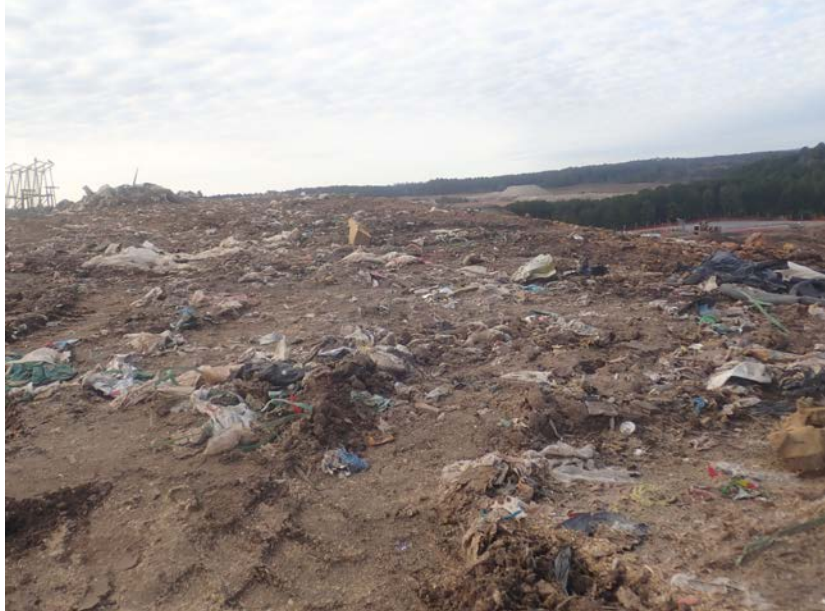
<b>Witness</b>	N/A		
<b>Photo #</b>	5	<b>Of</b>	6		<b>Date</b>	12/13/2021	<b>Time</b>	1415
<b>Description</b>	An example is shown of exposed waste in the interim cover across the top of Cells 3-5, looking west.

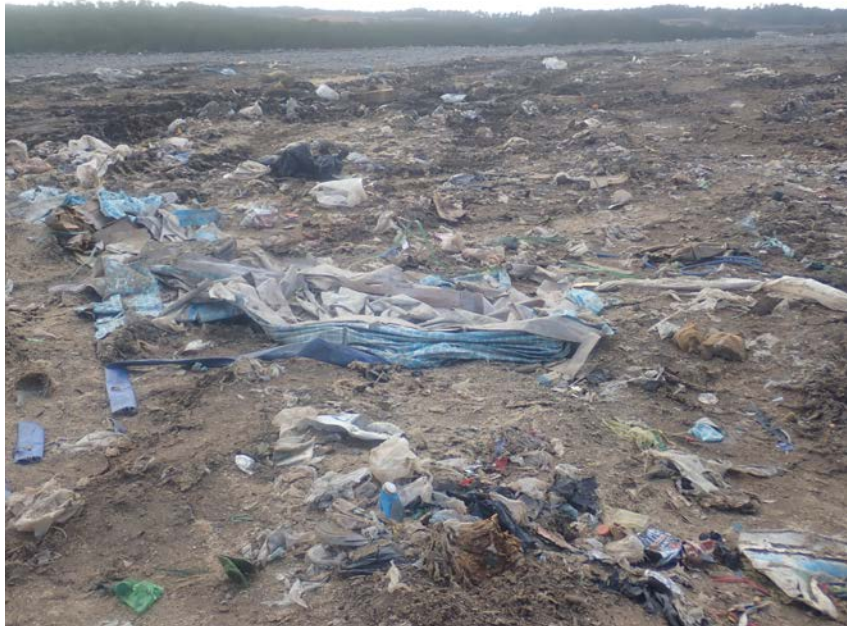
<b>Witness</b>	N/A		
<b>Photo #</b>	6	<b>Of</b>	6		<b>Date</b>	12/13/2021	<b>Time</b>	1417
<b>Description</b>	An example is shown of exposed waste across the top of Cell 4, looking south.
